WALBACH TOWER, BATTERY FARNSWORTH, ASSOCIATED STRUCTURES, AND ENVIRONS

Fort Point
New Castle, New Hampshire

HISTORIC STRUCTURES REPORT

PART II

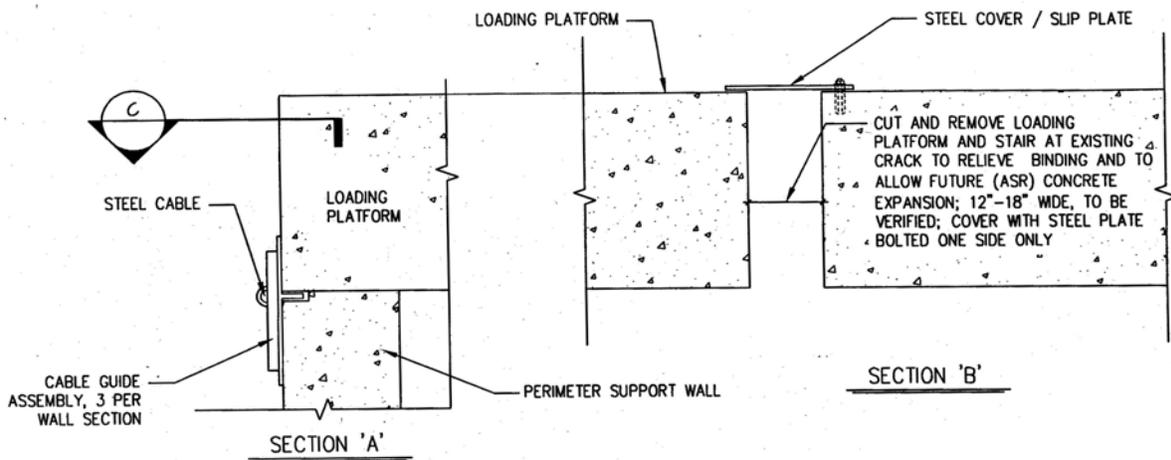
Another means of stabilization proposed by the University of New Hampshire is a system of steel plates and cables as shown in Figure 1, designed to restrain the outward movement of the wall at Gun Emplacement No. 1. A more detailed review by a structural engineer would possibly result in the addition of more vertical bracing and/or shoring, but this is a feasible means of providing a significant level of protection against catastrophic structural failure. This is a moderately reversible treatment, and will have minimal visual impact on the structure as proposed. As with other stabilization measure, the effective life span of this treatment would be in the range of 15- 20 years.

Figure 1. Detail of conceptual stabilization recommendations including relieving cut in loading platform slab and use of steel cable and plate to restrain outward movement of wall.

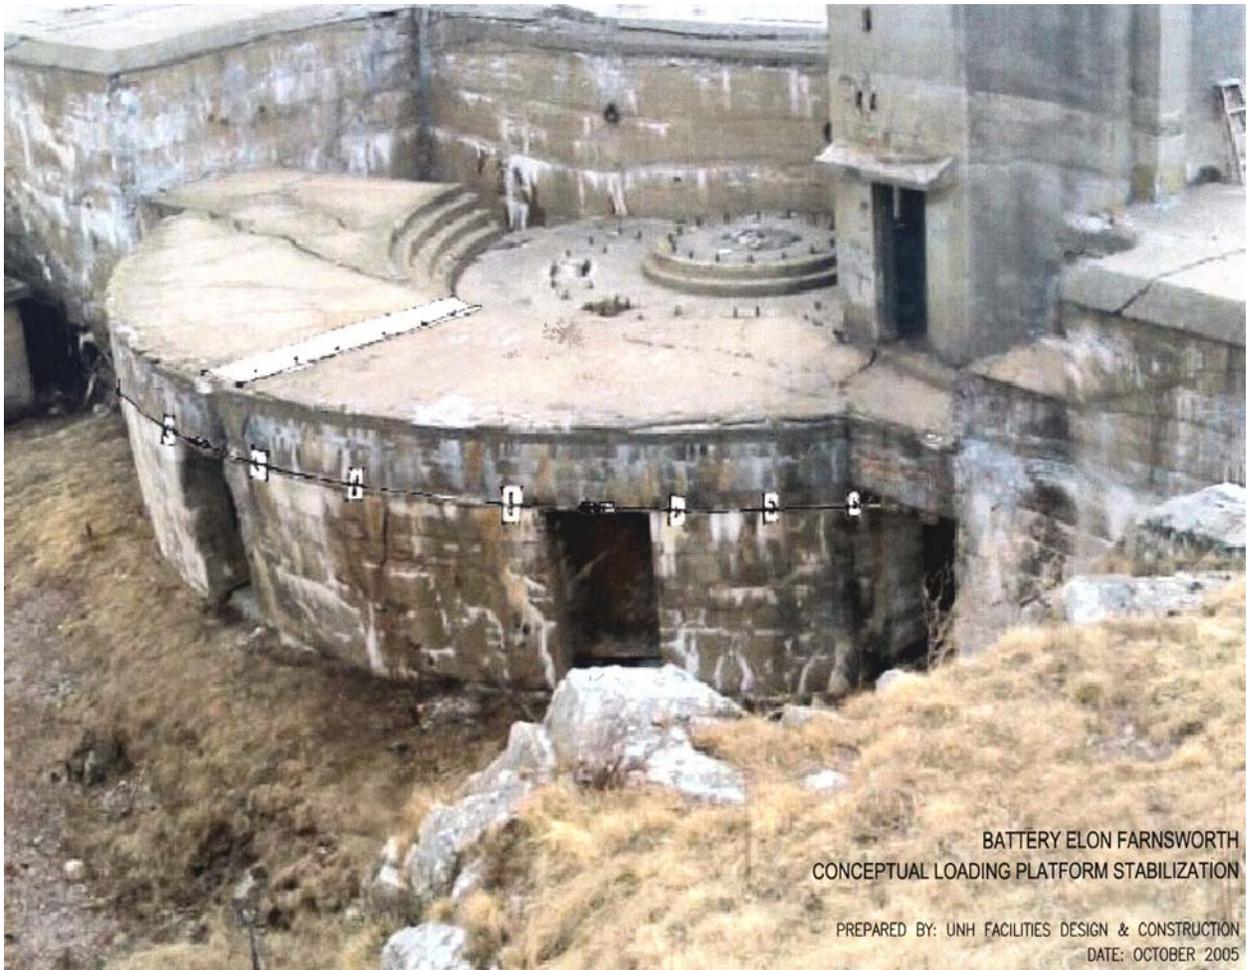
Figure 2. Conceptual Loading Platform stabilization plan.

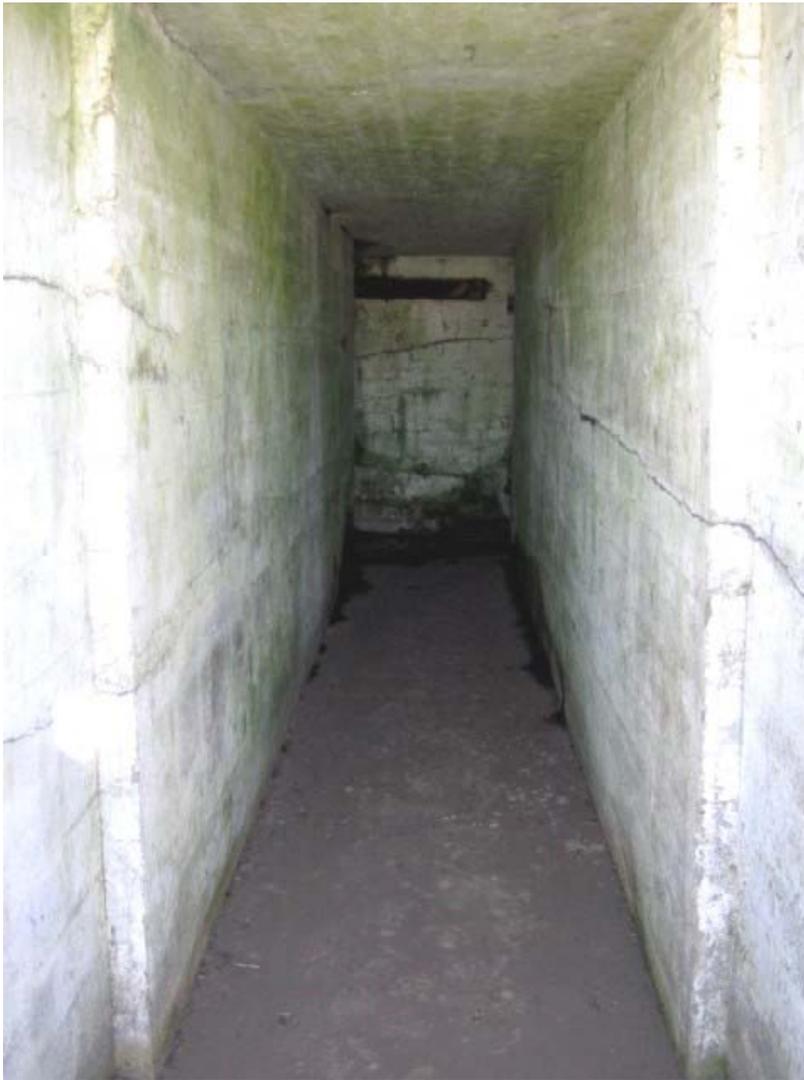
Casemate Entry Corridor

View from entry portal, looking down the length of the corridor

The pattern of horizontal cracking in the corridor is similar and related to the pattern of cracking in the mining casemate, with the highest crack in the casemate presenting on the northeast corridor wall as a crack 60"- 64" above the floor. The middle crack in the casemate presents on the southwest wall of the corridor approximately 52" above the corridor floor. There is particularly active moisture penetration in the middle of the length of the crack in the southwest wall. Biological growth appears on both walls, as a symptom of damp conditions. Standing water is present in the east end of the corridor.

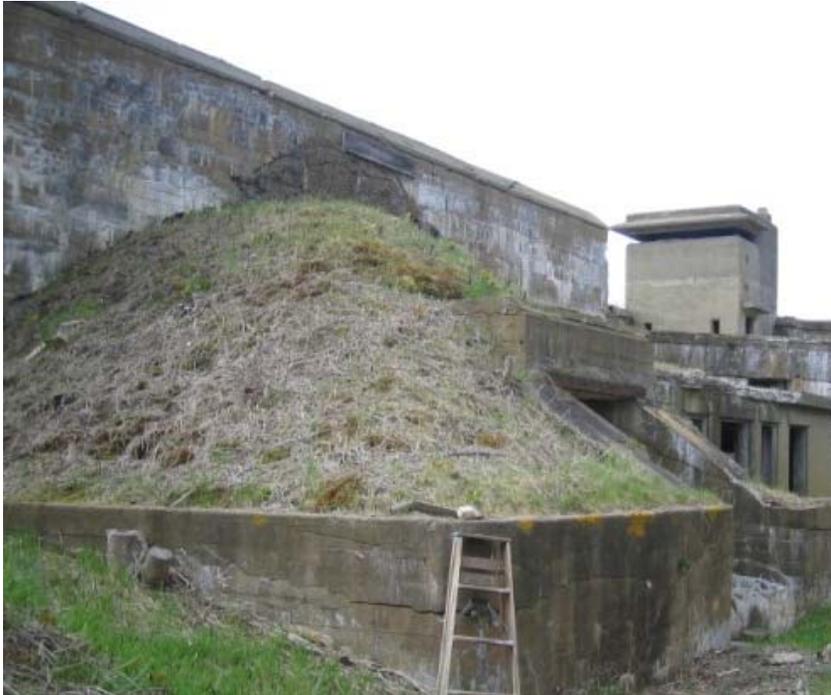
“Façade” Between Gun Loading Platforms and Above Long Corridor Entrance

Description: HC: esp. in section w/ removed berm and w/o cementitious skin
LC/ DC: coping
*SC
*MD: 50%
DC: at northeast end, along commander's post and along southwest side of removed berm

Deficiencies: mineral deposits
horizontal cracking (typically at cold joints)
cracking at dissimilar material interfaces
spiderweb cracking

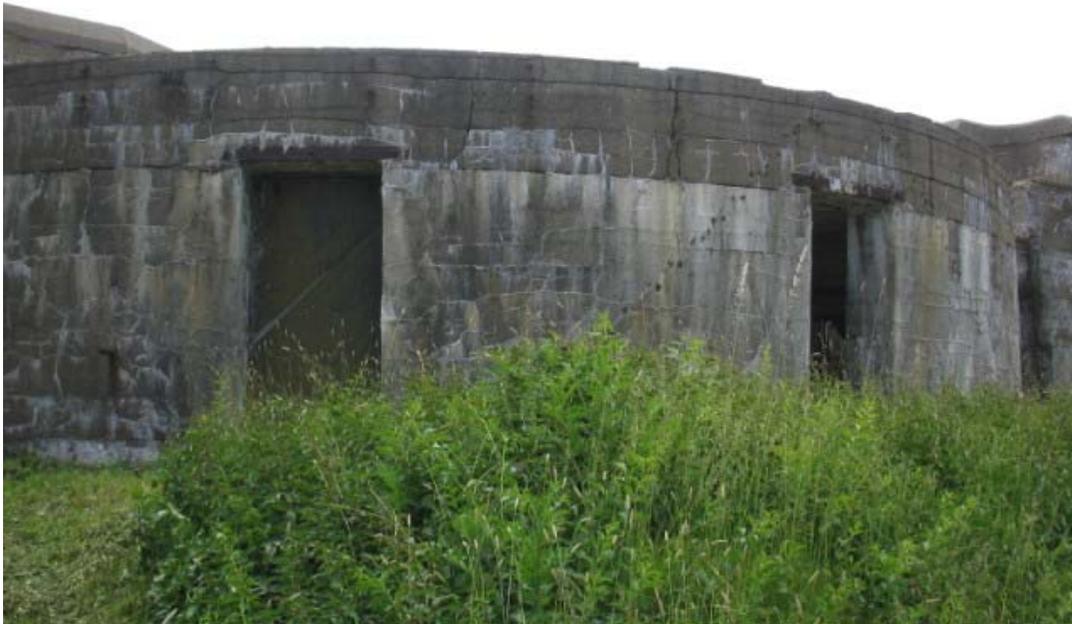
Fascia of Loading Platform Floor/ Roof Slab

Description: *SM: about half as much as No. 1
SP: 50% cornice
(SC/ MD)

Deficiencies: structural movement/deformation
large- scale structural cracking (more than 1" wide)
spalling
horizontal cracking (typically at cold joints)

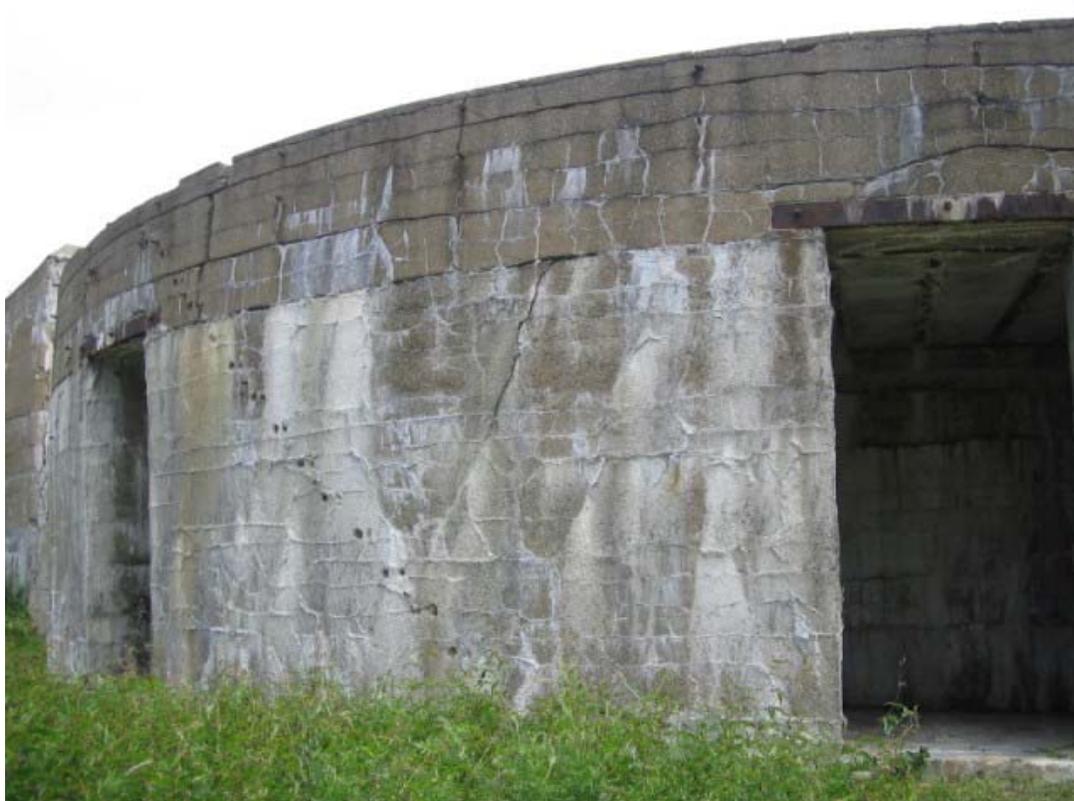
**West Section of Curved Wall Below Roof Slab
(Exterior of Guard and Shot Rooms)**

Description: *SC
MD: 90%

Deficiencies: structural movement/deformation
horizontal cracking (typically at cold joints)
diagonal cracking
spiderweb cracking

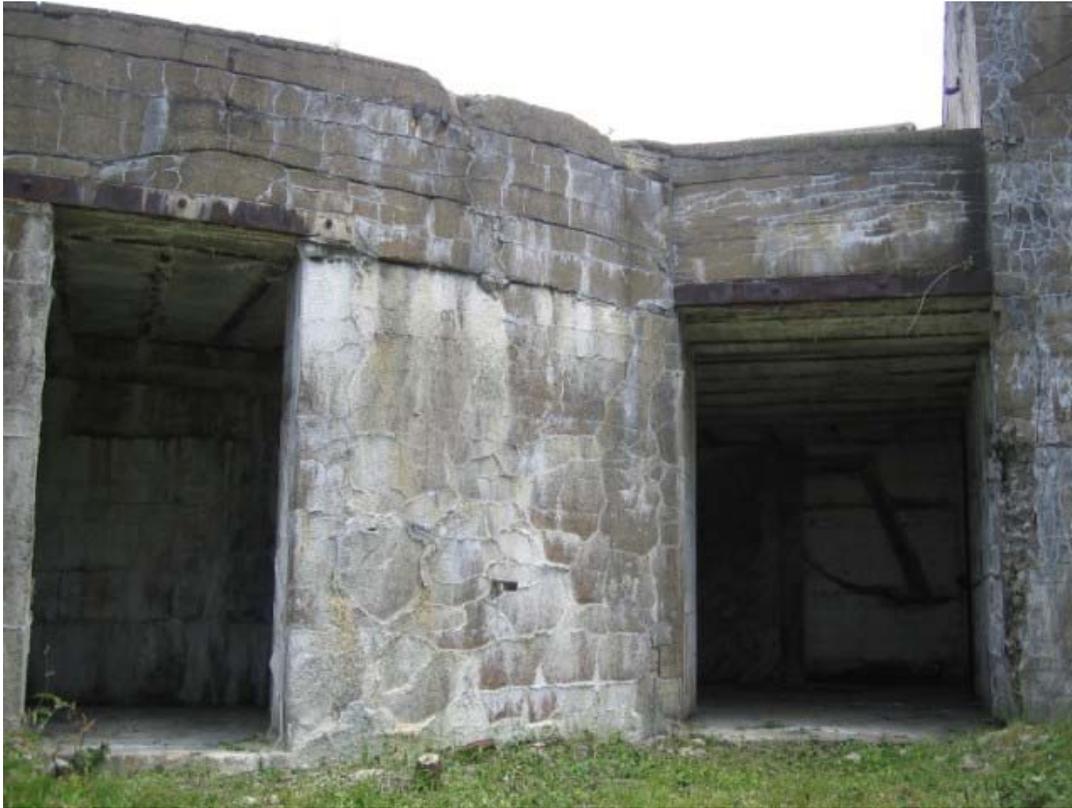
**Southwest Section of Curved Wall Below Roof Slab
(Exterior of Shot Room)**

Description: *SC
MD: 80%
(HC)

Deficiencies: spiderweb cracking
mineral deposits
horizontal cracking (typically at cold joints)

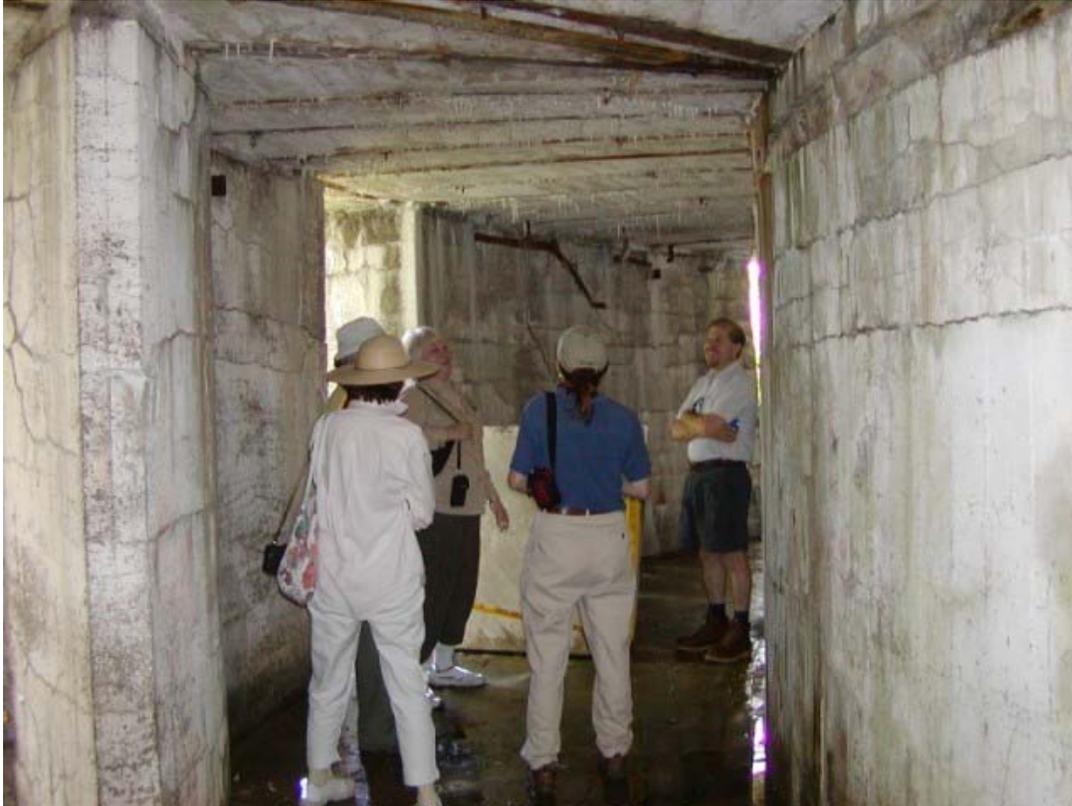
Curved Back Wall Opposite Entrance

Description: *MG: heavy, pronounced patches
MD: esp. along bottom and in center
SD: bottom 1'

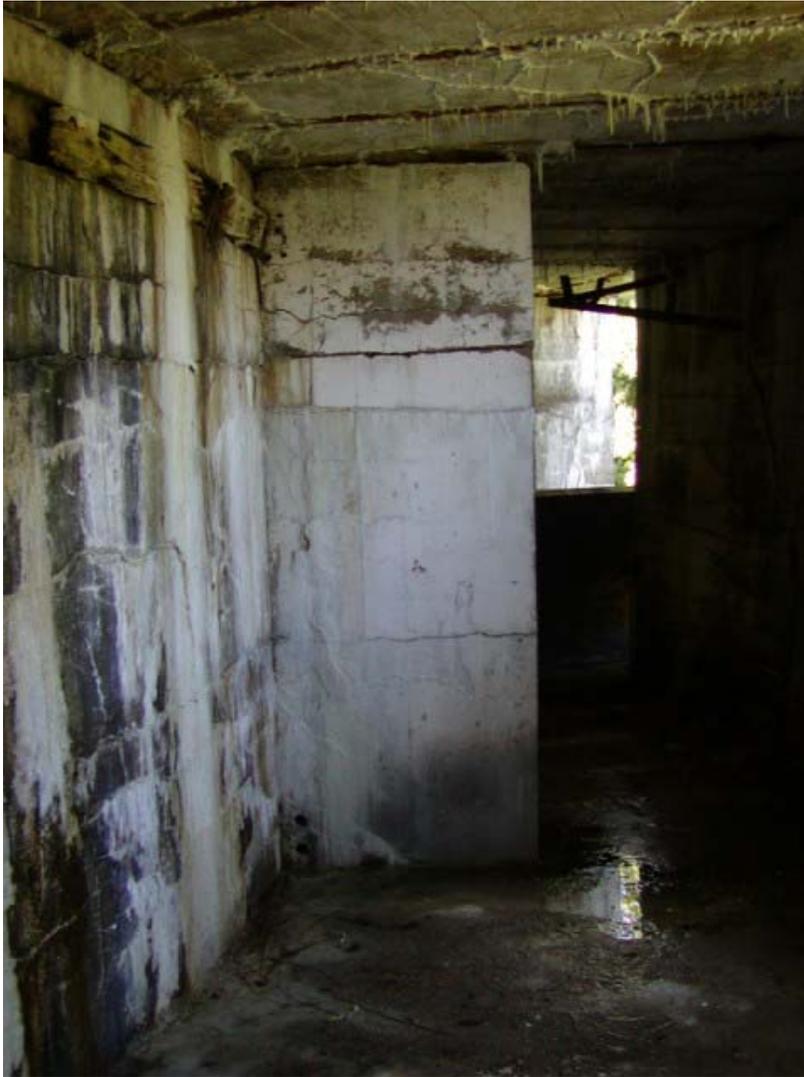
Stub Wall (Shared With Guard Room)

Description: HC
*SM: upper third
*MD: 50%; thick

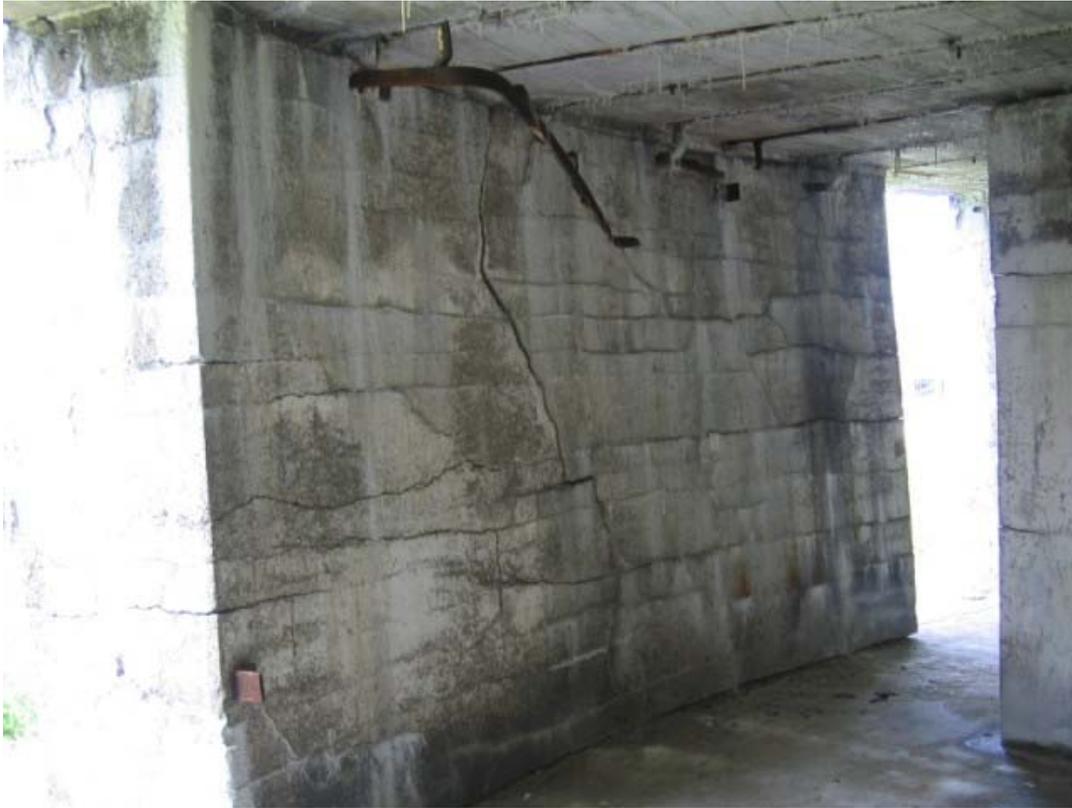
Front Curved Wall (Shared With Guard Room)

Description: *DC/ LC: down middle
MD: 70%

Deficiencies: structural movement/deformation
diagonal cracking
large- scale structural cracking (more than 1" wide)
horizontal cracking (typically at cold joints)

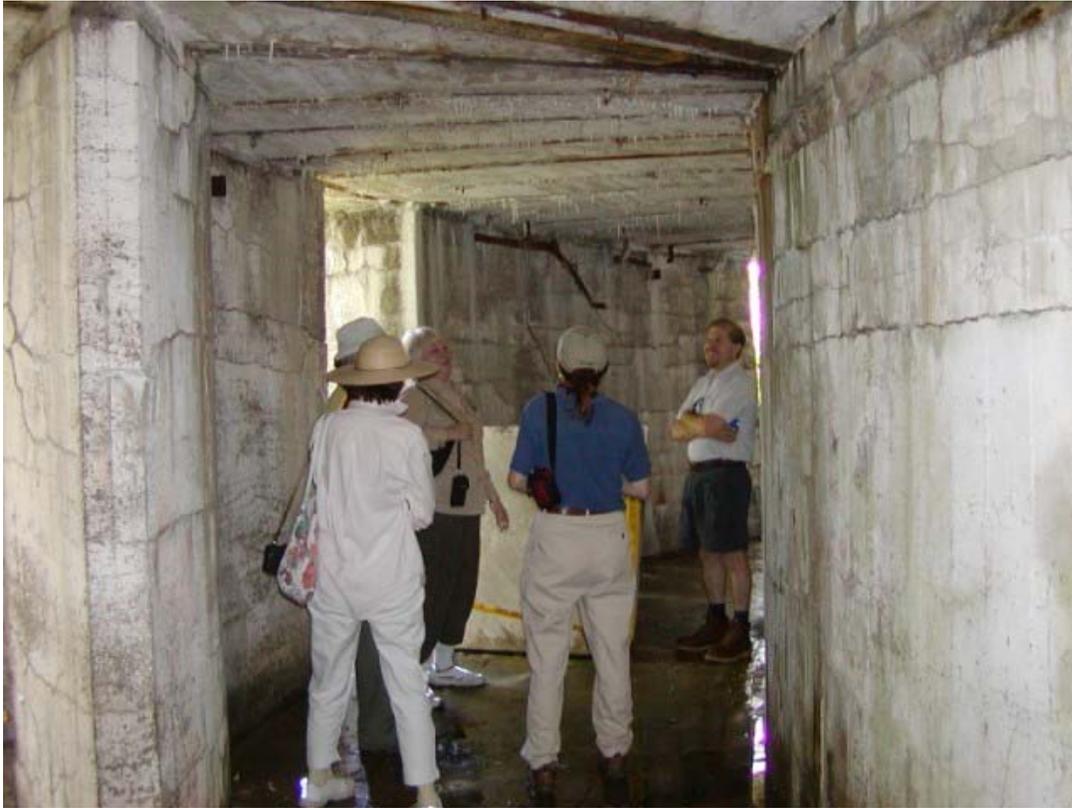
Curved Entrance Wall

- Description: (SM)
SW/ MD: minor, except at southwest edge and at southwest return of wall
(northeast of straight corridor entrance)
- Deficiencies: horizontal cracking (typically at cold joints)
diagonal cracking
structural movement/deformation
standing water

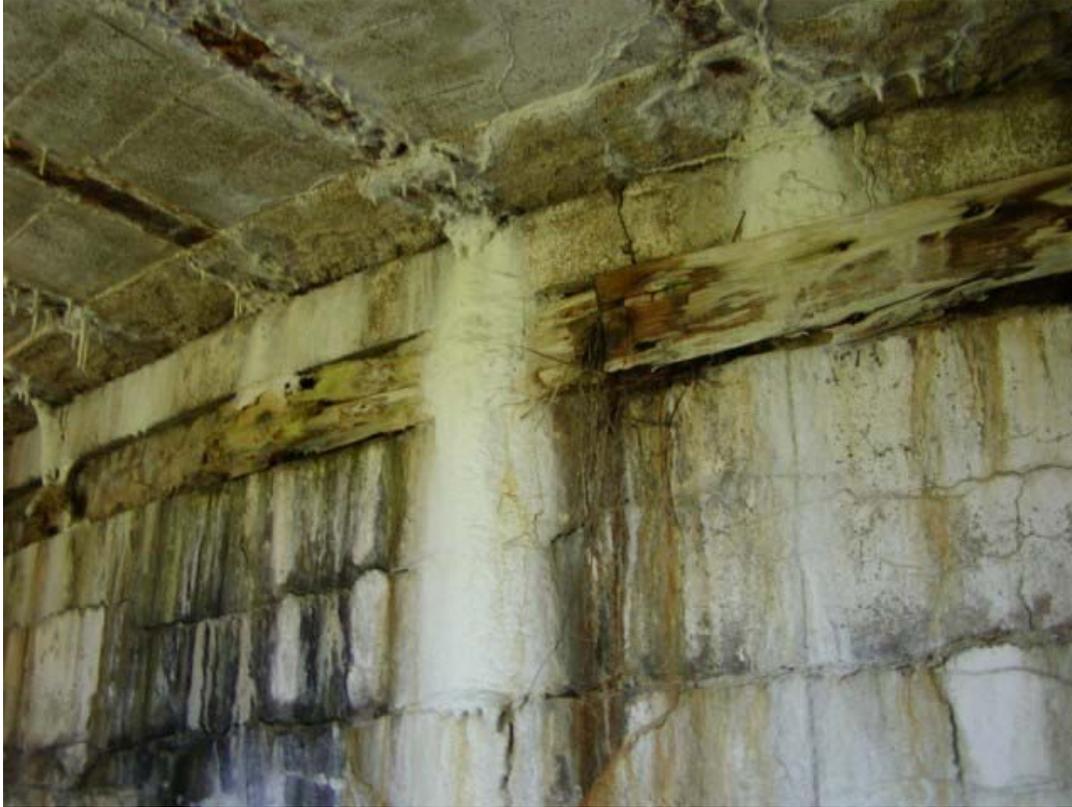
Curved Back Wall Opposite Entrances

Description: *SD: @bottom of biological growth
 *MG: 20%, some very thick
 *MD: 60%; very heavy
 *SC

Deficiencies: horizontal cracking (typically at cold joints)
 spiderweb cracking
 mineral deposits
 microbiological growth

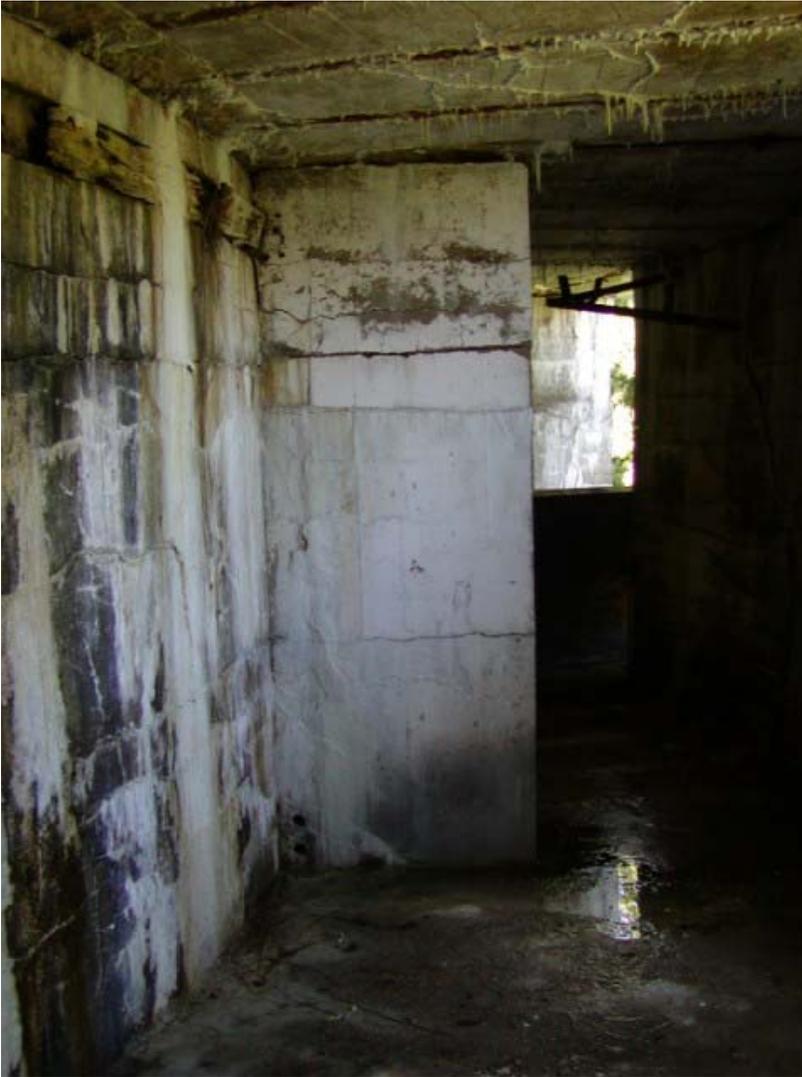
Floor

View of Guard Room interior looking southwest; note standing water

Description: MD: stalagmite “nubs”
*SW: 50%

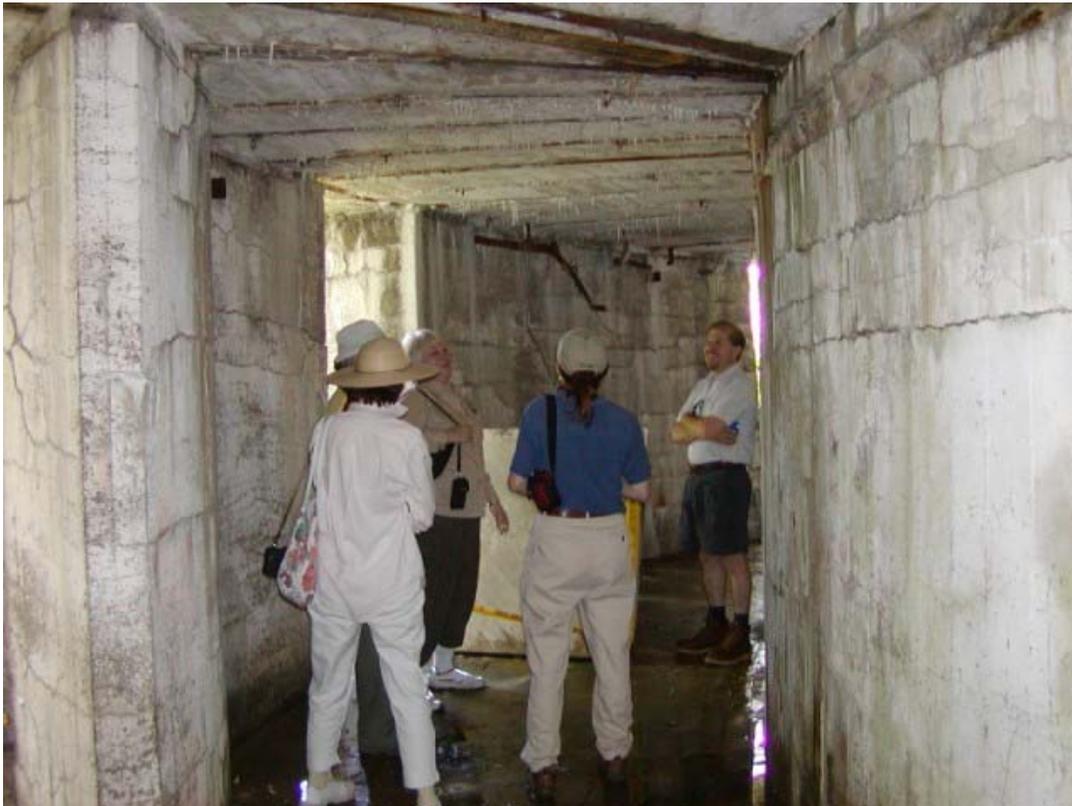
Curved Entrance Wall

Description: *HC/ VC/ DC: big stepped HC through middle; VC's at one- third wall intervals
*SM: tilted forward
MD: 50%, esp. at bottom
(SC)

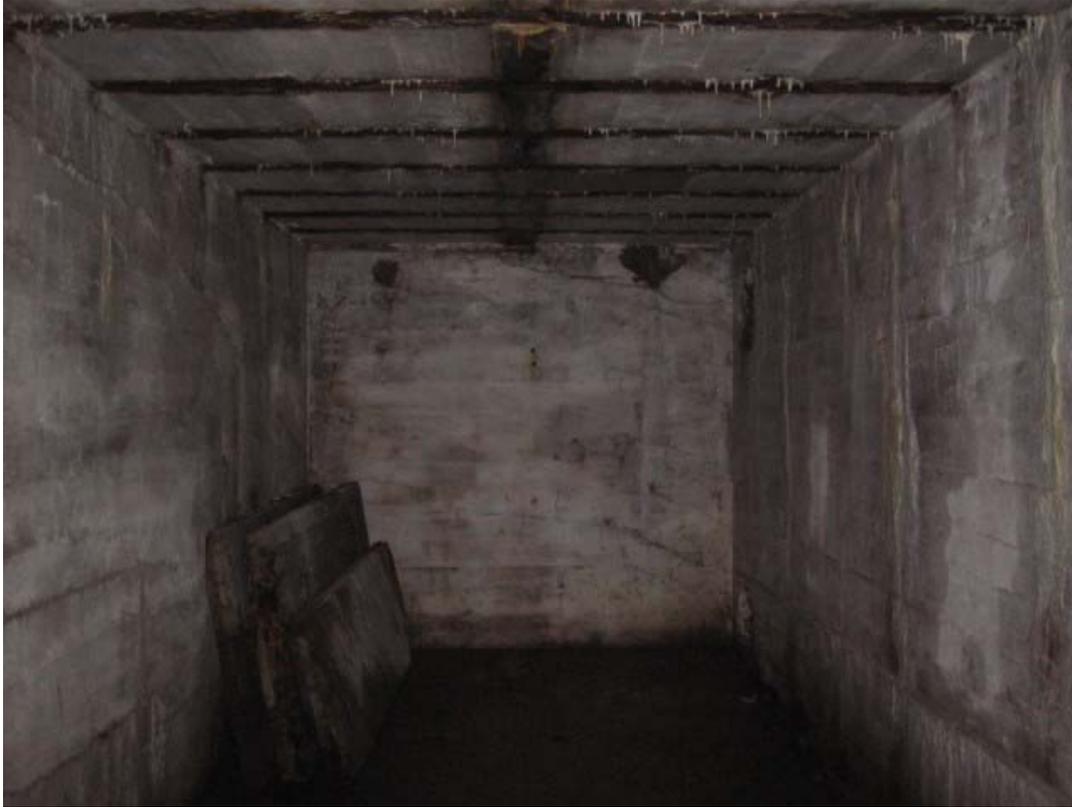
Ceiling

Deficiencies: oxide jacking
 surface dampness
 mineral deposits

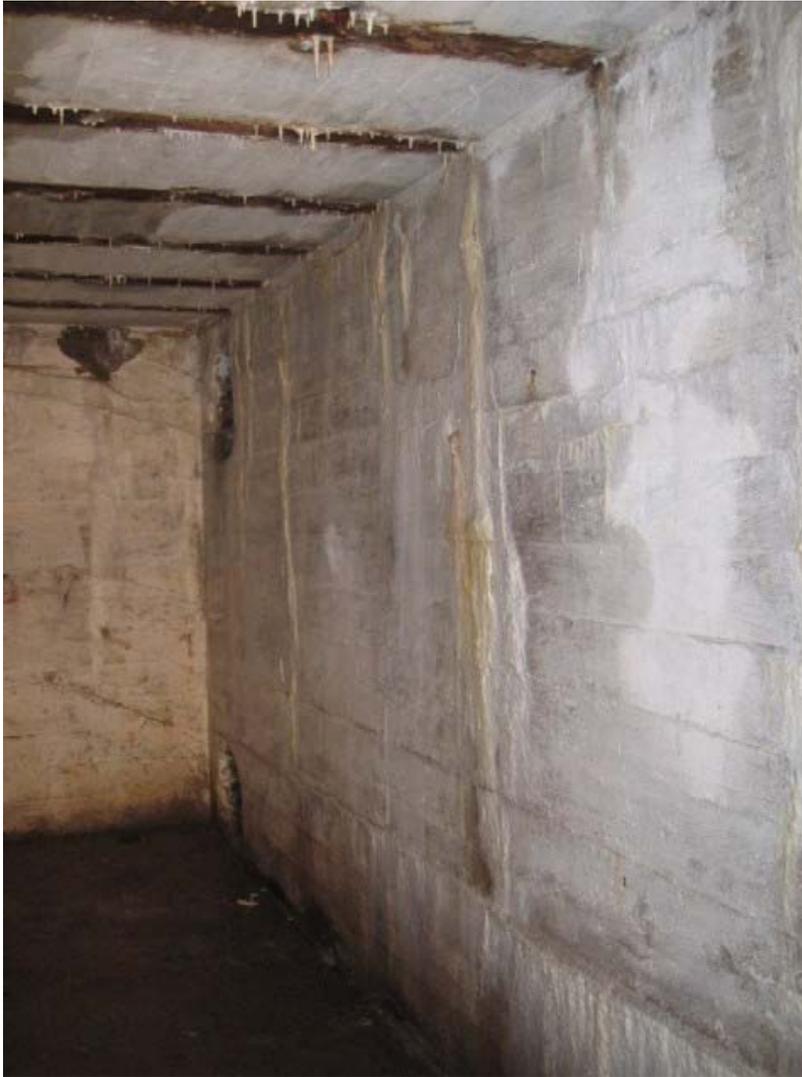
Walls

Description: HC/ DC: two on southeast wall become one on southwest wall, continuing on northwest wall
MD: in areas along crack, esp. northwest wall. "Cascades" at ceiling beams on southwest wall

Deficiencies: horizontal cracking (typically at cold joints)
diagonal cracking
mineral deposits

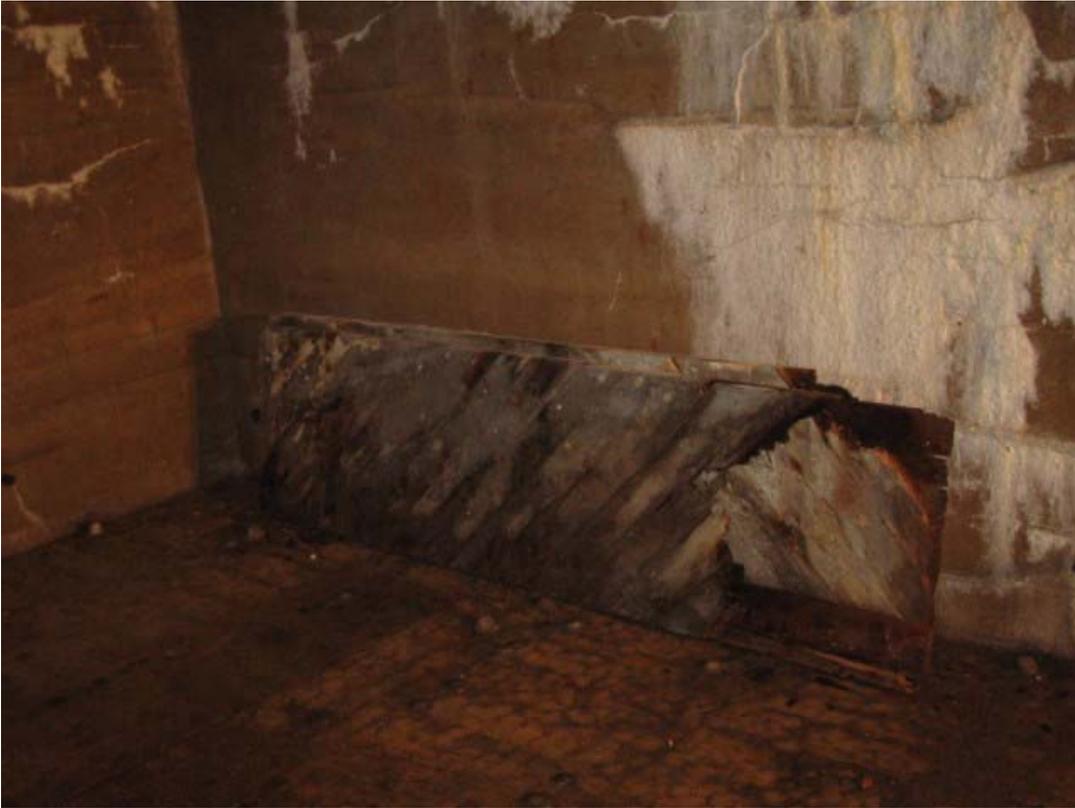
Floor

Deficiencies: standing water

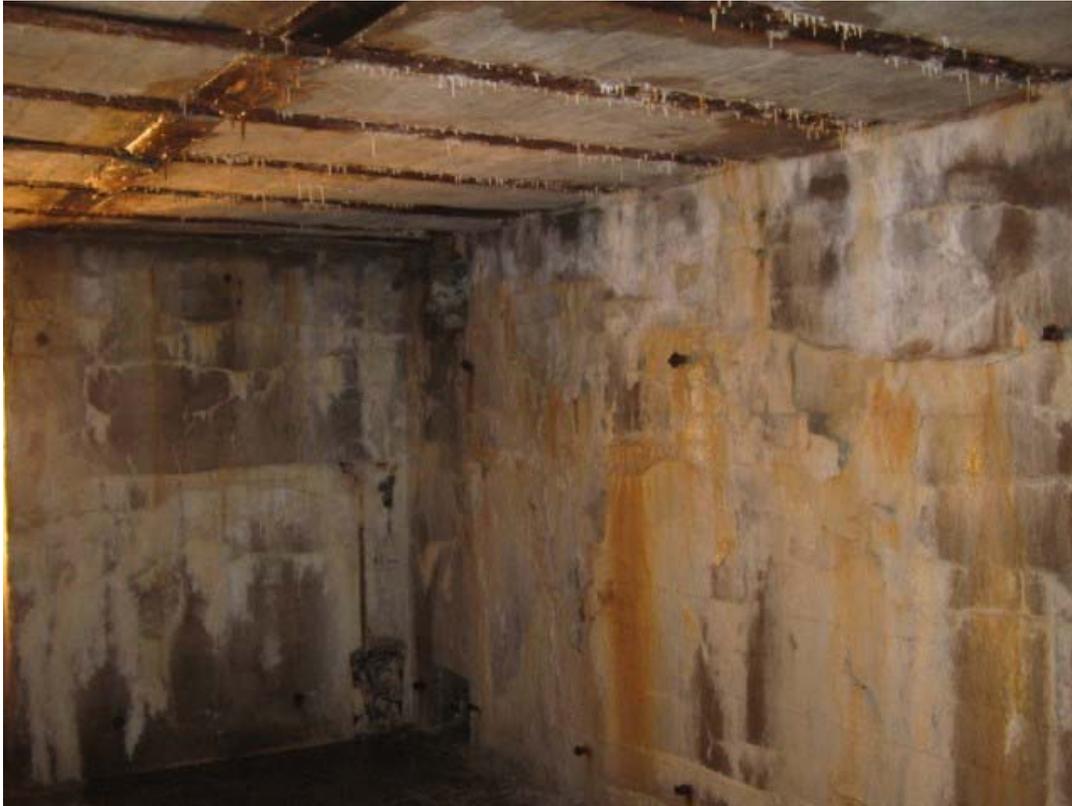
Northeast and Southeast Walls

Deficiencies: horizontal cracking (typically at cold joints)
 diagonal cracking
 mineral deposits
 surface dampness

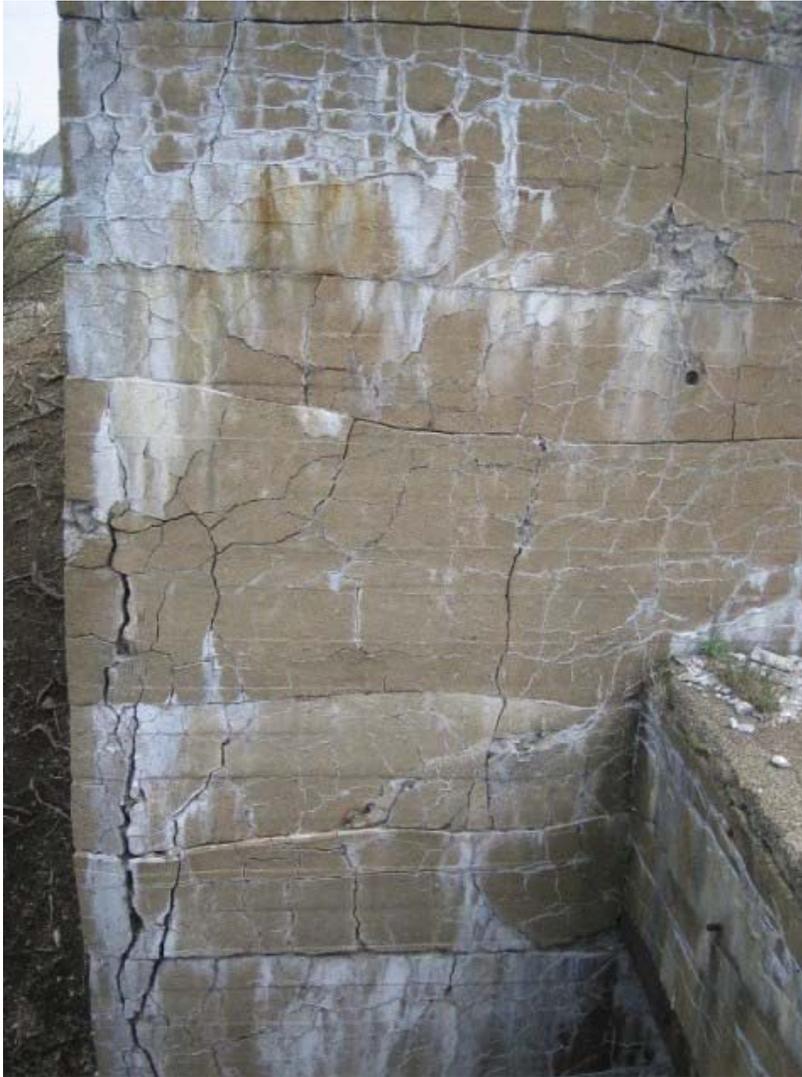
Northeast Wall of Corridor Leading to Stair

Description: *MD: very heavy along bottom four pours
 *SP: along coping, esp. 6' x 3' area at southeast, and at northwest corner

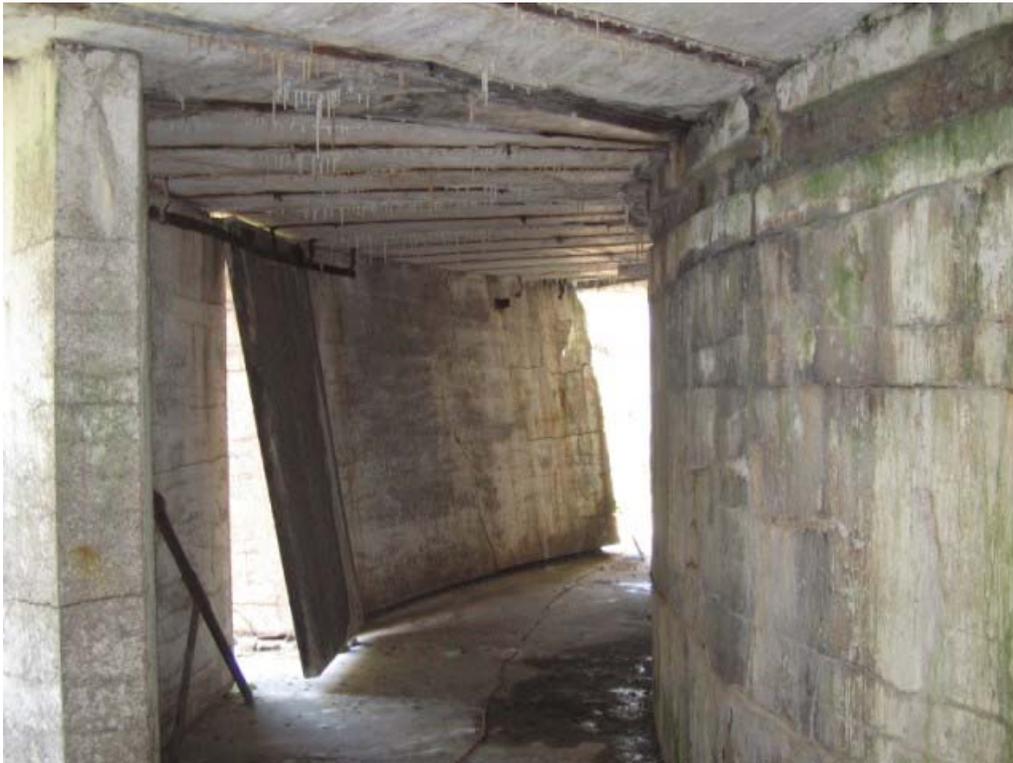
Shot Room

Shot room interior, facing north; note standing water along rear wall
