BATTERY ELON FARNSWORTH AND ADJACENT COAST DEFENSE STRUCTURES

Fort Point, New Castle, New Hampshire

Join us on a virtual tour of Battery Elon Farnsworth and adjacent coast defense structures located on Fort Point in New Castle, New Hampshire, at the mouth of Portsmouth Harbor.

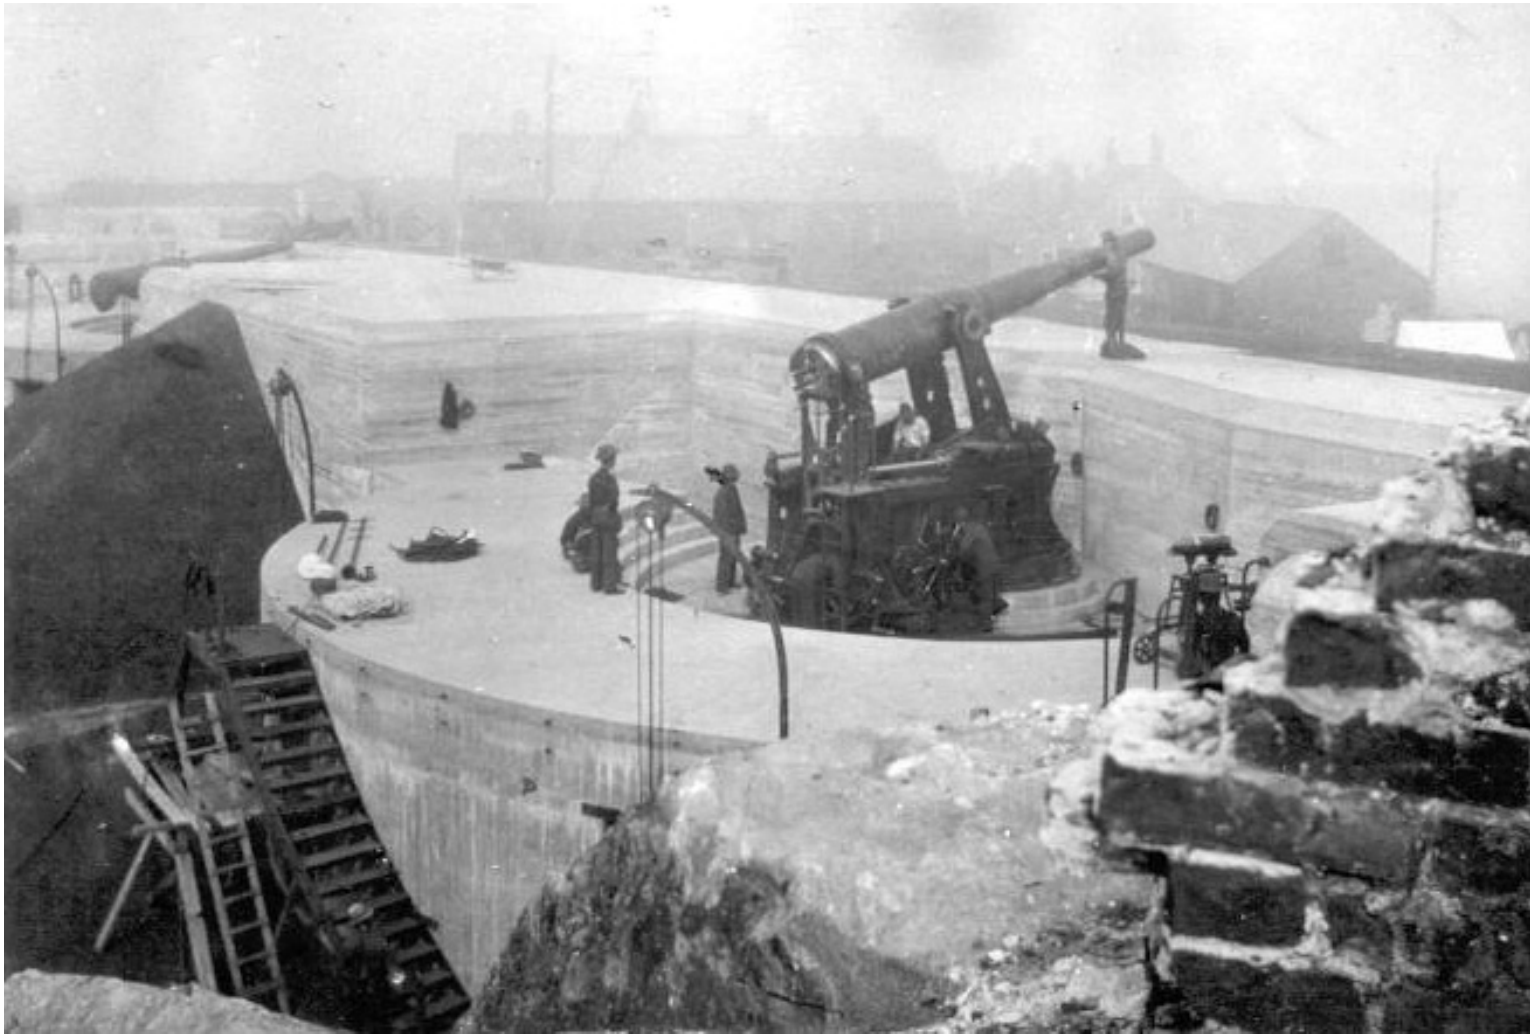
Battery Farnsworth, with the foundation of Walbach Tower in the right foreground. The battery has just been completed, except for the iron railings along the stairs and parapet. The two guns are 8-inch breech-loading rifles, mounted on disappearing-type carriages. The west wall and gate of Fort Constitution can just be made out in the left background through the fog. (from Bolling Smith Collection, via American Forts Network web site)

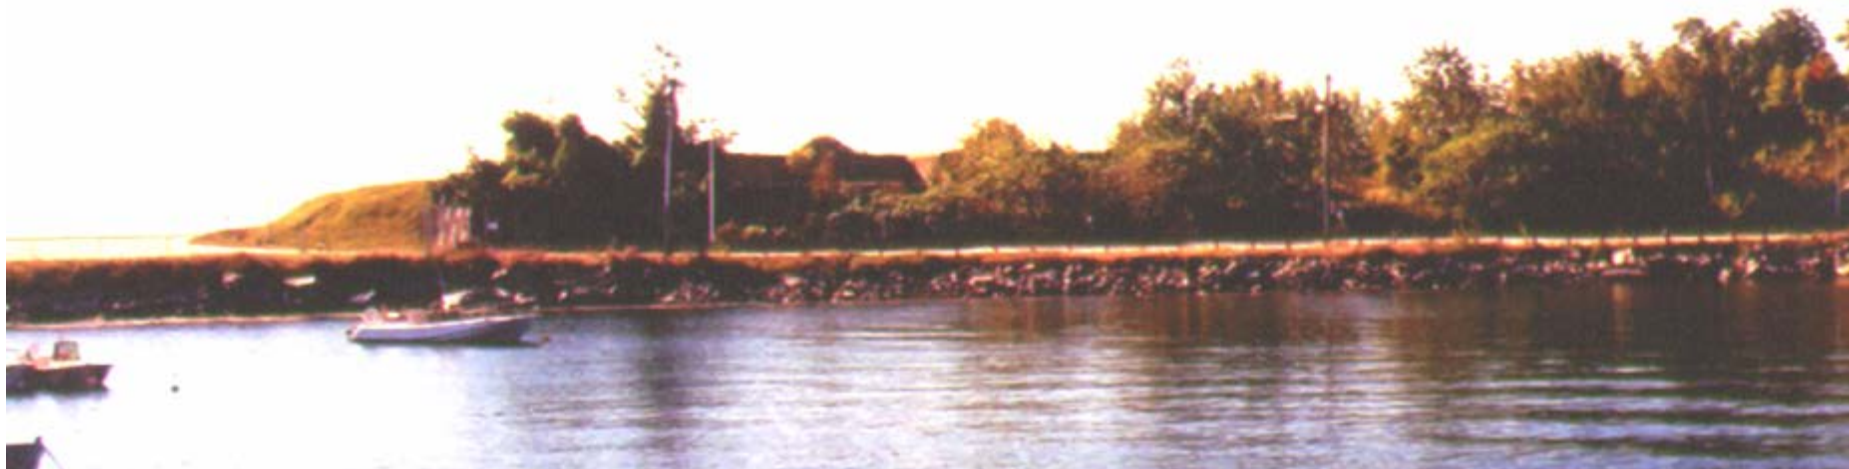
First Generation Mining Casemate

In 1899, construction commenced on a mining casemate at the east end of the only just recently completed Battery Farnsworth. It was turned over to the Army in 1901.

It is thought that this mining casemate may have never been used; possibly due to structural problems, or because it was an uncomfortable and potentially dangerous place to work. It was uncomfortable in that it was cold and damp and potentially dangerous in that the equipment being used put off noxious and potentially explosive fumes.

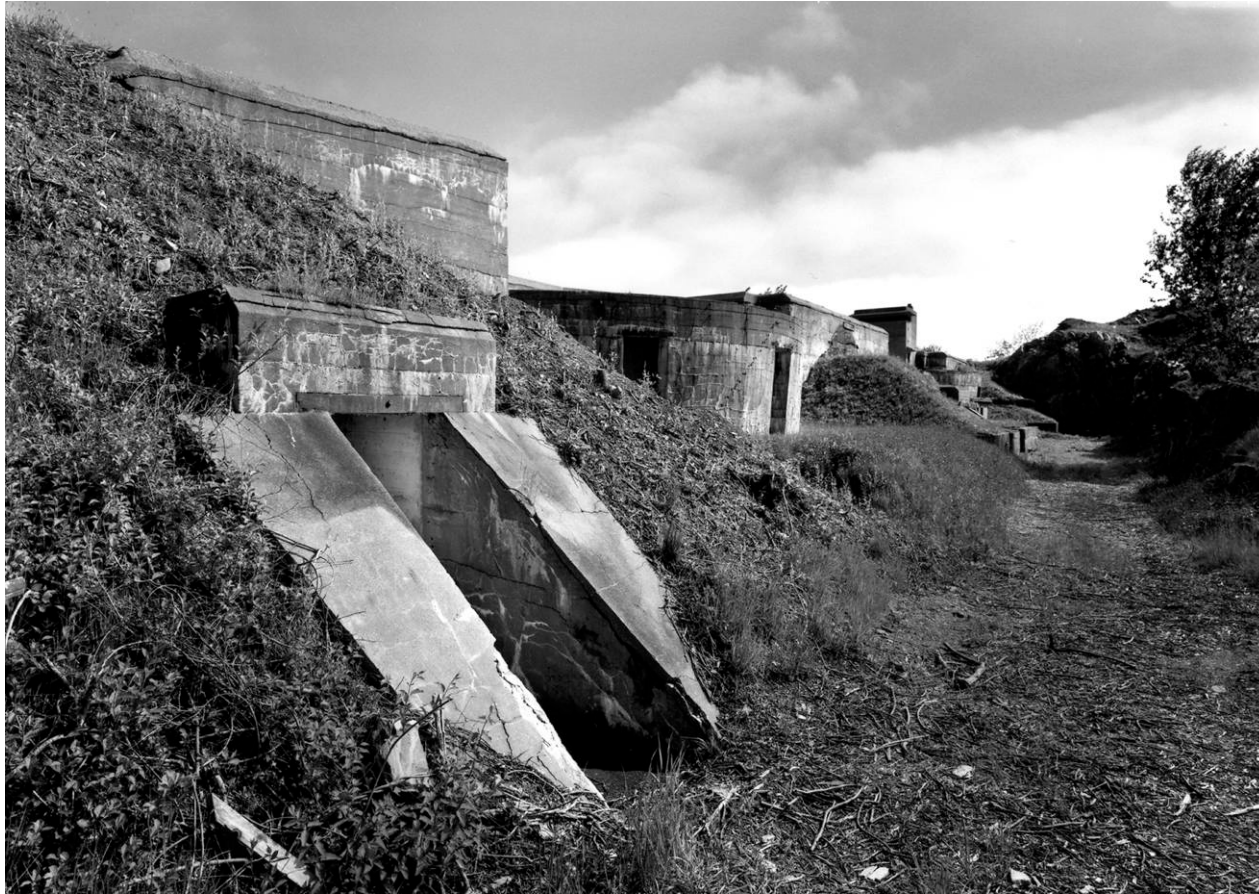
This is the entry portal into the 1901 mining casemate. It is located at the east end of the battery, north side, and is the first thing seen upon entry into the fenced enclosure around the battery.

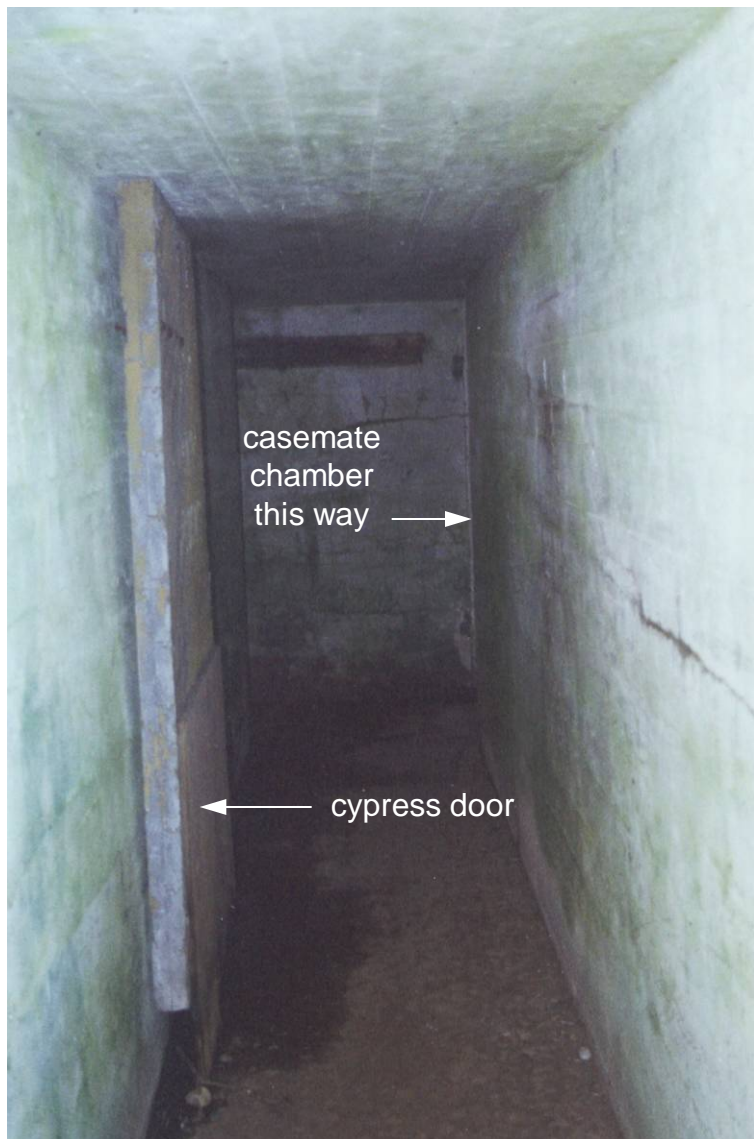
This is the entry corridor into the 1901 mining casemate.

At the far end of this corridor, there is an opening to the right that brings you into the casemate chamber.

Directly under this corridor is a tunnel, or cable gallery, intended for the routing of mine detonation cables. The tunnel, you will see, originates in the casemate chamber, runs under this corridor and out to Hart's Cove on the north side of Fort Point. It has since been blocked at a location under the entry portal shown on the previous slide.

On the left side of the corridor against the wall is one of the cypress doors from the original construction, still in reasonably good shape.

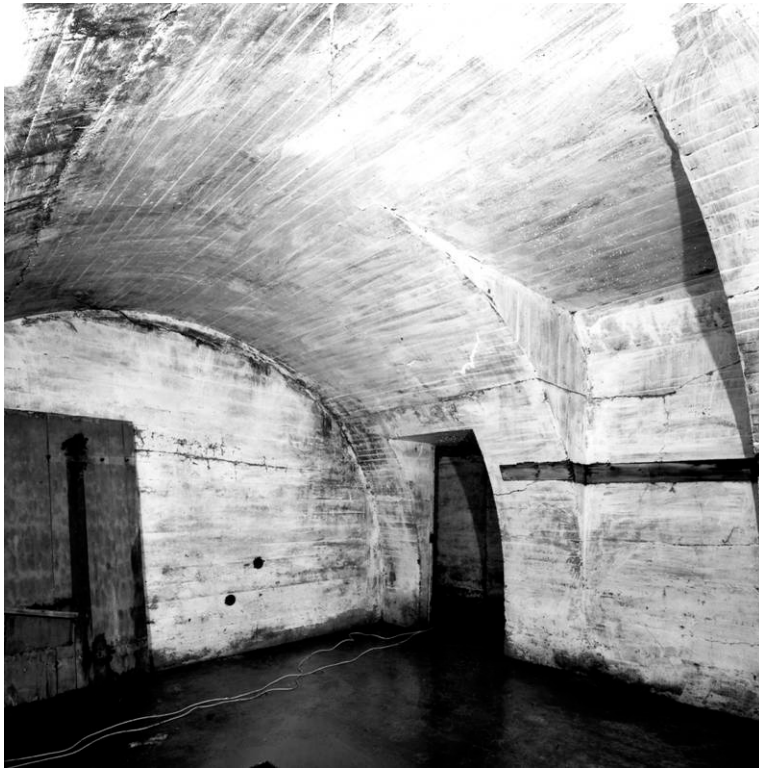
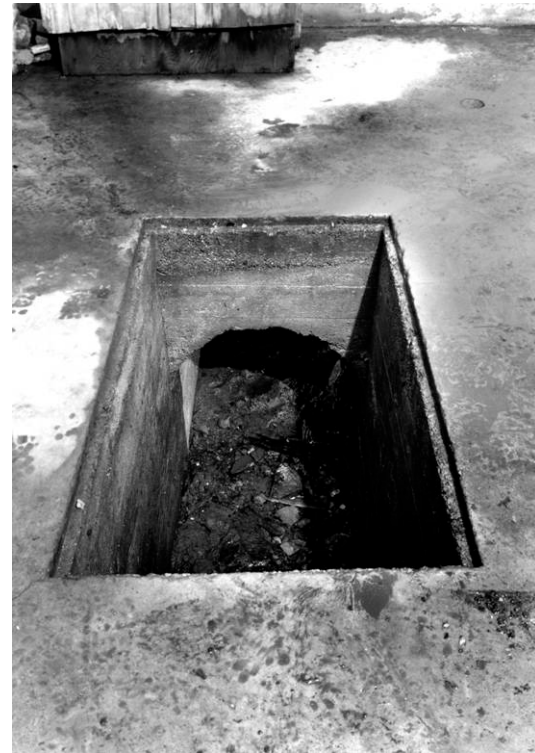
On the left is the casemate chamber looking toward the entry corridor. It shows the arched concrete ceiling, the concrete walls, and the cast-in wood nailers that were presumably intended for the mounting of fire control boards for the harbor mines. Leaning against the wall is another cypress door. On the right is the floor opening into the cable gallery.

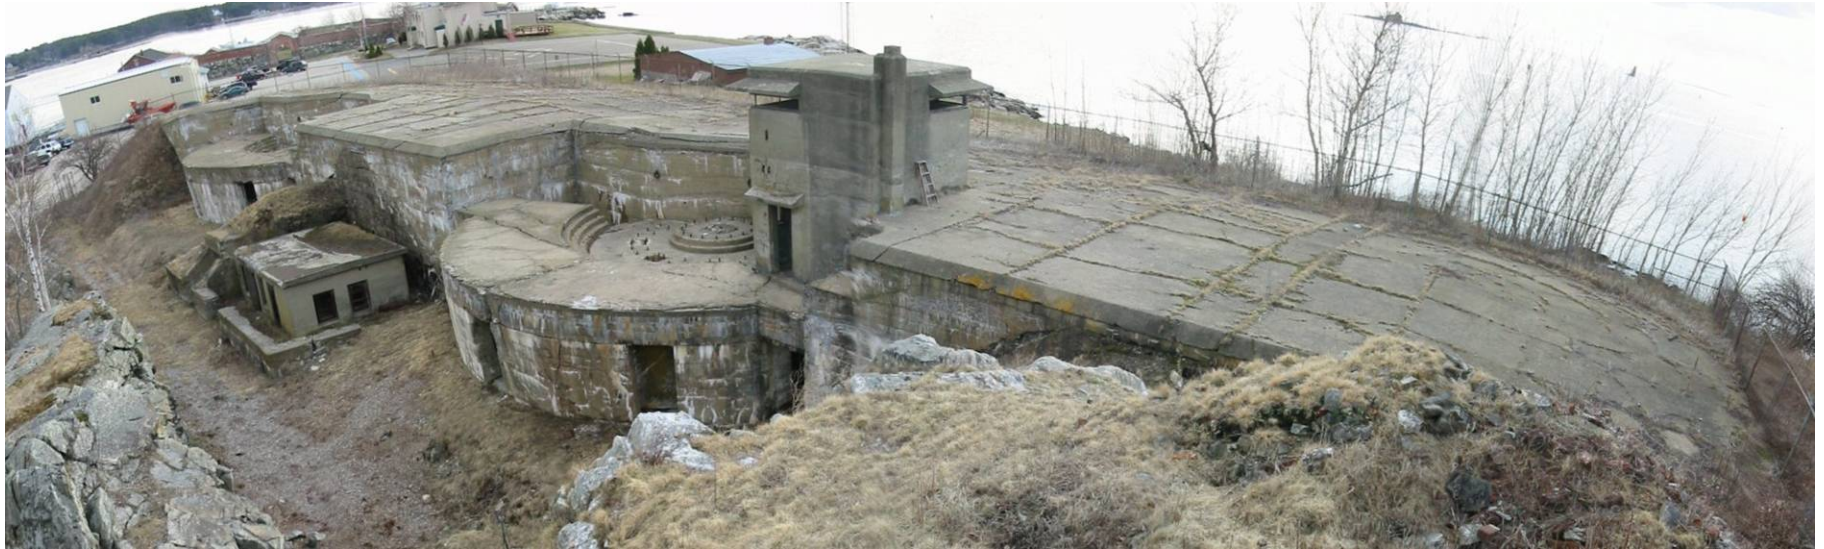
Battery Elon Farnsworth consists of two identical and essentially independent gun emplacements. Each was fitted with a model 1888 8-inch caliber breechloading rifle mounted on a Buffington-Crozier model 1894 disappearing carriage. At each gun was an elevated loading platform serviced by a hand-operated munitions hoist. There were also two davit cranes at each loading platform and, along the north side of the battery, there were curved iron stairs and a similarly constructed catwalk running between the two gun emplacements, all of which were removed during WWII for a massive ship building effort. Below each of the curved loading platforms are a shot storage room, a guard room and a battery room. Near the hoistway at the west end of the shot storage room, there is a half-flight of stairs that lead down to a small plotting room, a shell storage room, a powder magazine, and a corridor that provides a separate route to the exterior. A ceiling-mounted trolley system transported shells and shot to the munitions hoist, where they were manually winched up to the loading platform. For safety purposes, gunpowder was hand carried up to the gun.

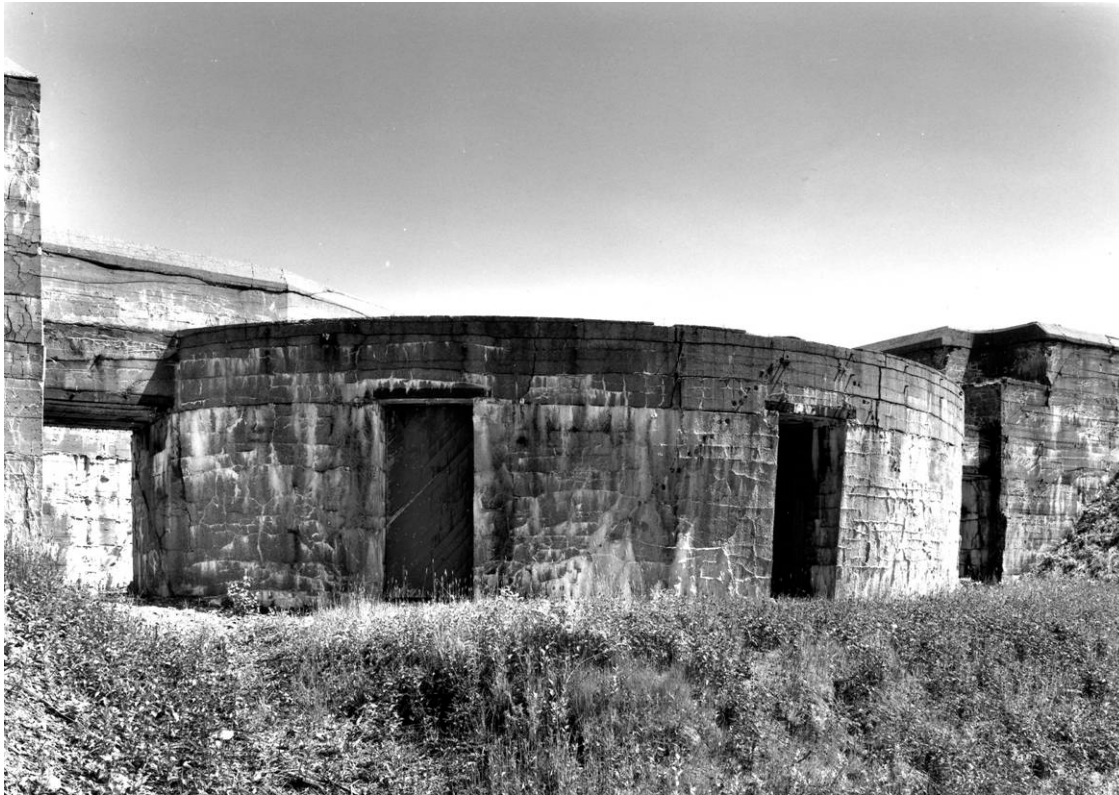
At the left of this shot is a covered entry leading to the base of an open stair that leads up to the gun mount and loading platform for Gun Emplacement #2. Before us are the loading platform (above) and the battery room, guard room and shot storage room (behind the curved walls).

This photo is taken facing south from the access path that runs along the rear of the battery. The 1901 mining casemate is out of the frame to the left.

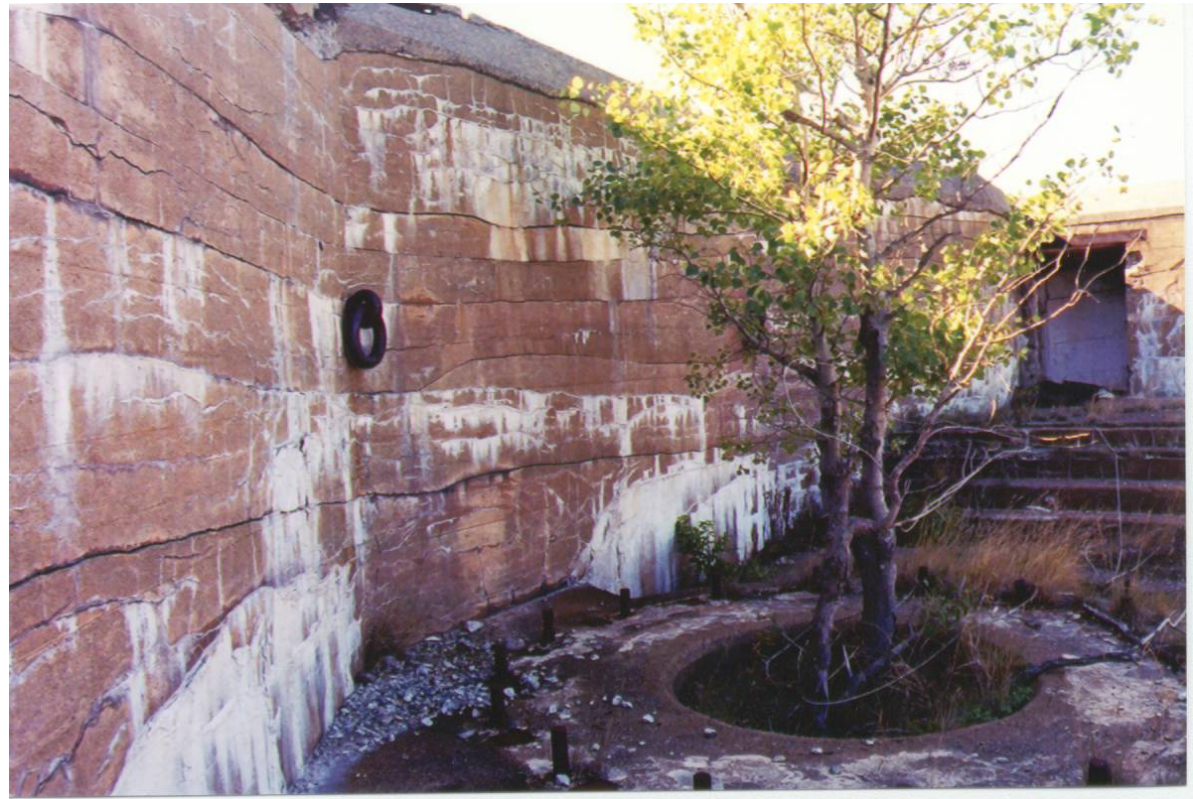
No . . . that thing on the wall to the left is not a door knocker. It is a heavy steel ring and eyebolt assembly. There are several of these rings spaced around each gun well. From historical photos, it appears these may have been “hard points” to which winches or cables could be attached for the occasional handling of materials. When the gun was in place, this particular ring was essentially inaccessible.

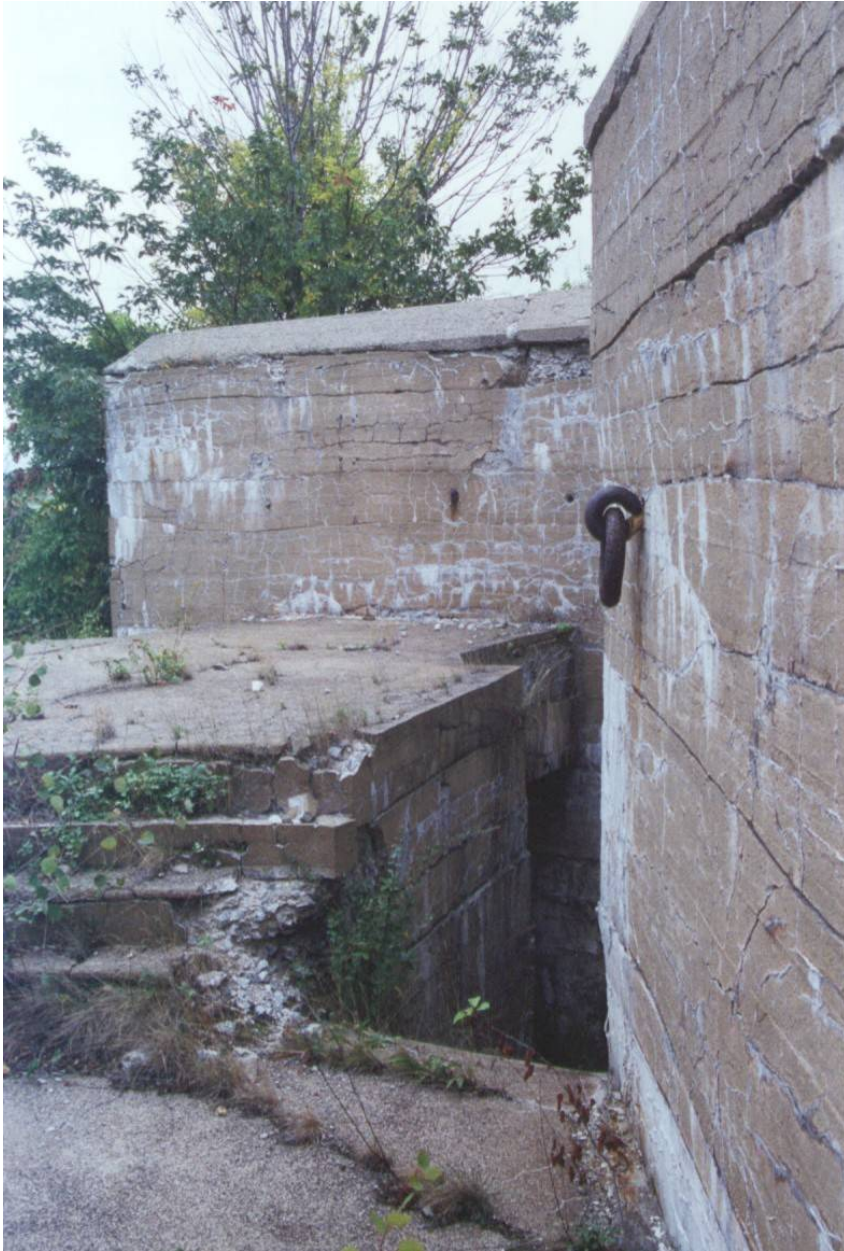
Now, turning around, this photo shows the open stair down. To the left are the steps up to the loading platform.

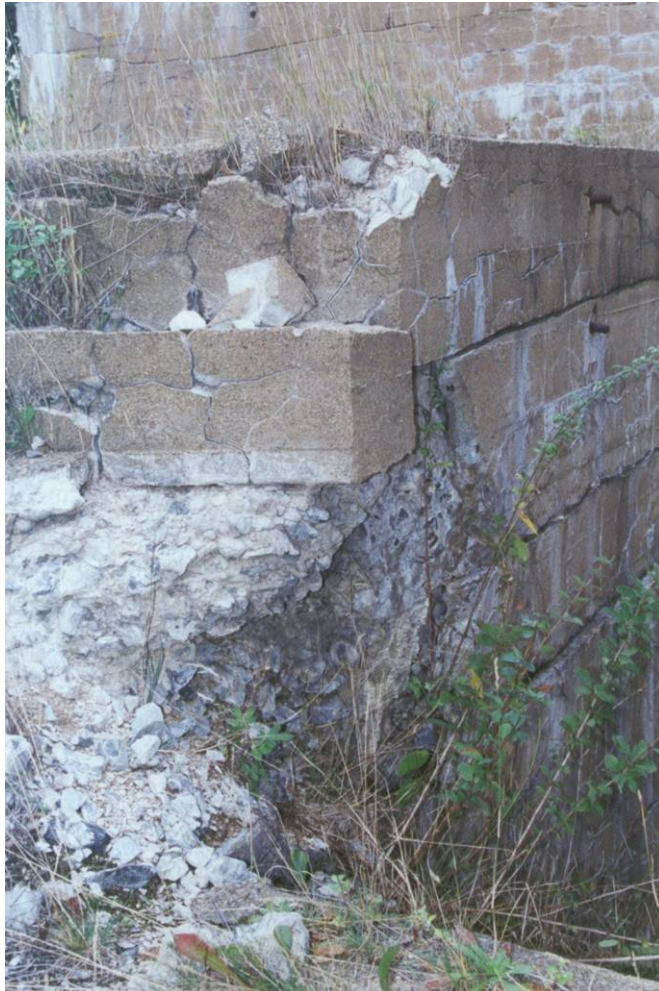
Here is a good example of the condition of Battery Farnsworth's concrete. The main reasons why the concrete is in such bad shape and among the reasons why the battery was plagued with structural problems from the outset are:

1. Use of natural Rosendale cement from New York State, which produced concrete with relatively low frost resistance, rather than imported higher quality, manufactured portland cement from Europe ,
2. Use of local aggregate including beach sand,
3. Combined, the alkali in the Rosendale cement and the silica in the local aggregates have experienced Alkali-Silica Reaction, an expansive chemical process that causes massive micro- and macro-cracking throughout the concrete,
4. Low volume on-site concrete batching resulted in countless “cold joints”, which invite water penetration and associated freeze/thaw action,
5. Poor quality control (at the time, rapid construction was vastly more important).

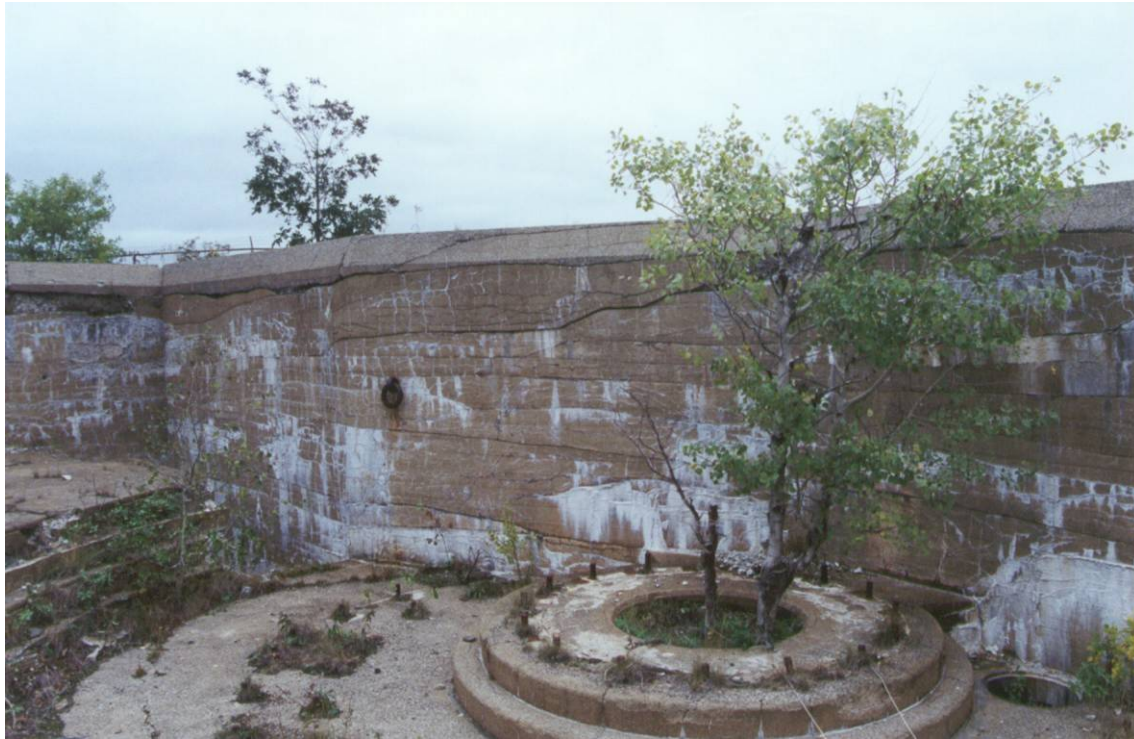
We are now standing on the loading platform, again looking toward the stairway. Here, more of the gun mount can be seen; “imagined” may be a better word. As previously mentioned, the inner bolt circle establishes the central pivot point of the gun carriage. The outer circle of bolts provided anchorage for the curved track along which the back of the gun carriage traveled.

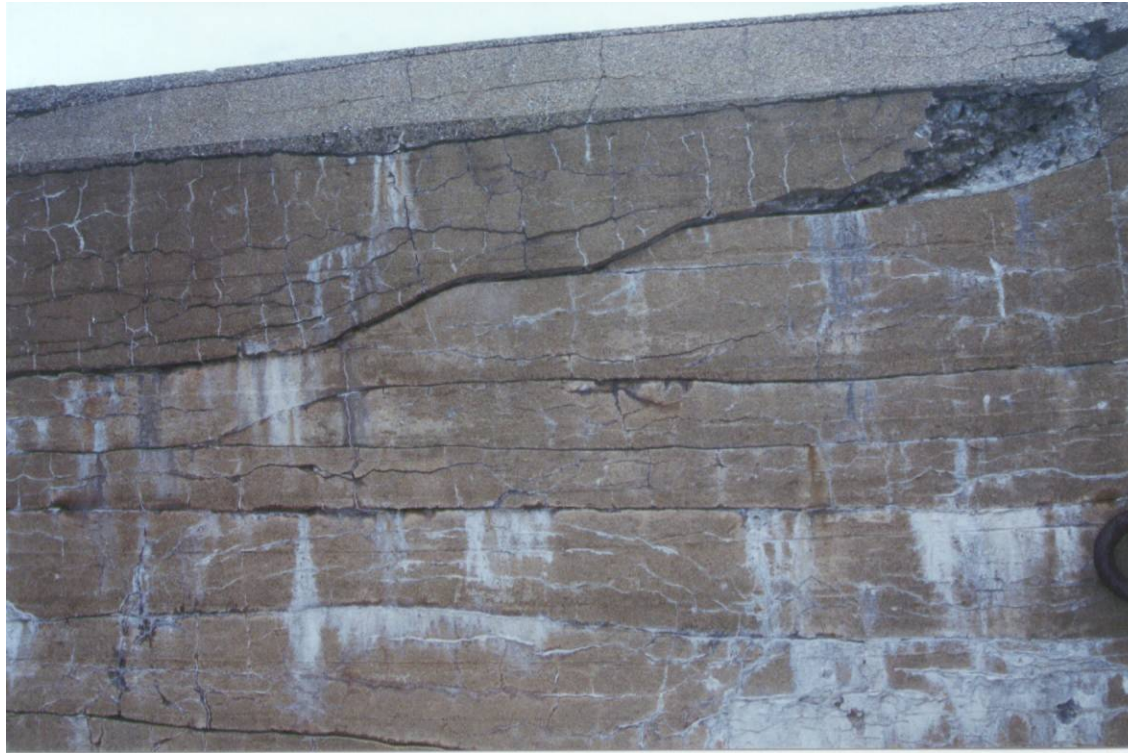
This is a close-up shot of the south wall, seen in the previous photo. Note the cracks in the wall. The larger, more defined cracks are “cold joints”, which are formed when fresh concrete is placed against set or partially set concrete. The finer cracks are the result of Alkali-Silica Reaction (ASR) and years of freeze/thaw action. The white stains on the walls are efflorescence (salts leaching out of the concrete), while the gray expulsion is the product of ASR.

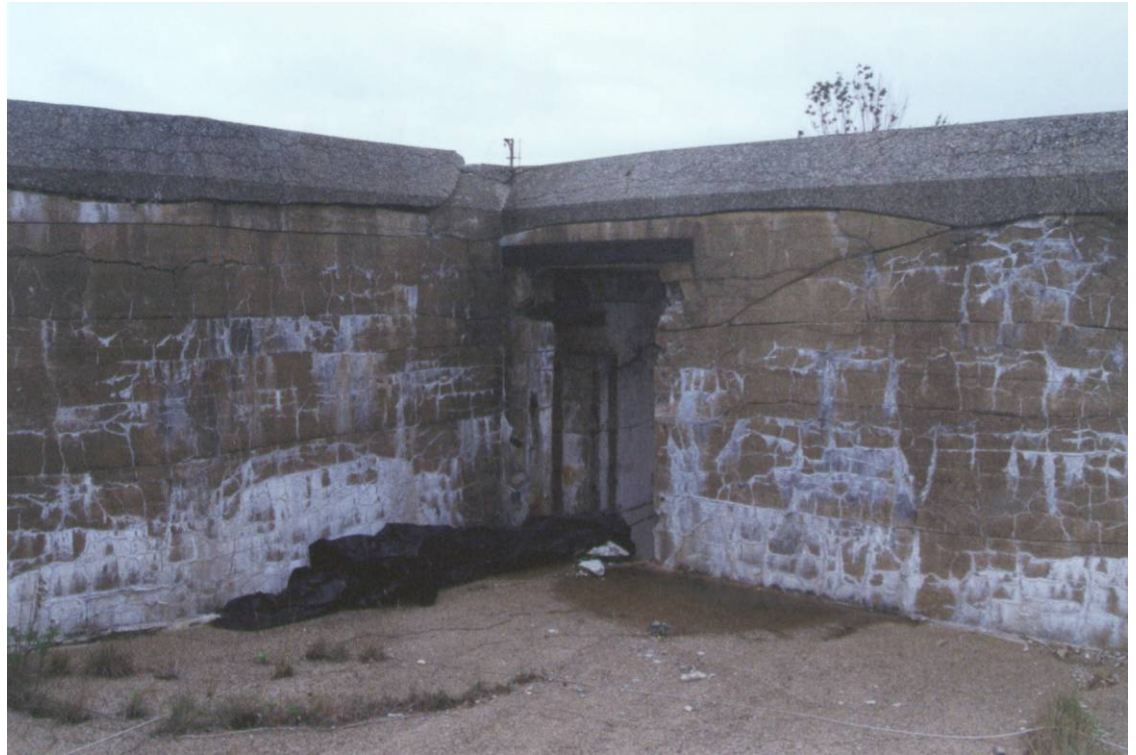
Note the change in coloration of the concrete at the top of the walls. We are of the understanding that the concrete used in the protective apron, which is shown here to also cap the tops of the battery walls, was different from the other concrete used in the battery, in that it contains the more durable and more frost resistant portland cement. Hence the differing color.

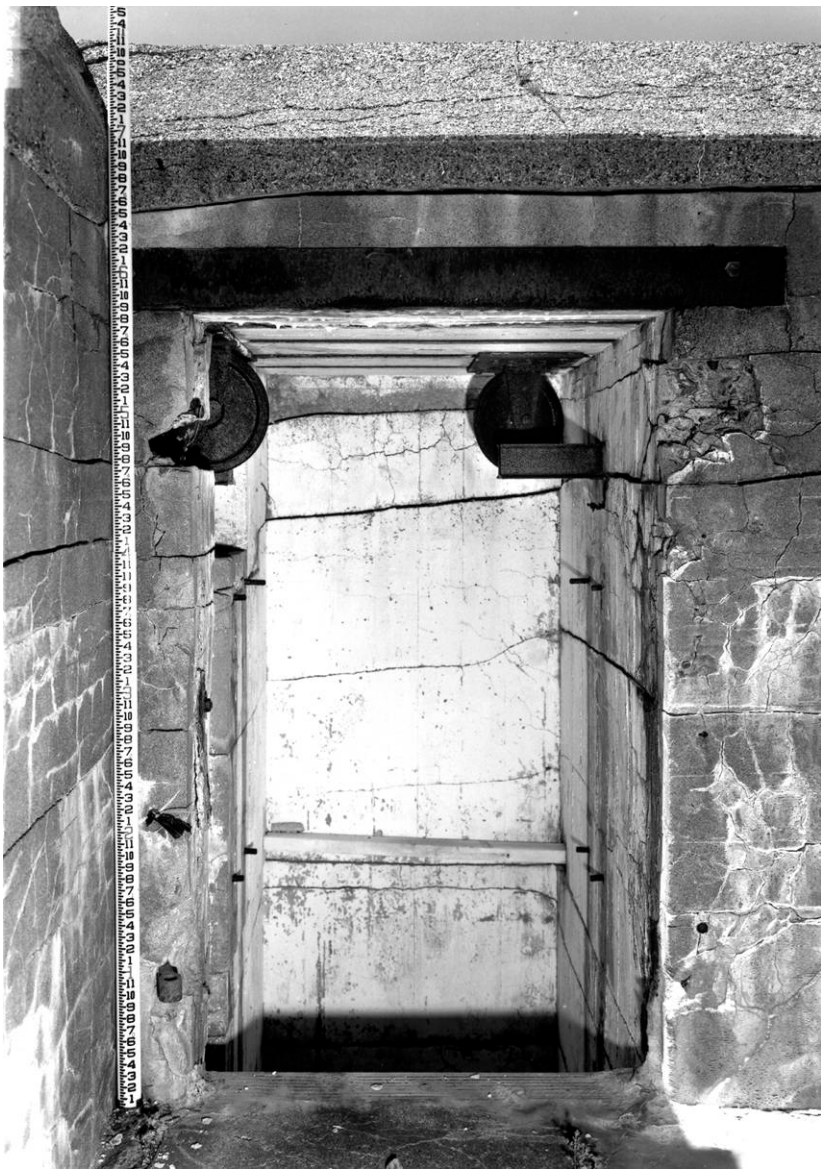
Hoistway – Gun Emplacement #2

A steel angle appears to have been used as a lintel over the hoistway opening.

The hoistway once held a cable and pulley "balanced platform hoist", later determined to be inherently unsafe and unreliable, although I am not entire sure as to the underlying issues.

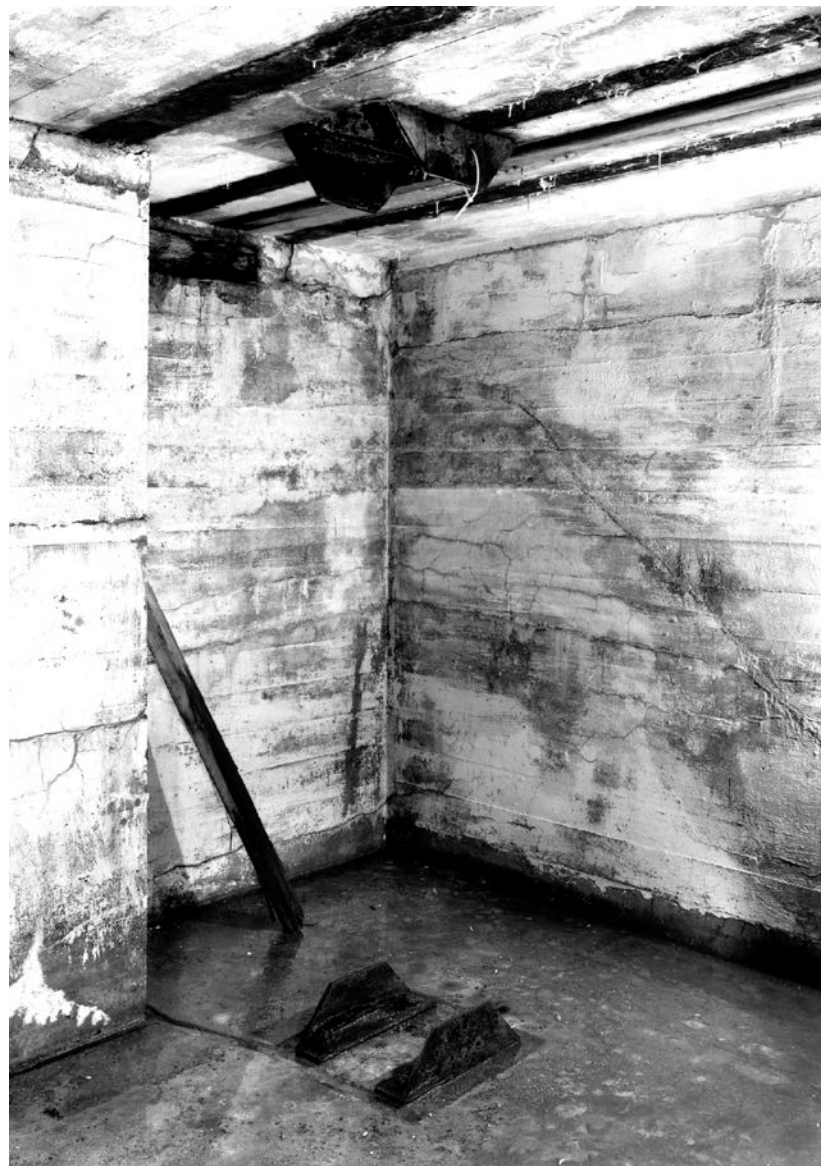
Winch Alcove – Gun Emplacement #2

At the base of the hoistway is a small alcove with a concrete equipment base on the floor, which provided mounting for a hand cranked winch (remember . . . no electricity) used for hoisting the shells and shot up to the loading platform. For safety reasons, powder was hand carried up from below in a wooden litter.

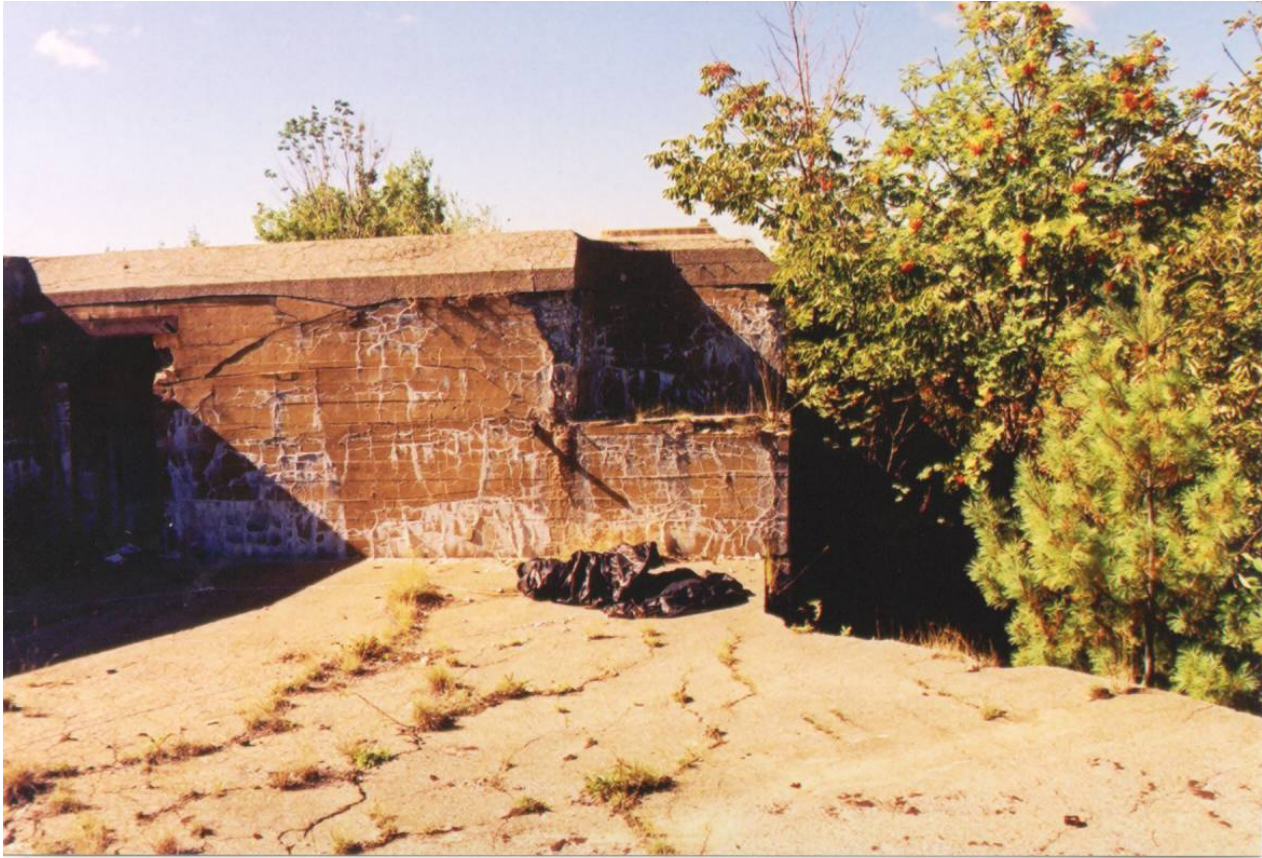
Turning right again, we see a somewhat primitive crow's nest, which would have been the battery commander's station during battle. It was accessible both from the loading platform and by way of an external ladder up from below, mounted to the north face of the battery.

Here also, we get our first good look at the loading platform. Notice the radial cracking propagating out from the top of the steps.

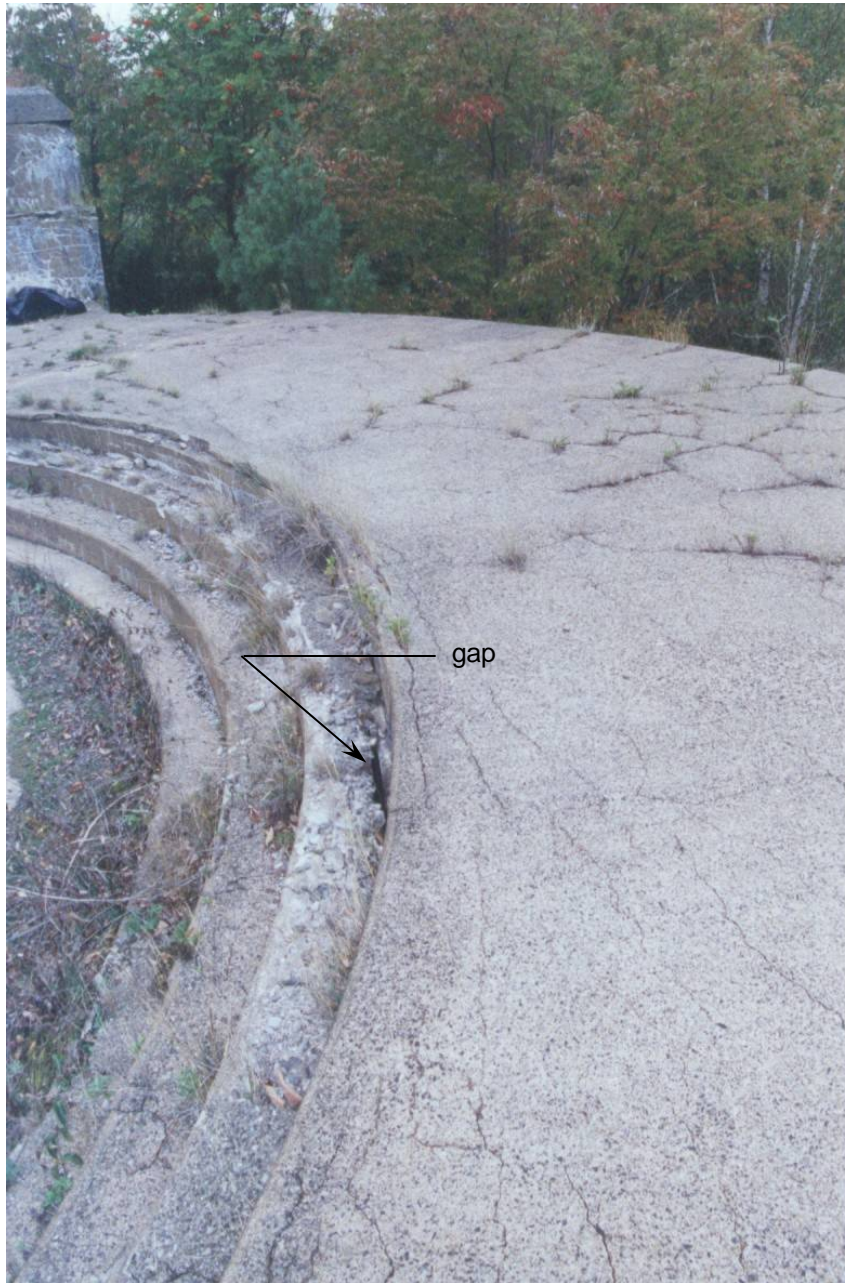
This is more of the loading platform at Gun Emplacement #2.

Again, notice the cracks.

Also, check out the gap developing between the top step and the loading platform. This indicates that the loading platform is bulging to the right (northward). The extent of the movement is more obvious from below and far worse at Gun Emplacement #1, as you will see.

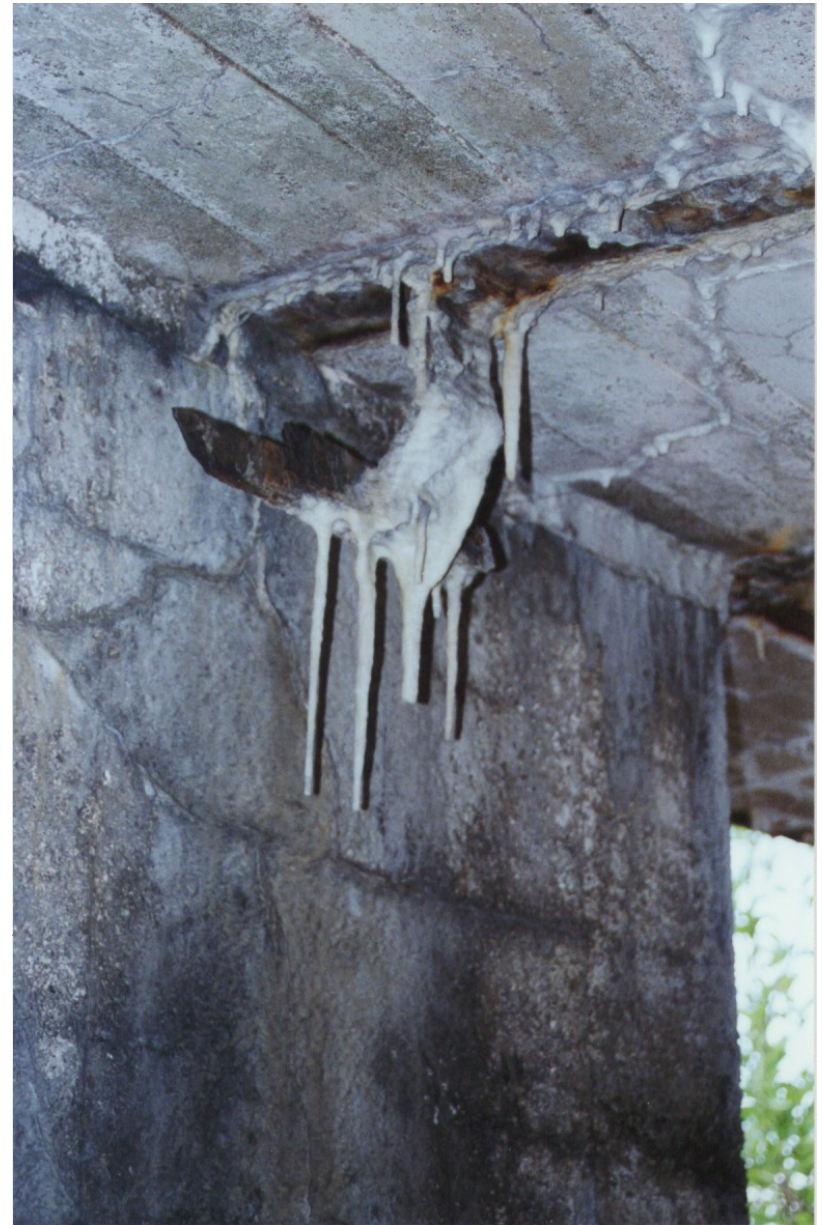
Shot Corridor – Gun Emplacement #2

As promised, we are now in the guard room under the loading platform of Gun Emplacement #2, looking into the shot storage corridor.

Most important to note is the extent to which the loading platform has moved. Basically, what is happening is that, because the loading platforms are effectively pinned at the ends, the ASR-induced expansion is being expressed as an outward/radial bulging.

Also, note the stalactites. Normally seen in caves, these stalactites are comprised of natural salts leaching out of the concrete.

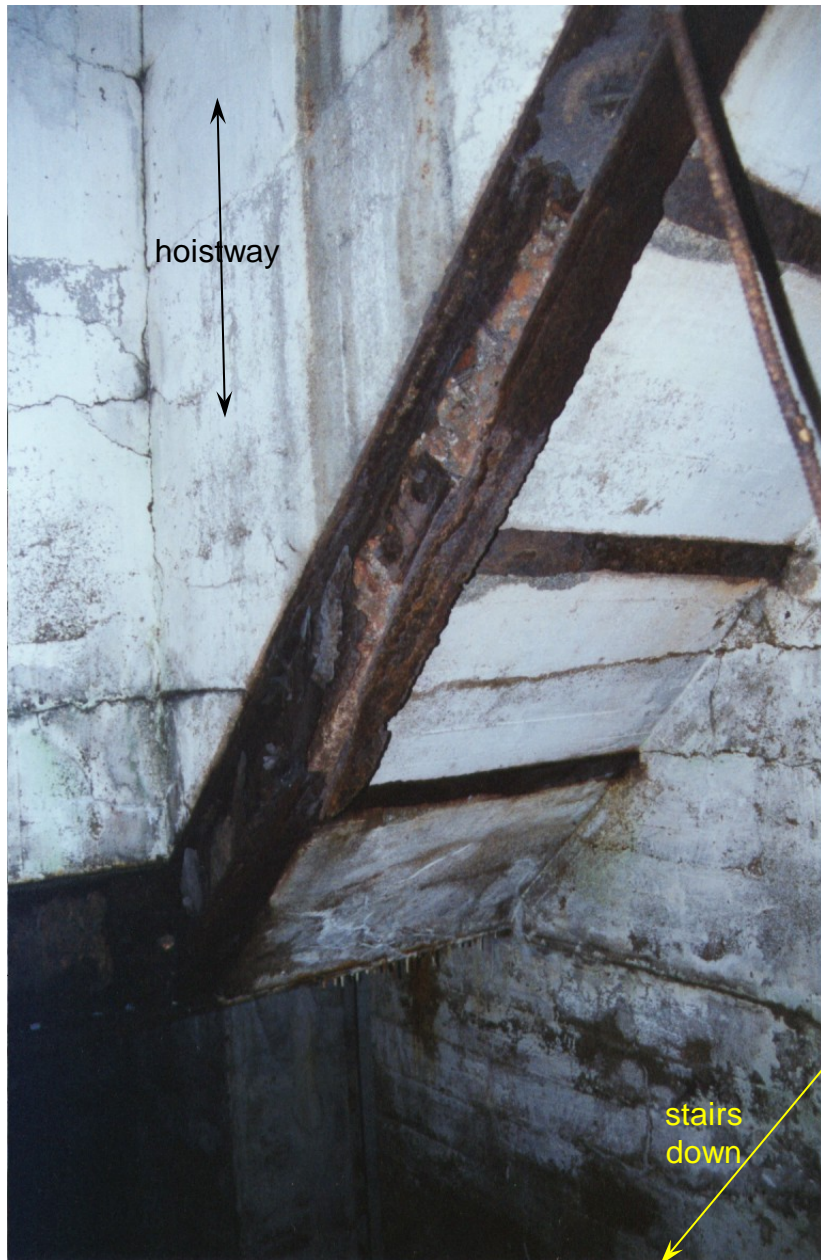
We are now at the far west end of the curved shot storage corridor. We are standing essentially at the landing area for the hoist. There is a half-flight of stairs immediately beside the hoistway that lead down to the powder magazine, shell storage room and relocating room.

Note more of the same in terms of the poor condition of the concrete. Also note the degree of deterioration on the steel elements that has been hastened, I am sure, by the salts leaching out of the concrete.

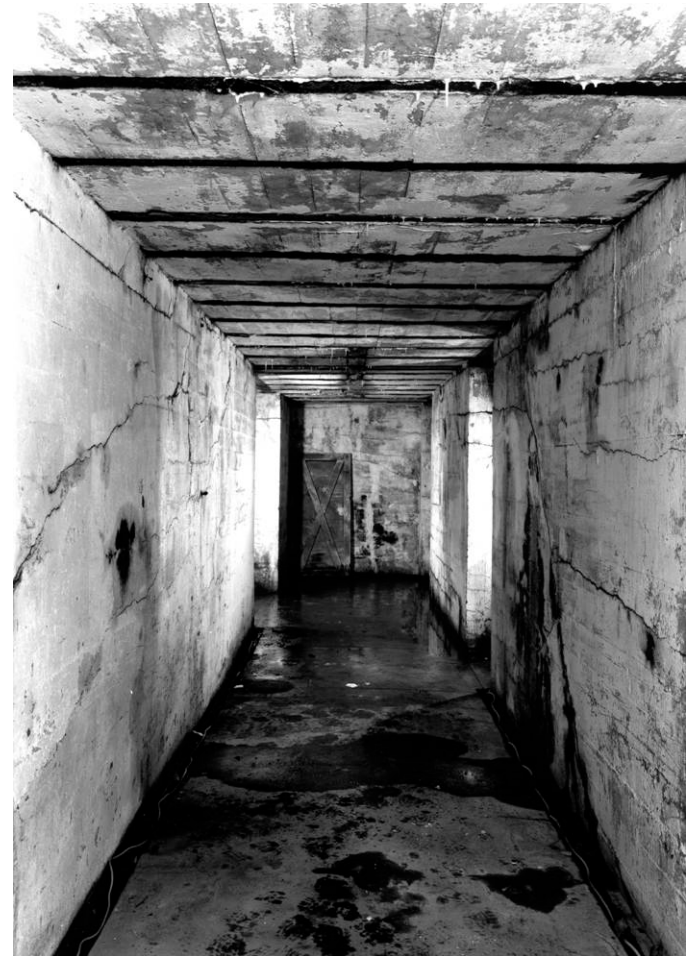
Lower Level Entry Corridor
Gun Emplacement #2

We are now in the main corridor into the lower level of Gun Emplacement #2. The first room on our right is the powder magazine. At the end of this corridor on the right is the shell room and on the left are the relocating room, hoistway, winch alcove, and half flight of stairs up to the shot corridor. The lower level for Gun Emplacement #1 is identical.

The lower portion of the gun emplacements were plagued with water intrusion problems. Much effort was expended to correct these problems, including tearing up and replacing the concrete floors in order to add an underdrain system, busting high and low ventilation holes between the shell room and the powder magazine and to the exterior hoping to dry things out, and lining of the powder magazine ceiling with copper and walls with multiple thicknesses of waterproofing roofing materials. All of this was to little avail and this ongoing problem was a significant factor in the eventual decision to abandon Battery Farnsworth rather than upgrade it for World War I.

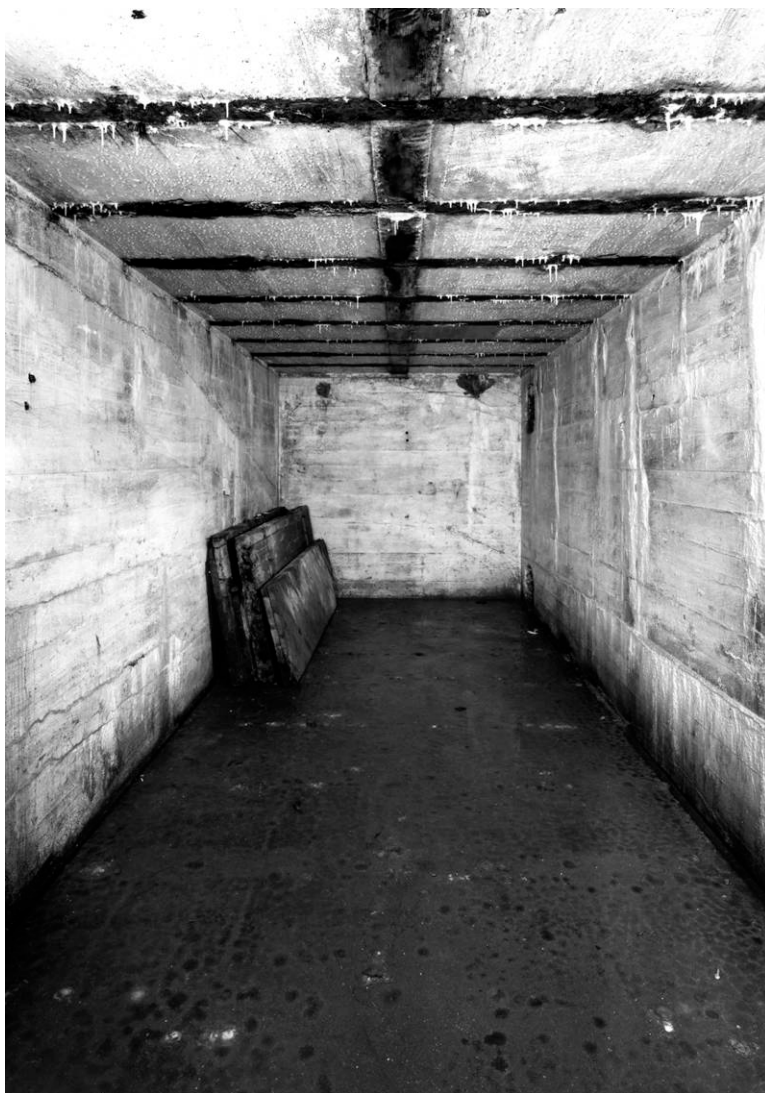
Shell Storage Room – Gun
Emplacement #2

Vent Holes to Powder Magazine
