BATTERY ELON FARNSWORTH AND ADJACENT COAST DEFENSE STRUCTURES

Fort Point, New Castle, New Hampshire

Join us on a virtual tour of Battery Elon Farnsworth and adjacent coast defense structures located on Fort Point in New Castle, New Hampshire, at the mouth of Portsmouth Harbor.

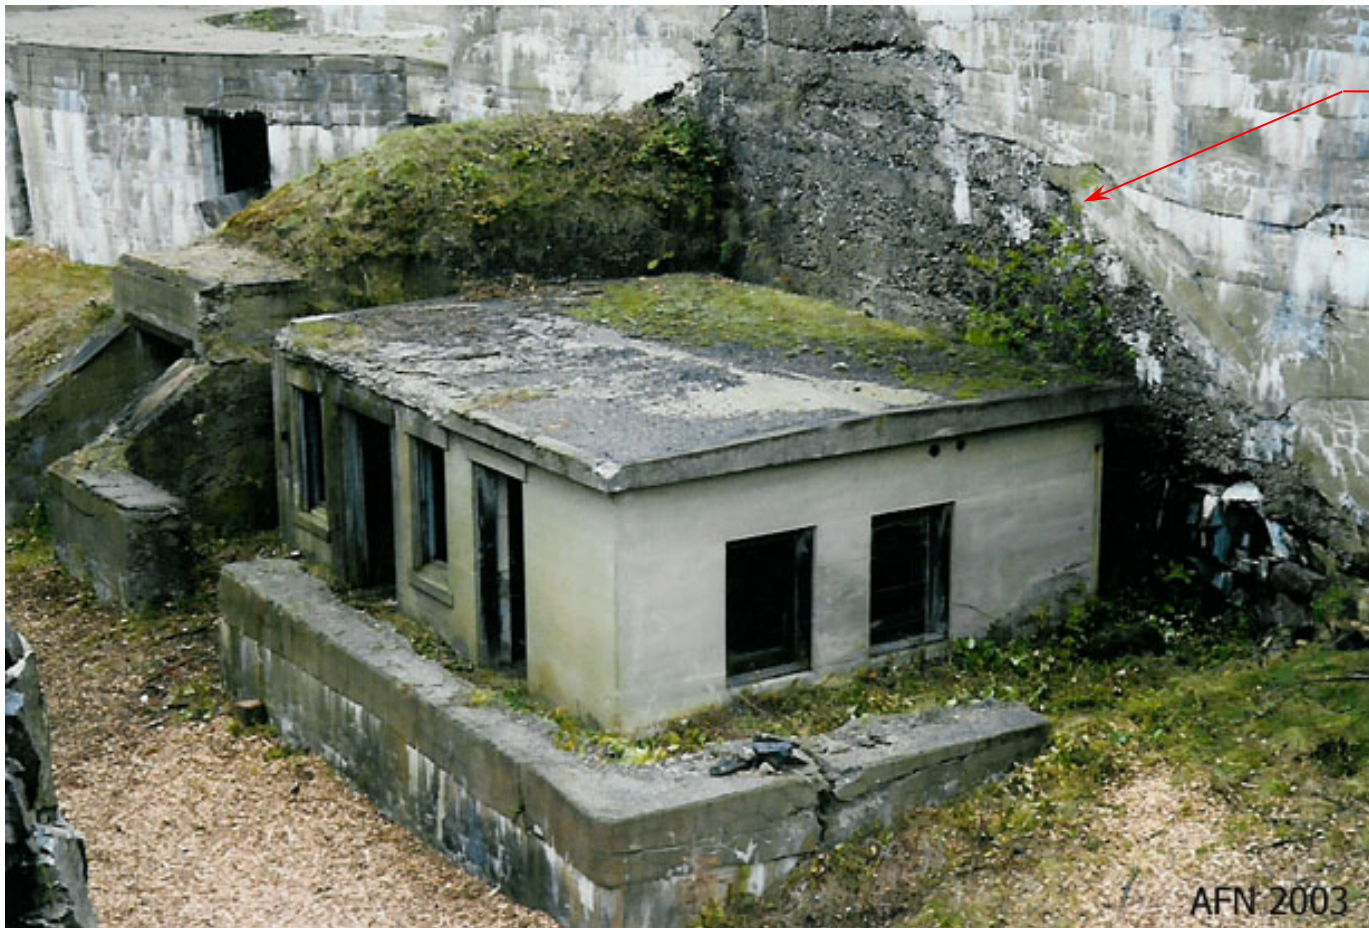
Line of original earthen berm, placed against the wall early enough in the Rosendale cement's slow cure period to damage the surface. Shortly after its original placement, the top portion of the berm was removed to allow the installation of a catwalk between the two gun emplacements. In 1920, the remainder of the berm was removed to allow construction of the power plant.

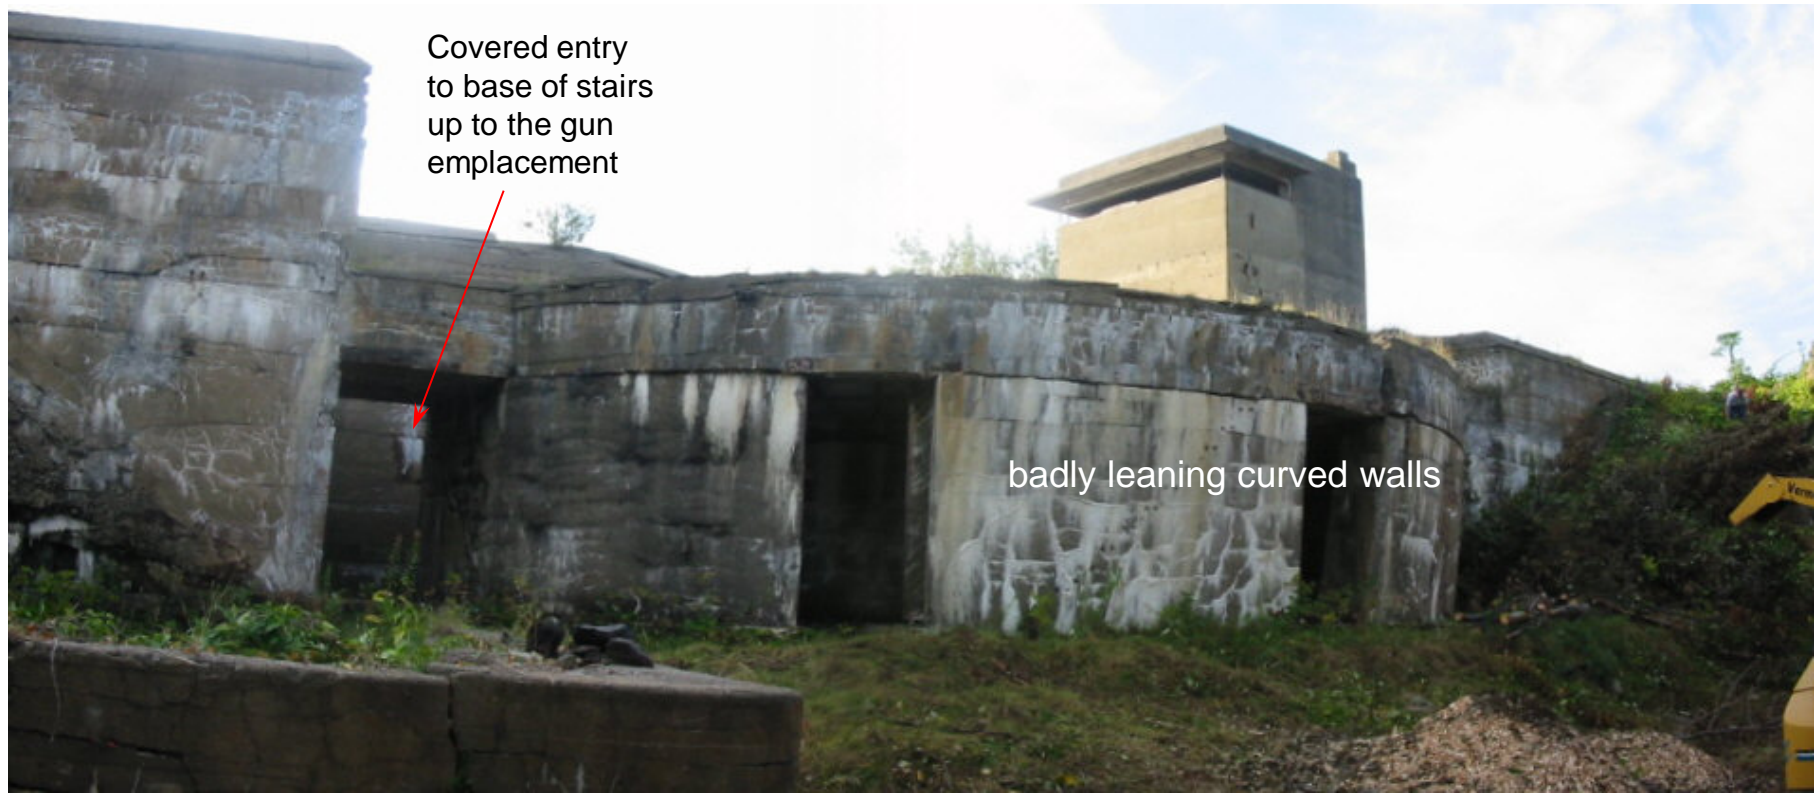
Approaching Gun Emplacement #1, we immediately see that something looks a bit “out of kilter”. And, it is certainly more than just a case of holding the camera crooked. In fact, the curved walls that support the loading platform are leaning to the extent that they appear ready to collapse.

Atop the gun emplacement we see the WWII Base-End Triangulation Tower.

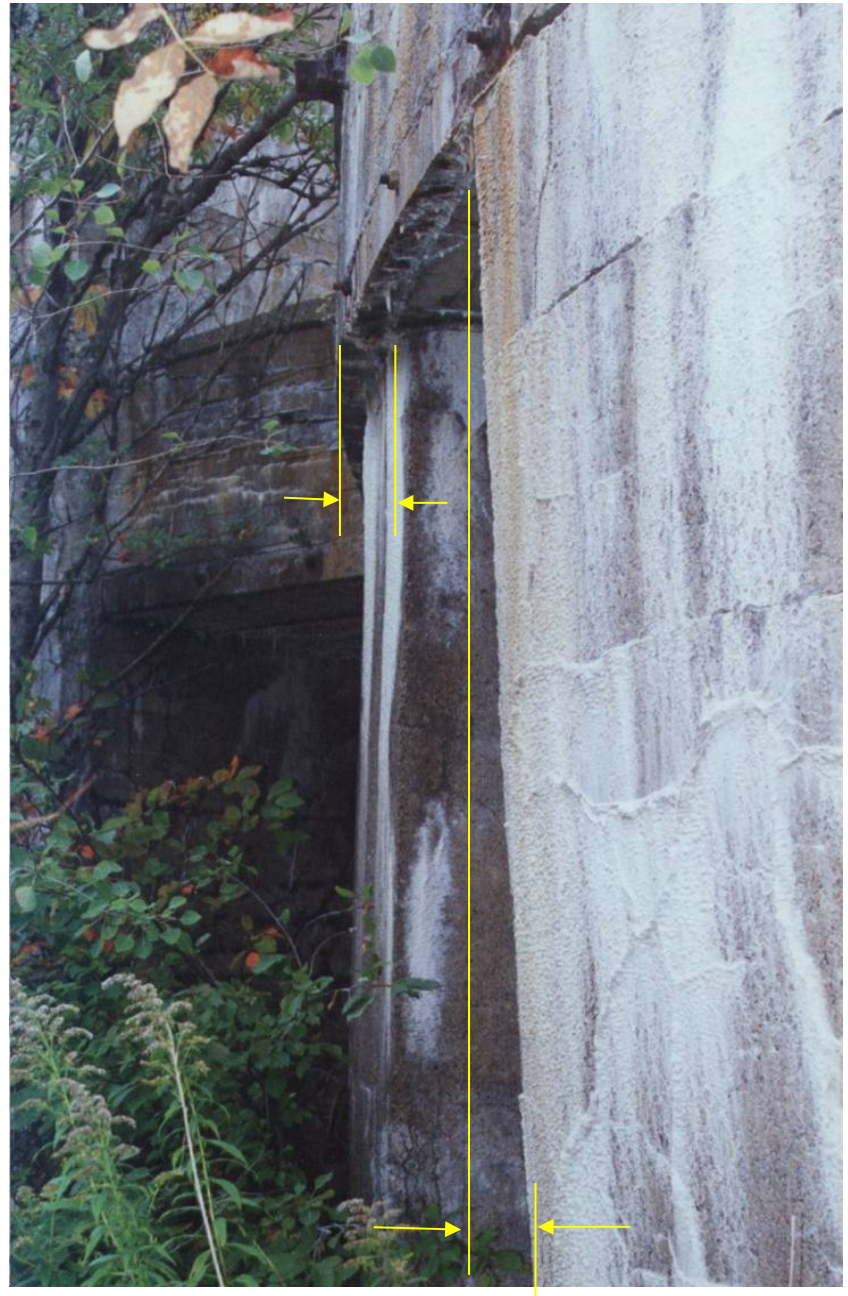
Note the degree of lean associated with the curved loading platform support wall to our immediate right. What is happening, as we will see shortly, is that the loading platform above is bulging northward away from the fixed gun base and pushing the outer curved support walls with it. The wall in front of us, however, is braced by another wall that returns to the right. As such, instead of the wall leaning, the landing platform is sliding over the top of the wall

In fact, this is occurring at both gun emplacements, with the condition at Gun Emplacement #1 having progressed to the point of near collapse.

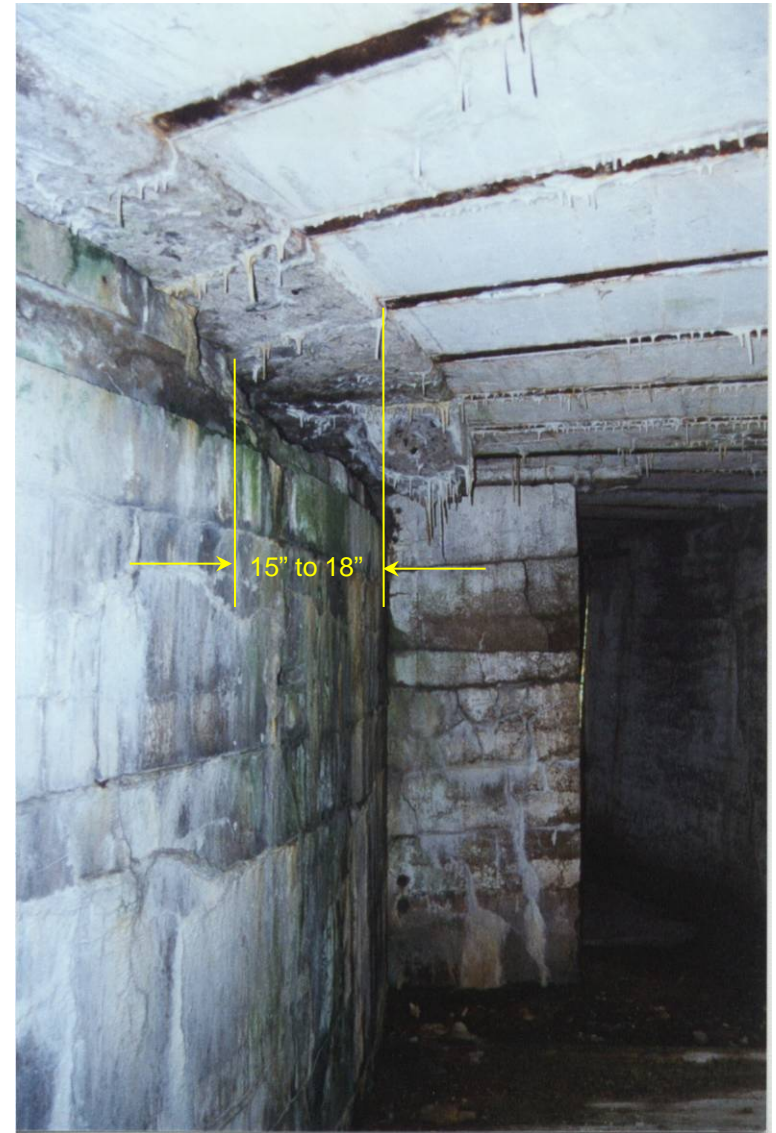
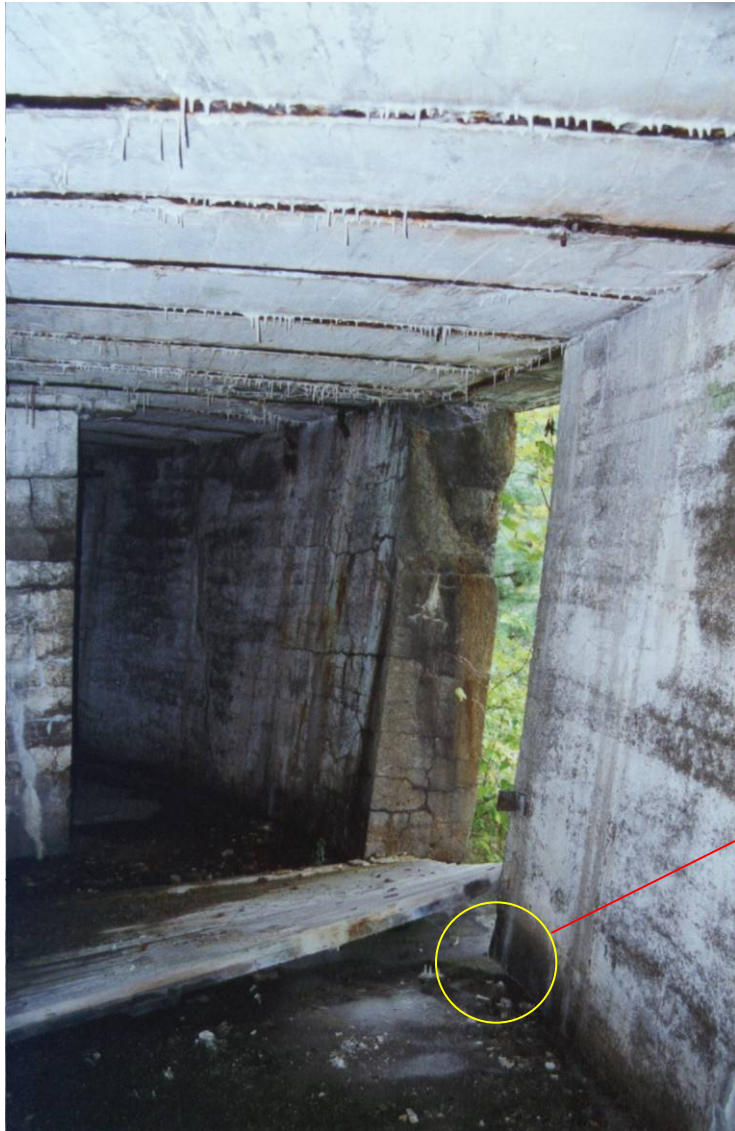
Although tough to see in this photo, the approximately 2 foot thick concrete walls are leaning so much that the inside edge has lifted about $3\frac{1}{2}$ " off the floor slab, putting significant pressure on the outside edge of the wall and on the edge of the floor slab. The $3\frac{1}{2}$ " lift corresponds to the top of the wall having migrated out about 15", which is consistent with what we saw earlier.

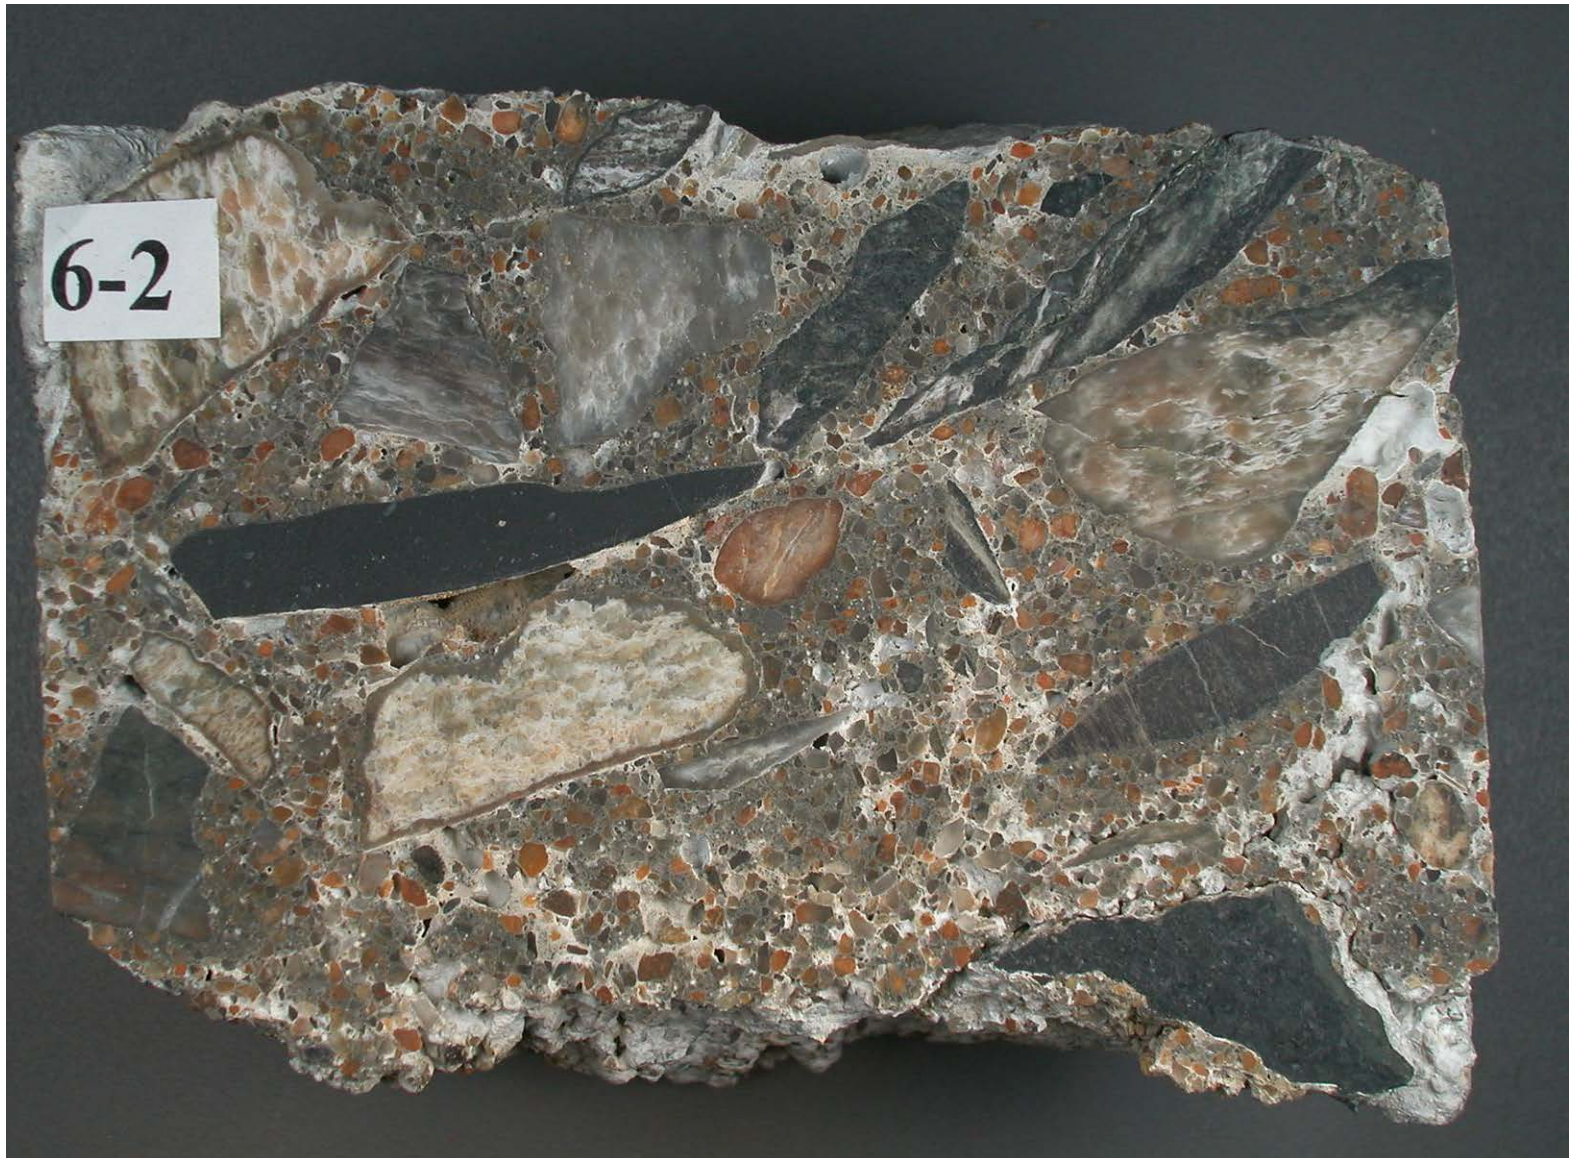
Polished core 6-2 showing gel deposits and internal fractures

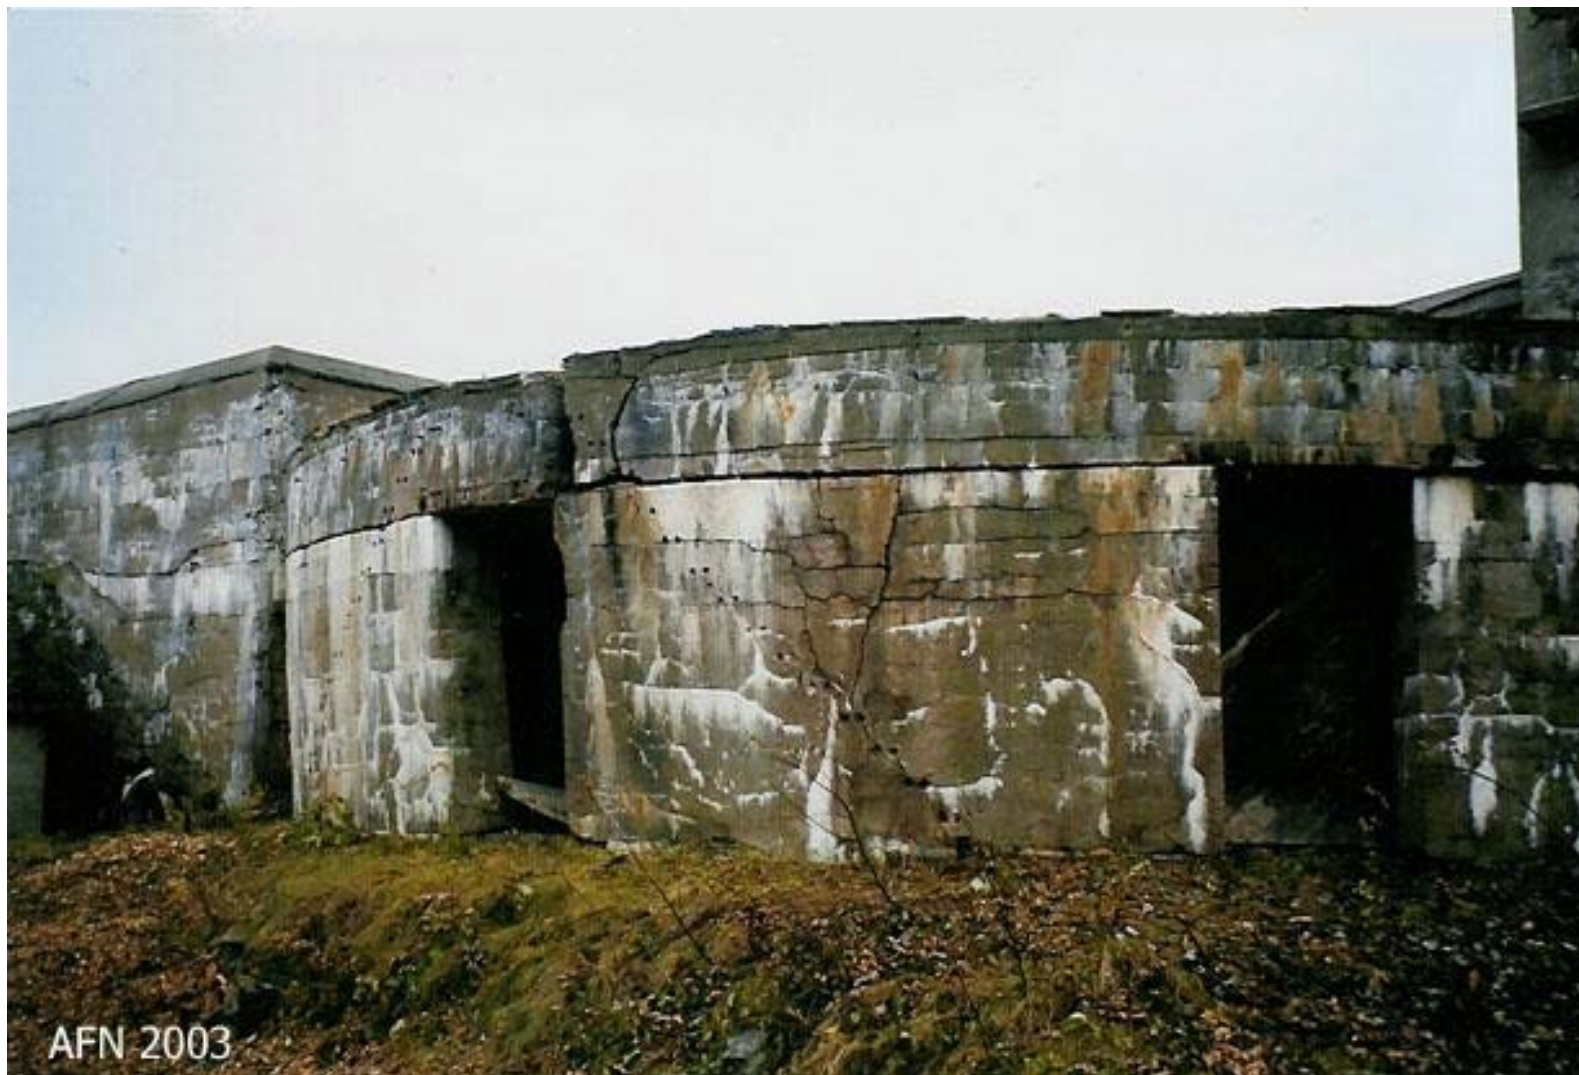
As we get ready to head topside, check out the condition of the concrete. The large crack shows the loading platform tearing itself apart as it bulges northward.

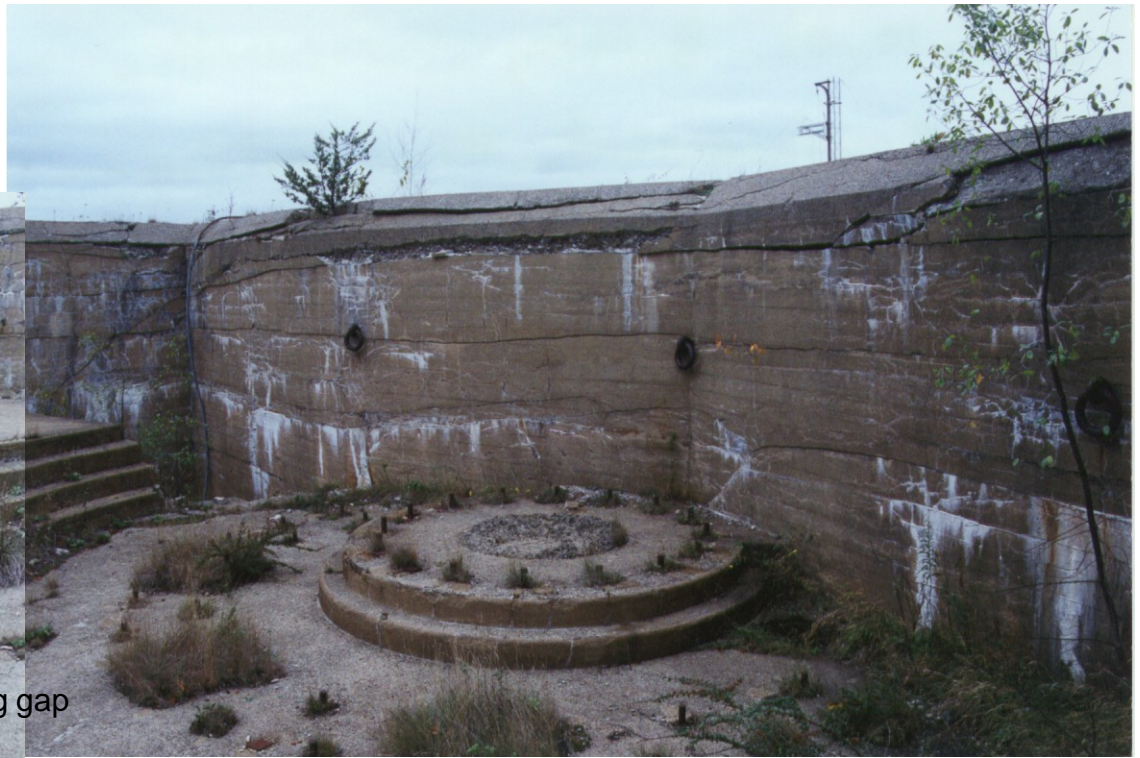
Gun Emplacement #1 is much the same as at Gun Emplacement #2 (sans tree in the gun carriage mount), except the concrete here appears to be even more distressed and, of course, there's the matter of the loading platform bulging outward 15" or more.

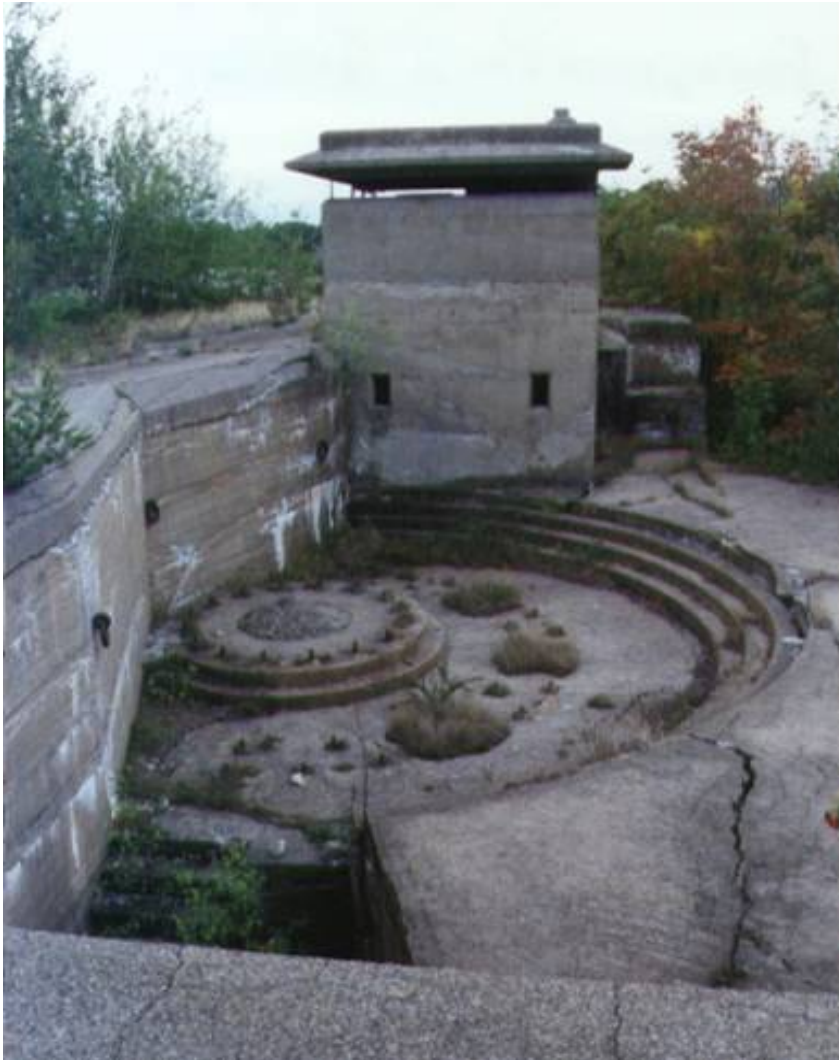
This vantage point also provides a good look at the condition of the loading platform.

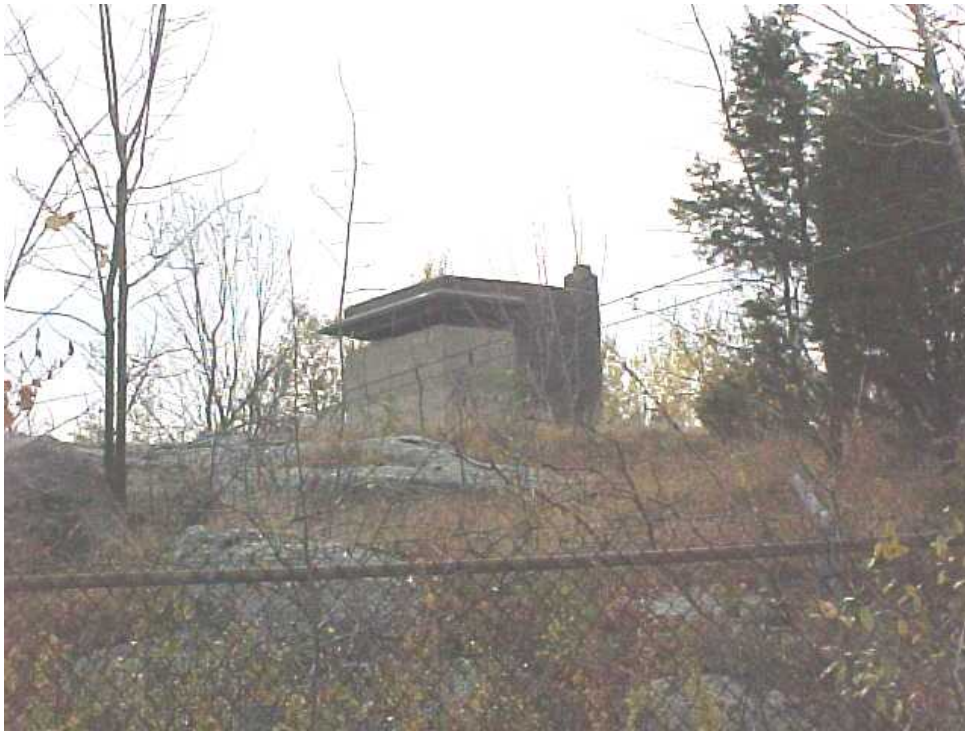
WWII Base-End Triangulation Tower

Added in 1943 atop Battery Farnsworth, soldiers in this base-end triangulation tower were able to provide enemy vessel siting information to mine control personnel. In combination with siting information from a sister tower at Fort Foster on Gerrish Island in Kittery, Maine, the position of approaching vessels could be plotted relative to that of harbor mines, thereby allowing remote detonation of mines nearest to the target. Prior to the addition of this tower, Battery Farnsworth was effectively hidden from approaching vessels.

The 1943 base-end triangulation tower (a.k.a. observation tower) consists of two levels . . .

The lower level held a work table for plotting vessel sightings as well as communications equipment linked to the mine control personnel, who were located within the protection of the 1920 mining casemate.

The upper level, accessible only by way of a wooden “ship’s ladder” from the plotting room, contained a manned sighting instrument and a sentry.

Observation slits wrapped around 70% of the tower perimeter . . . pretty much wherever there was water to see.

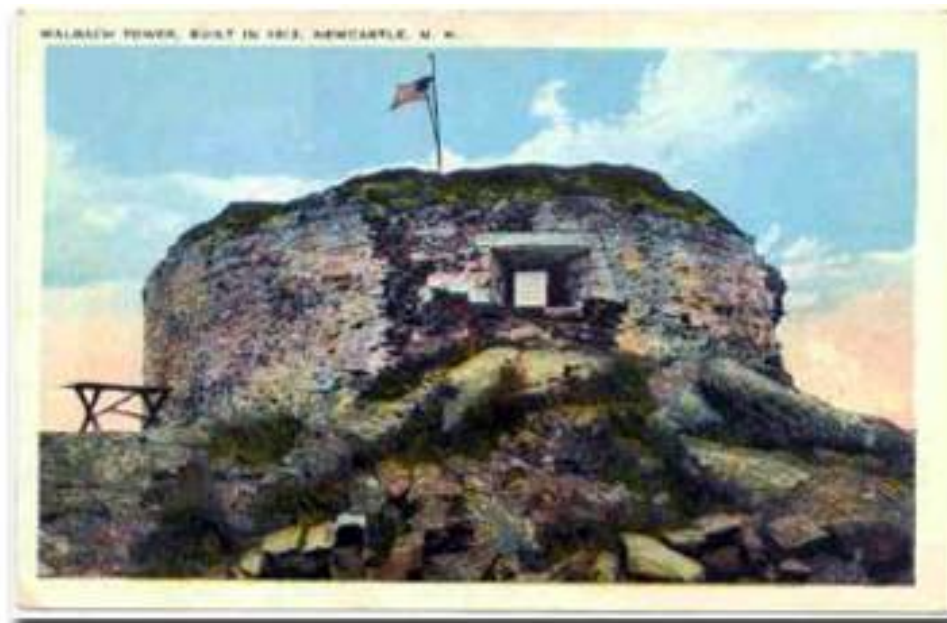
Early postcard of Walbach Tower built at the Fort in 1812

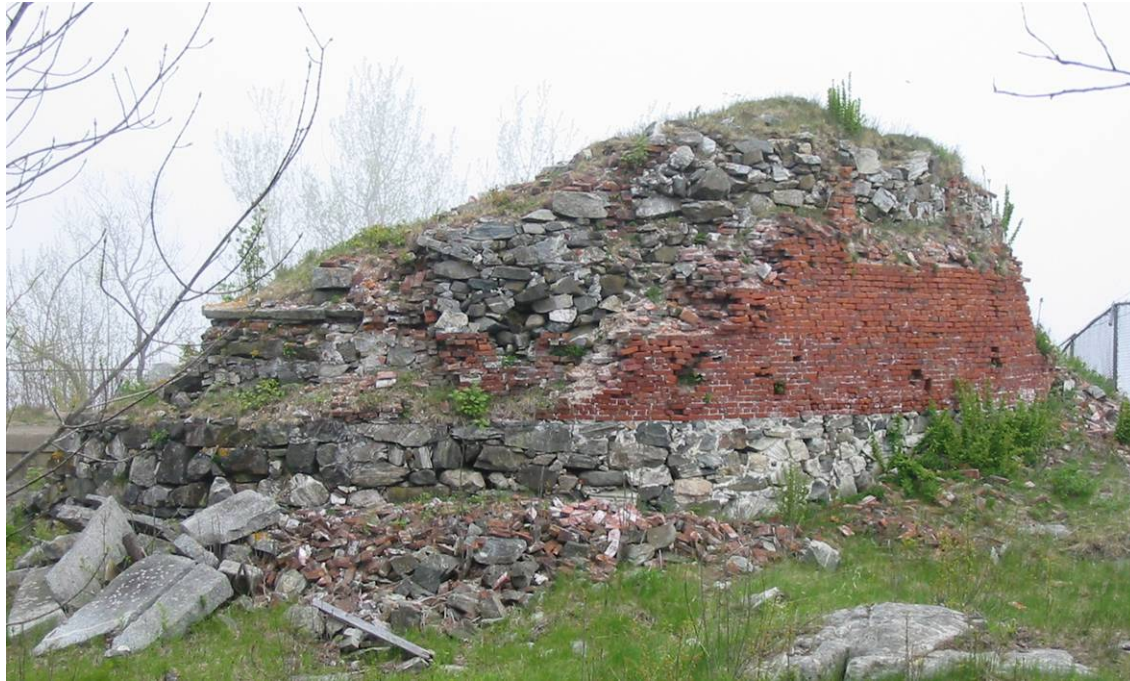
Walbach Tower Ruins (from northwest)

Walbach Tower is now in ruins as a result of the passage of time as well as due to damage associated with the construction of Farnsworth Battery, and thought to have been further demolished during World War II to reduce its prominence. Walbach Tower was a three-level Martello-type cylindrical stone and brick masonry structure, which supported a heavy cannon on its top level and had rooms beneath serving as barracks and a magazine. It is said to have been constructed in the course of only a couple of weeks in 1814 under the cover of dark.

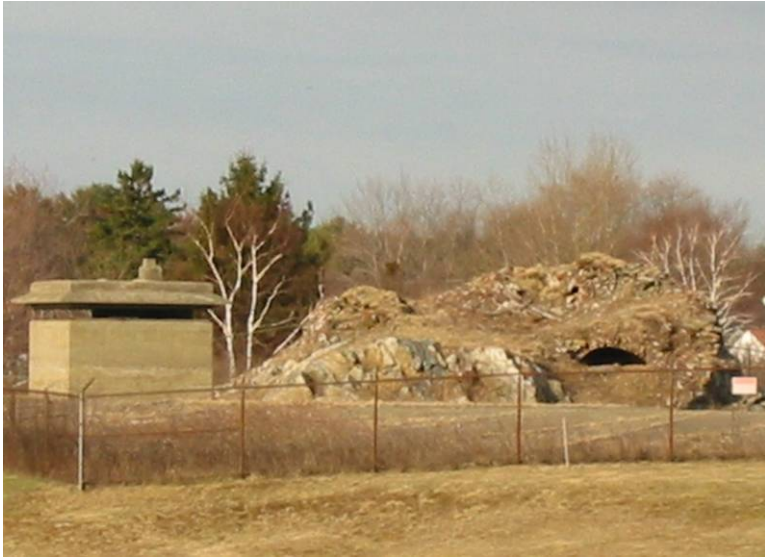
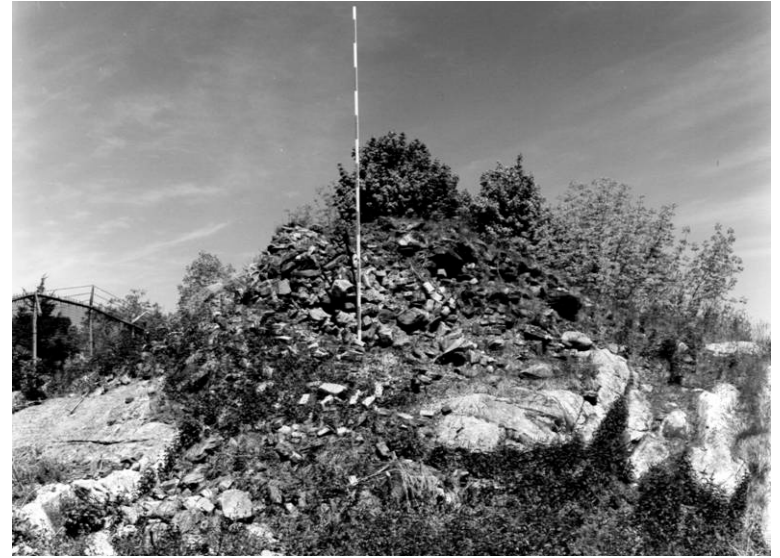
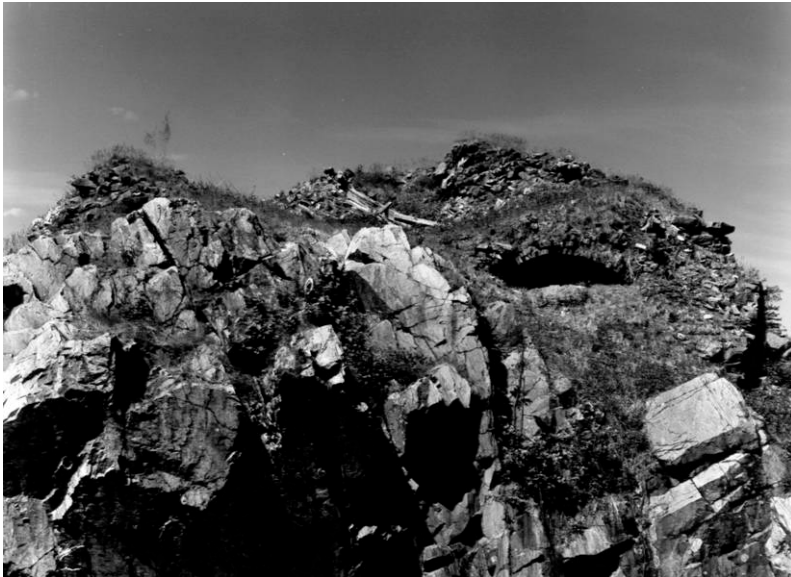
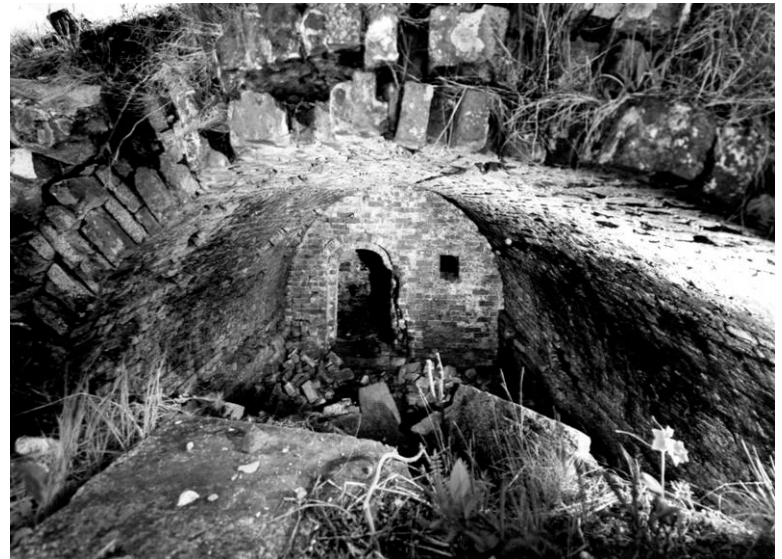
Walbach Tower - Magazine

The entrance to the lower level magazine has been somewhat blocked by falling debris from the tower above and by rocks displaced by blasting operations associated with the construction of Battery Farnsworth. To get into the magazine, it is now pretty much necessary to do the army crawl.

The magazine interior is in surprisingly good condition considering its age. While some of the bricks littering the floor have fallen from the arched ceiling, most appear to have tumbled in from the walls of the tower above, as they either collapsed or were knocked down.

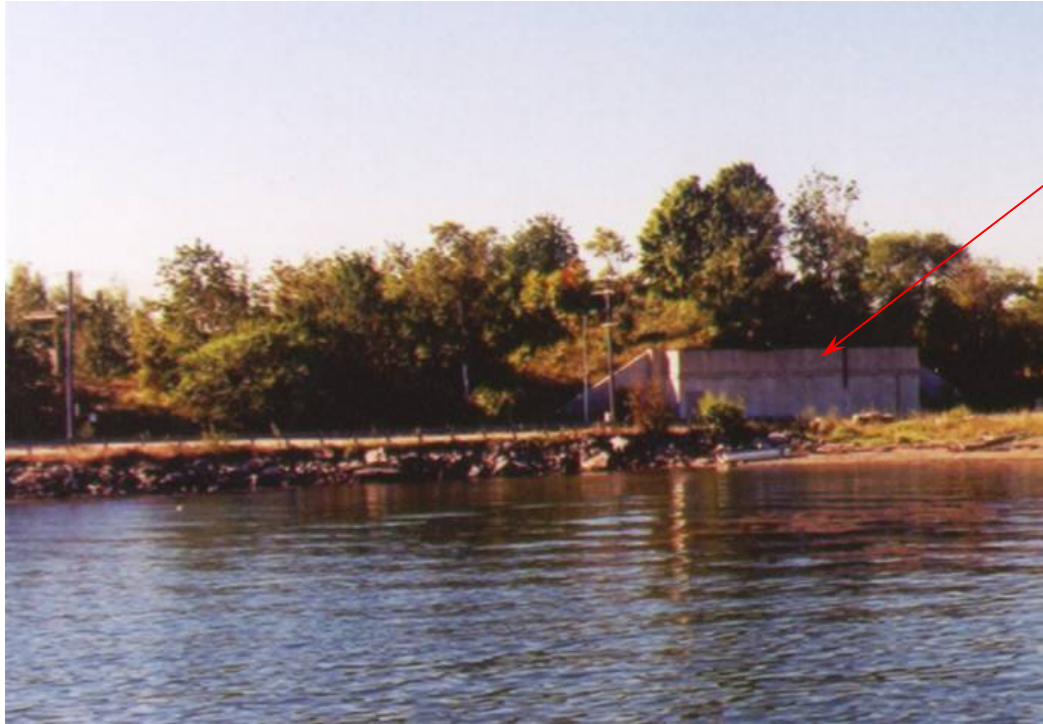
1920 Mining
Casemate with
WWII blast proof
concrete face

Also seen from Hart's Cove is the 1920 Mining Casemate. Actually, all we see of the original structure are the flanking wingwalls. At the center, we see a rather stark concrete facade that was constructed as part of WWII efforts to offer protection against attack from the north.

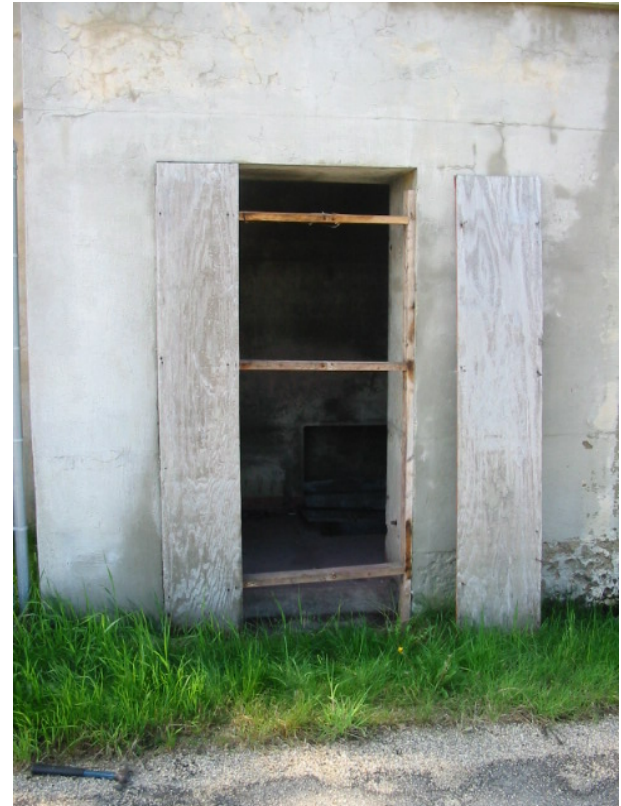
Blast-Proof / Gas-Proof Entry Corridor (1942)
