WALBACH TOWER, BATTERY FARNSWORTH, ASSOCIATED STRUCTURES, AND ENVIRONS

Fort Point
New Castle, New Hampshire

HISTORIC STRUCTURES REPORT

PART II

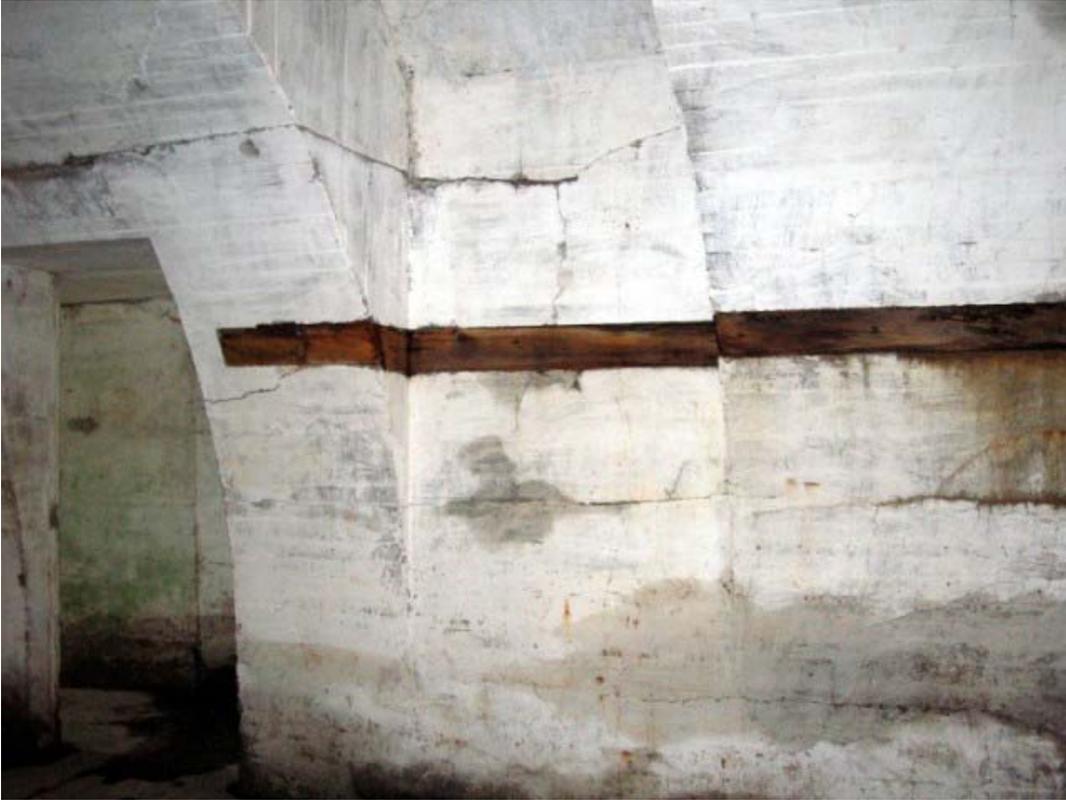
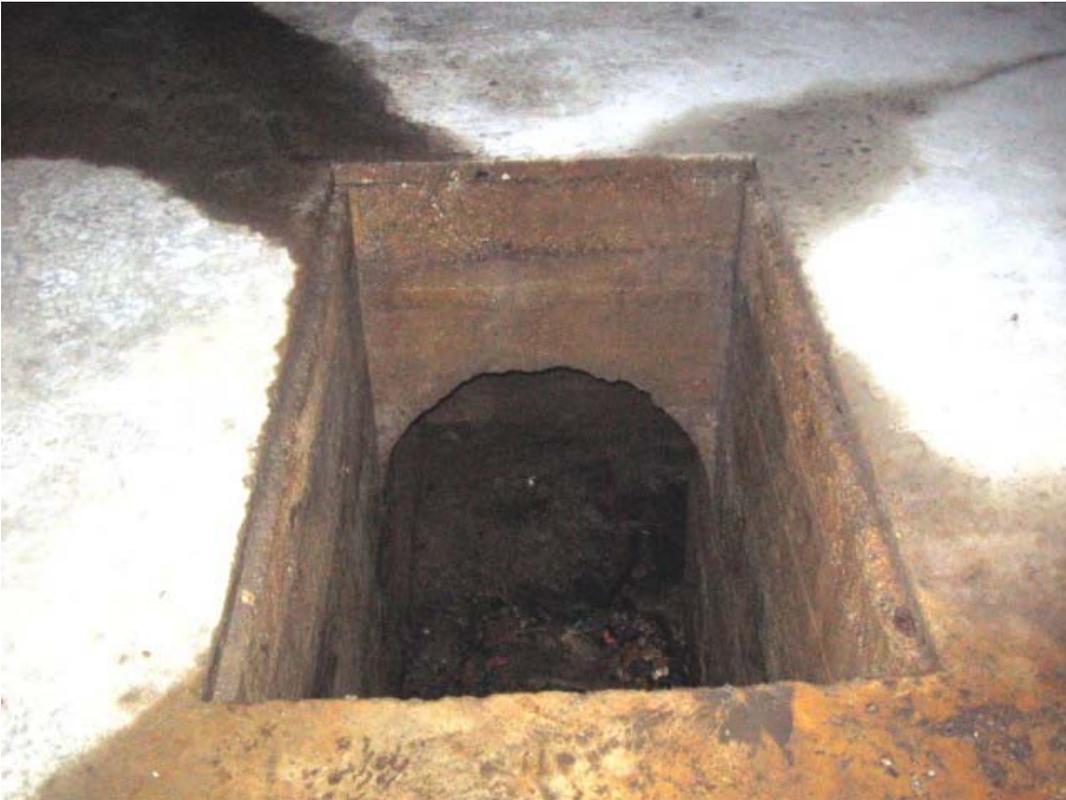
Casemate and Cable Gallery

The concrete floor of the chamber is in sound condition, with minimal cracking.

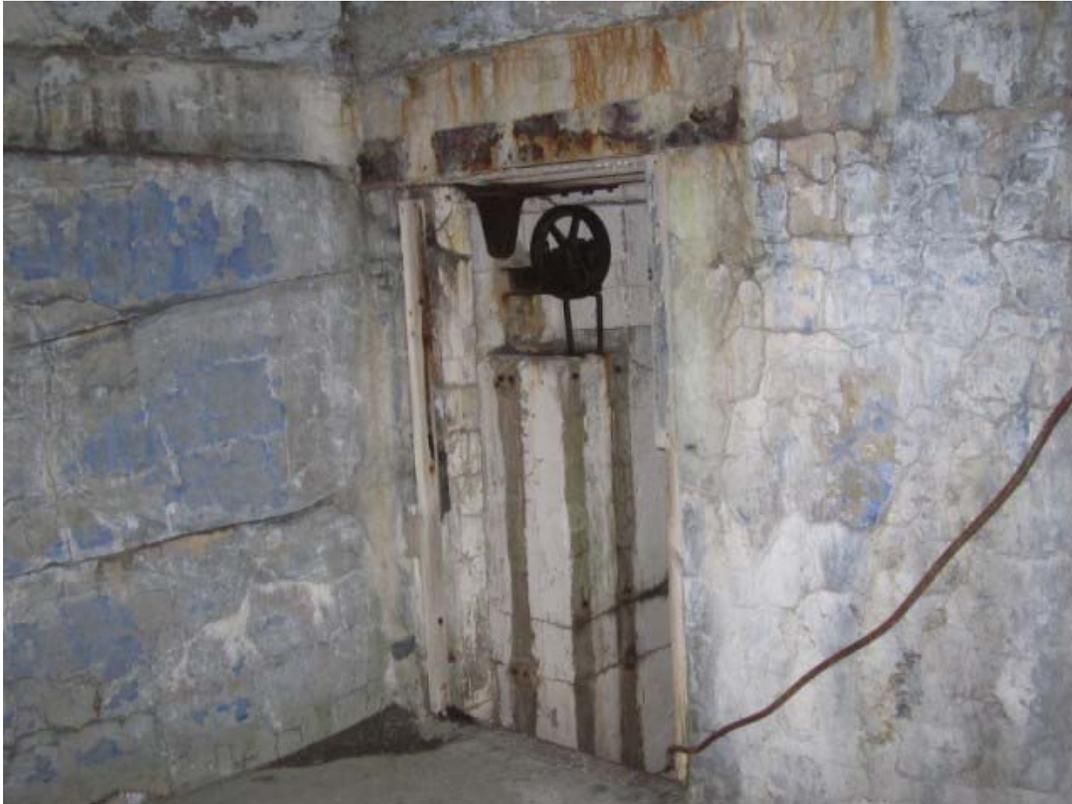
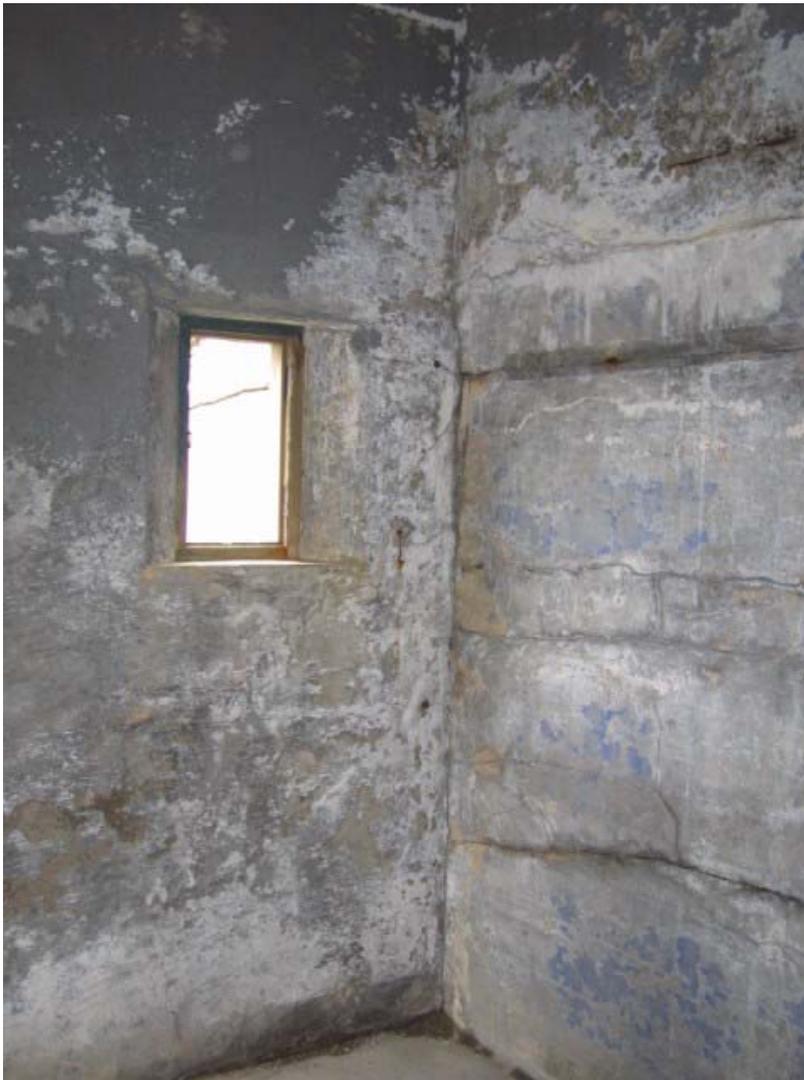
Plotting Room

There is exposed rebar in the ceiling along the east and west walls. Approximately 25 square feet of rebar and damaged concrete is exposed.

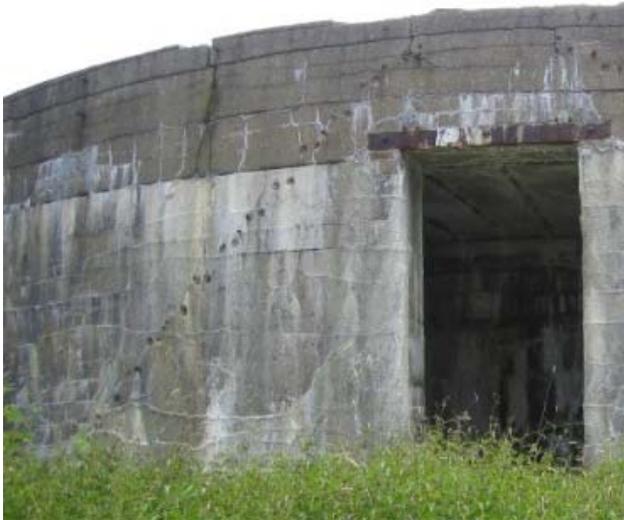
**Northwest Section of Curved Wall Below Roof Slab
(Exterior of Guard Room)**

Description: MD: 50%

Deficiencies: horizontal cracking (typically at cold joints)
structural movement/deformation
mineral deposits
spiderweb cracking

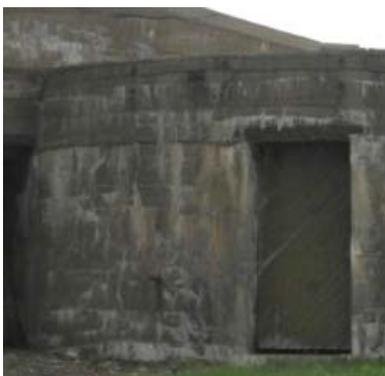
**North Section of Curved Wall Below Roof Slab
(Exterior of Battery Room)**

Description: MD: 20%

Deficiencies: horizontal cracking (typically at cold joints)
spiderweb cracking
mineral deposits
vertical cracking

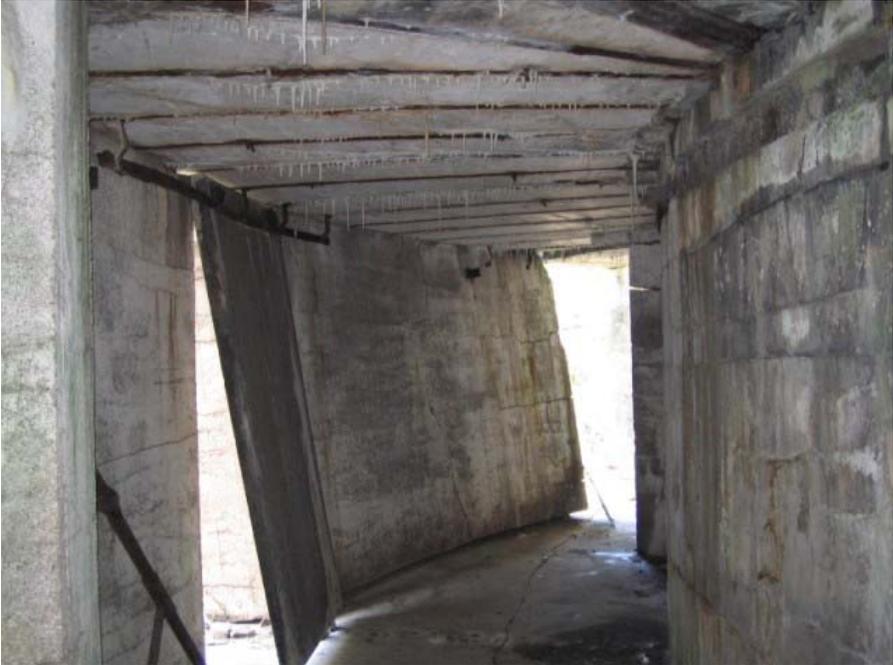
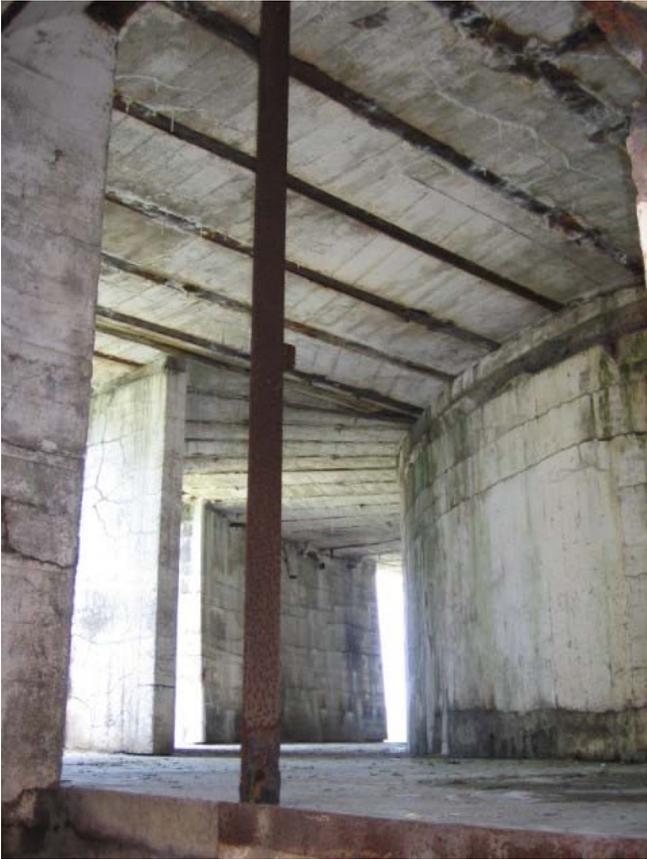
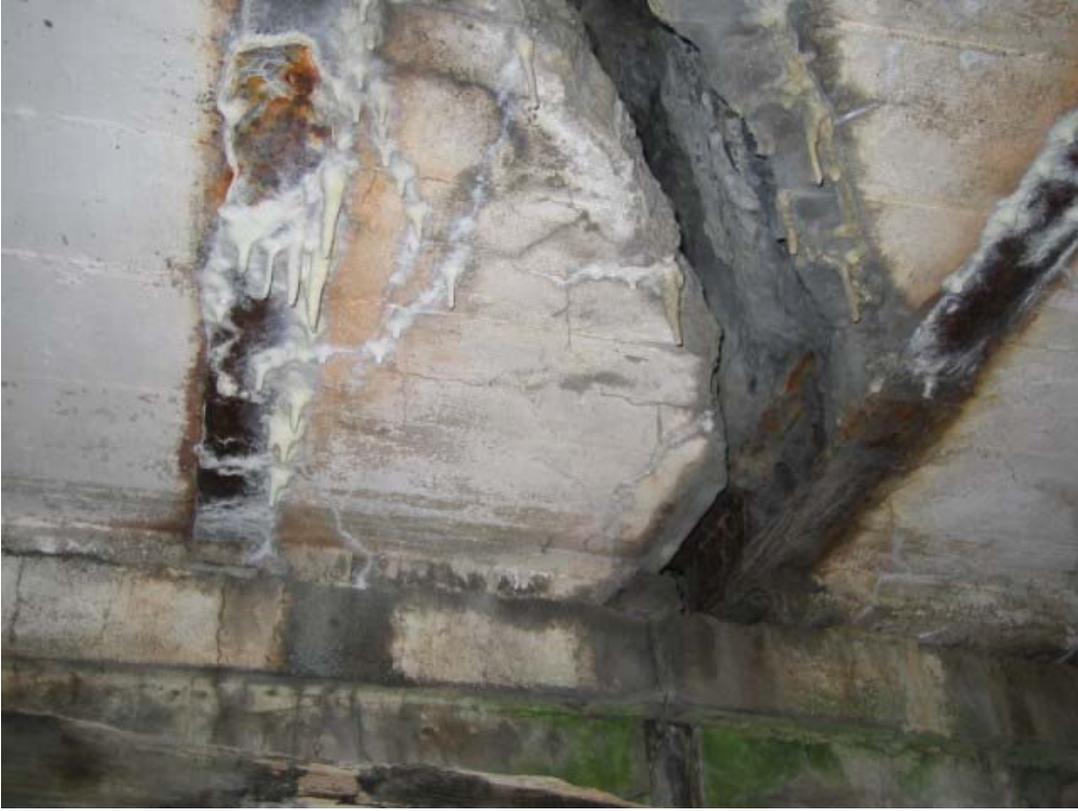
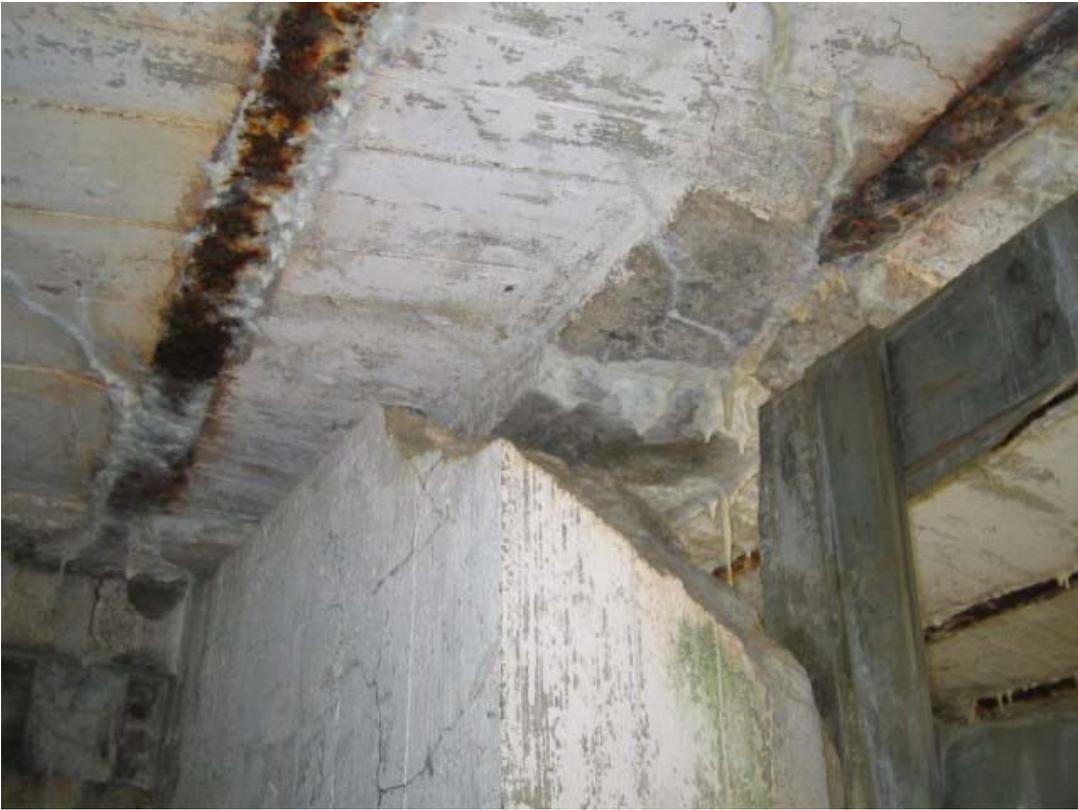
Curved Corridor Ceiling

The ceiling of the curved corridor, which is the underside of the Loading Platform above, is cracked and shows the severe structural displacement outward discussed in the "Feature Condition" section of the Loading Platform. There is evidence of severe moisture infiltration on all ceiling surfaces. The steel I-beams are all corroded to varying degrees. Where there are wood "beams" (nailers) cast into the ceiling, they are saturated with water. Many areas have clusters or rows of small stalactites.

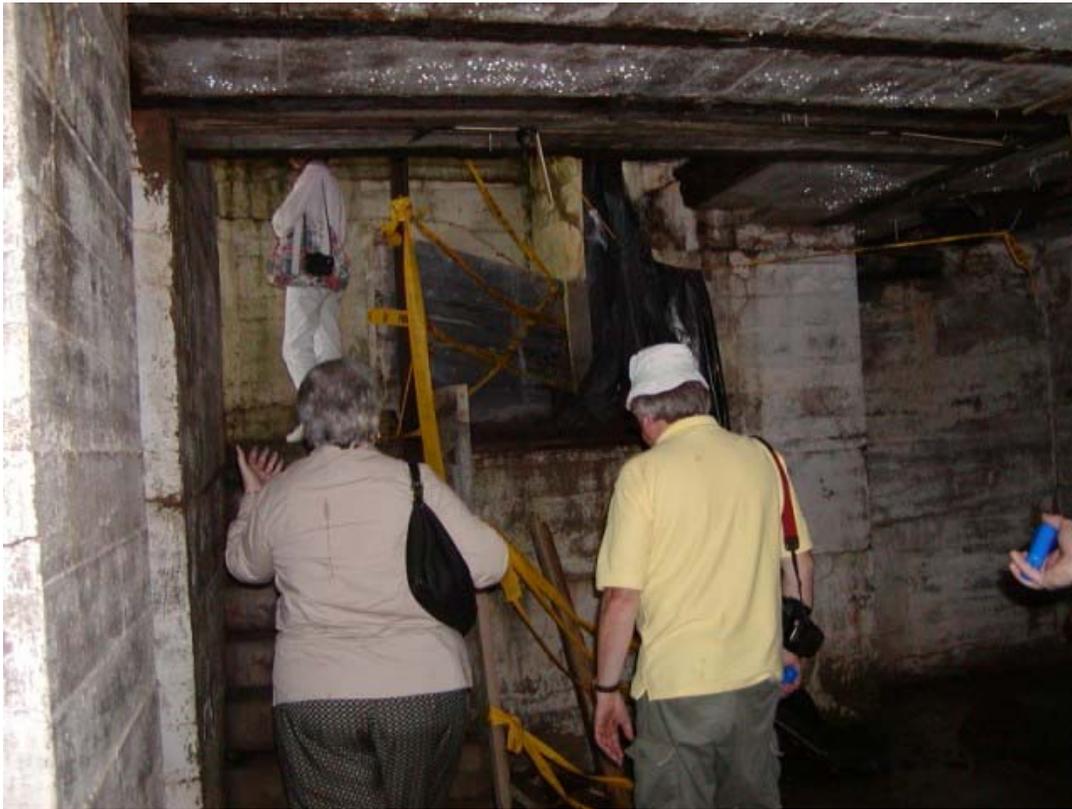
Manual Winch Alcove

Deficiencies: horizontal cracking (typically at cold joints)
 diagonal cracking
 mineral deposits: 60% southwest wall; thick
 microbiological growth: esp. southeast wall
 standing water

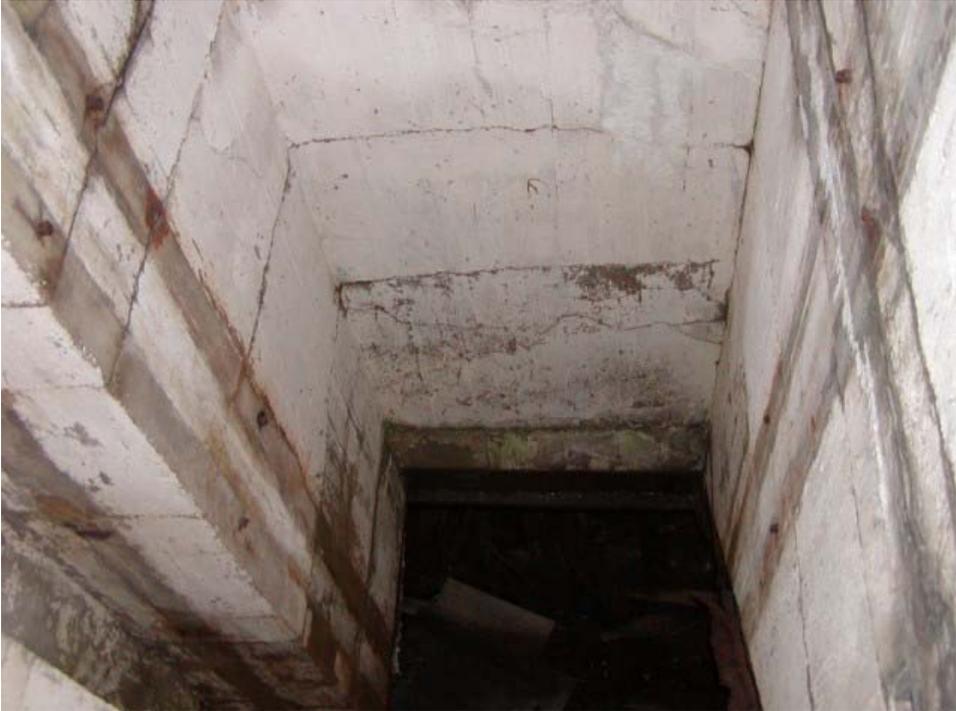
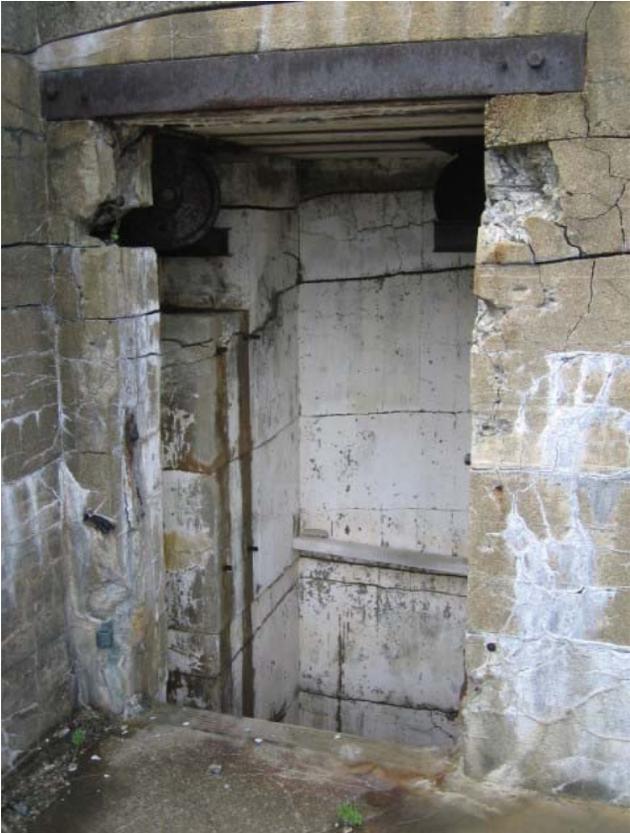
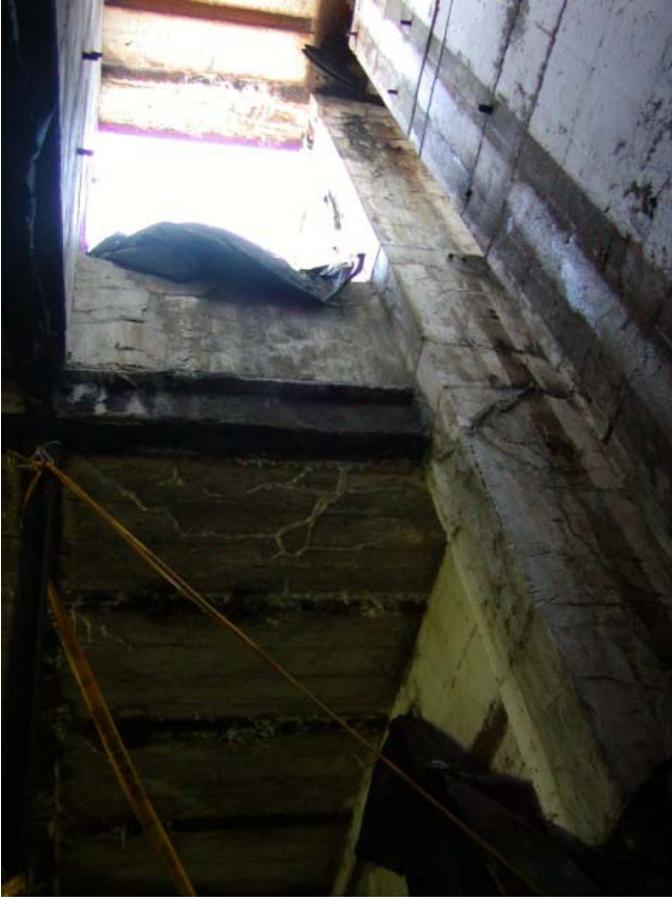
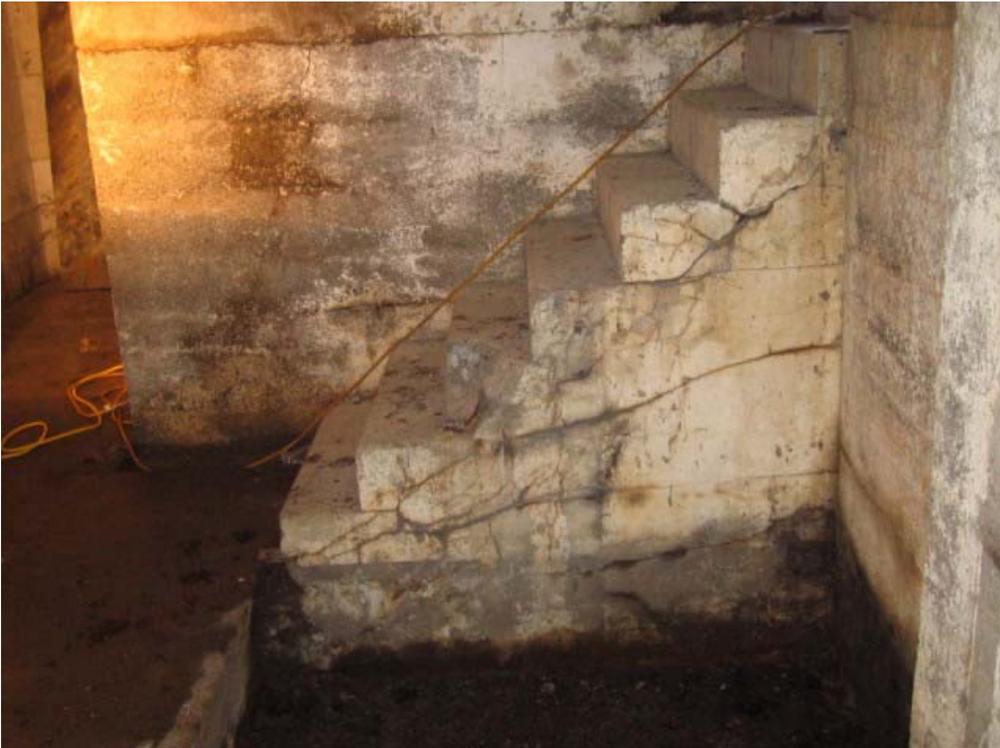
Hoistway

Deficiencies: horizontal cracking (typically at cold joints)
 standing water
 spiderweb cracking
 mineral deposits: heavy on ceiling

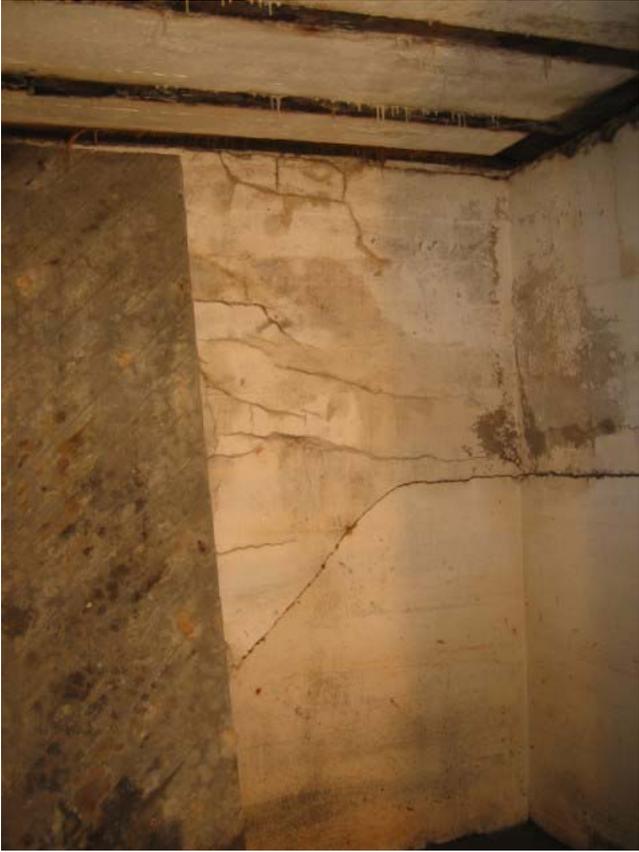
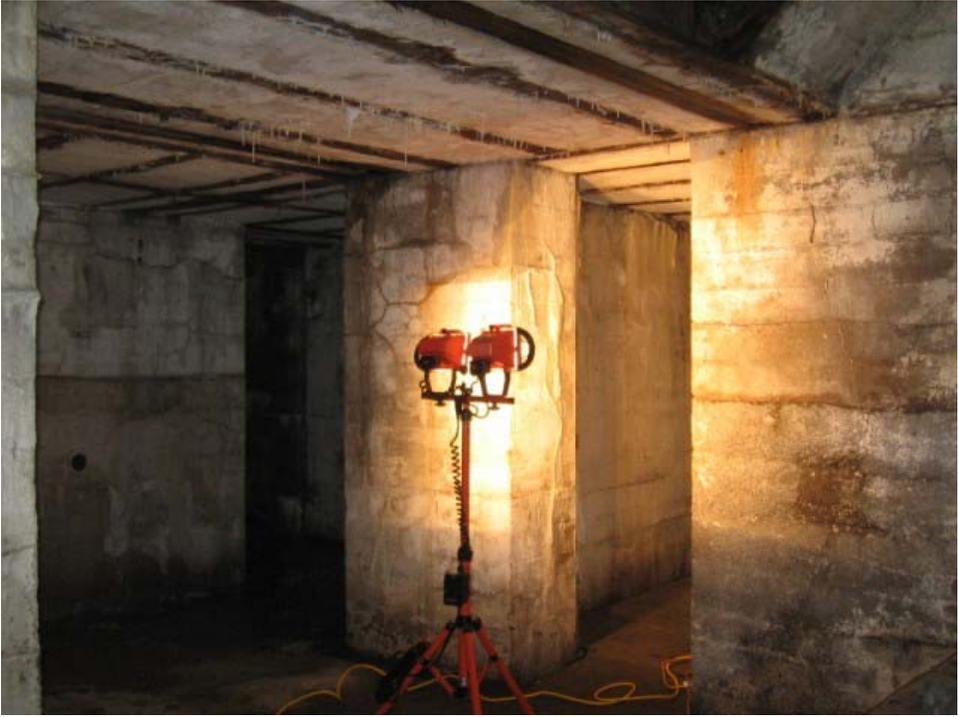
Relocating Room

Deficiencies: horizontal cracking (typically at cold joints)
 diagonal cracking
 spalling: 4" x 12" on southwest wall

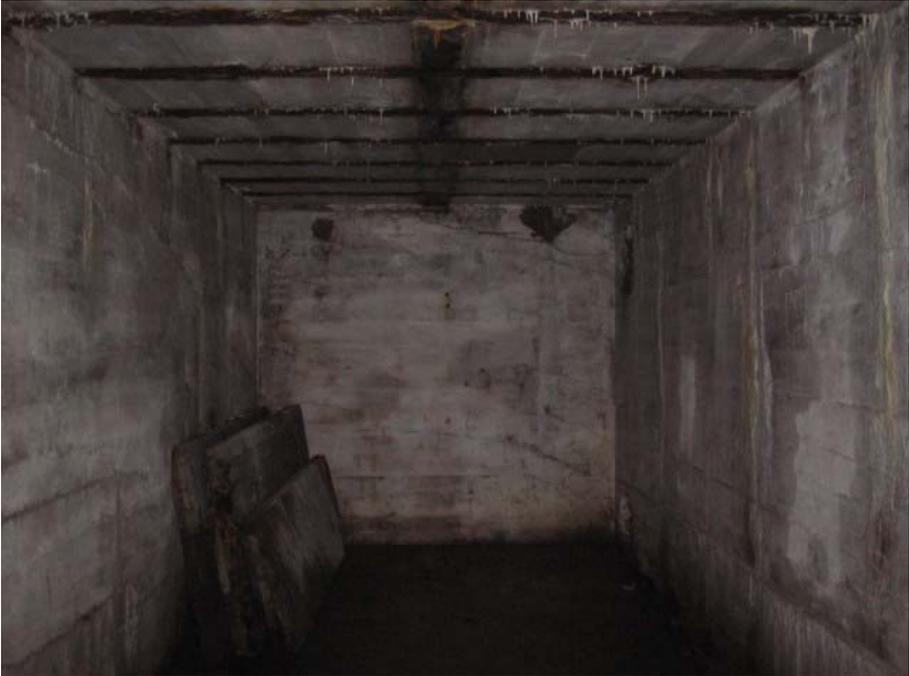
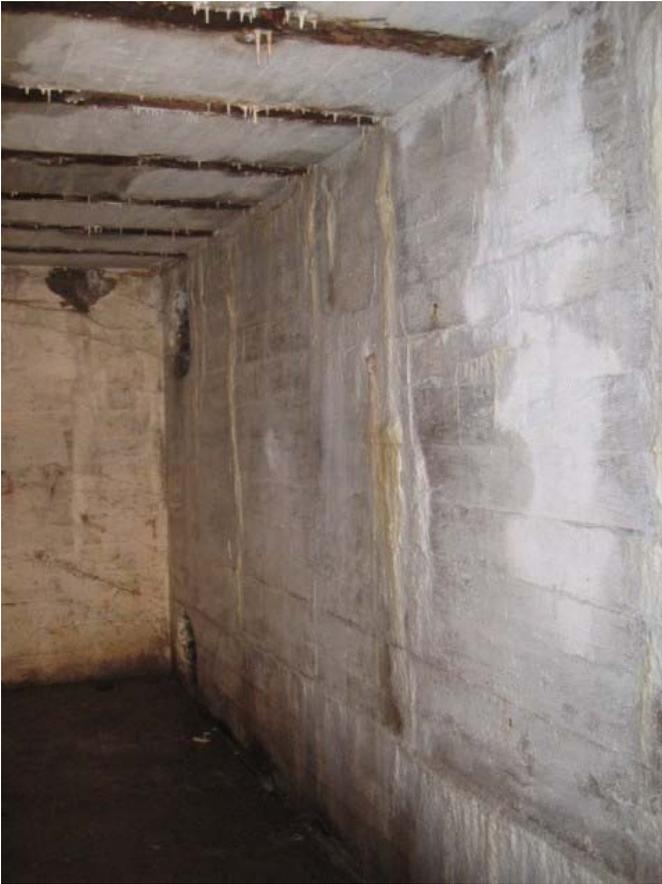
Shell Room

Deficiencies: horizontal cracking (typically at cold joints)
diagonal cracking
mineral deposits

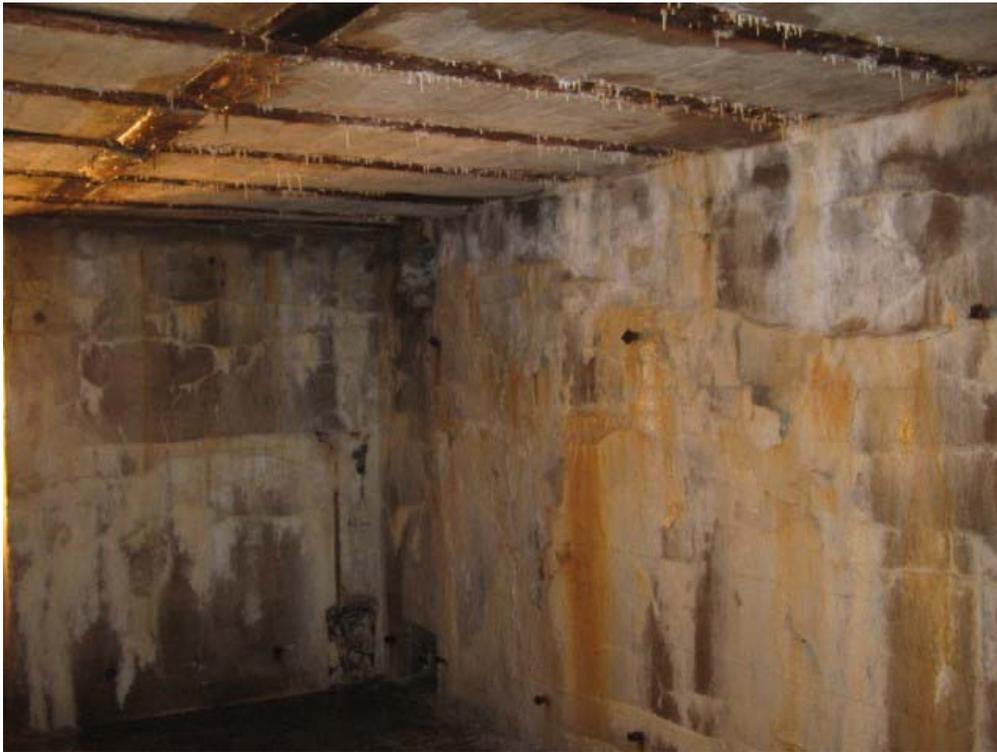
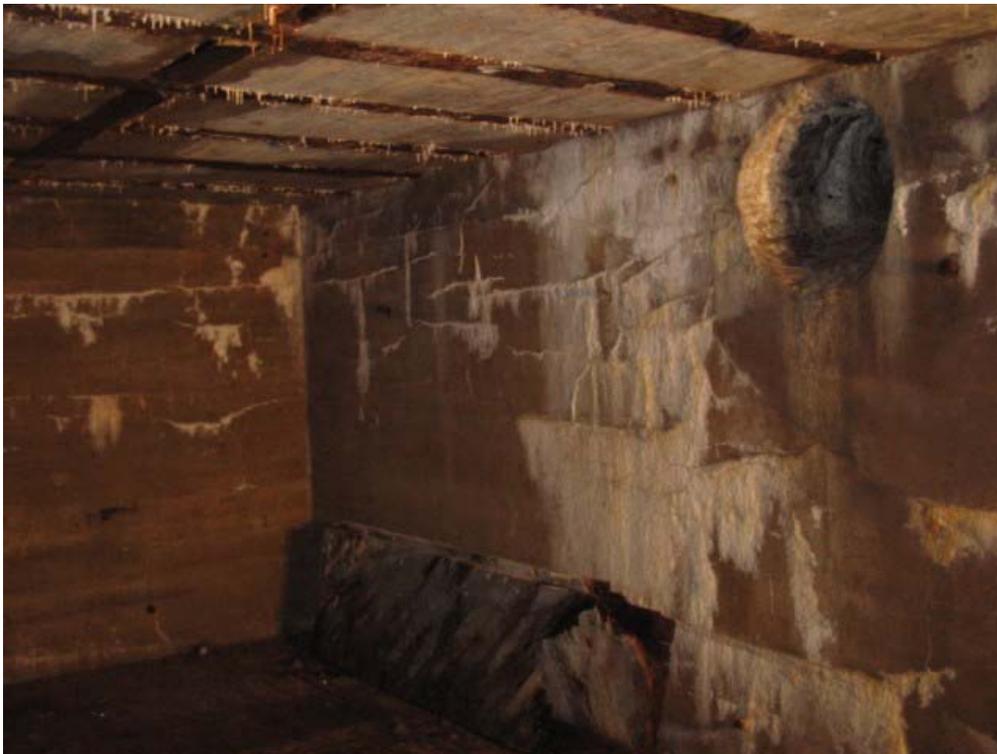
Powder Magazine

Deficiencies: horizontal cracking (typically at cold joints)
 mineral deposits
 surface dampness

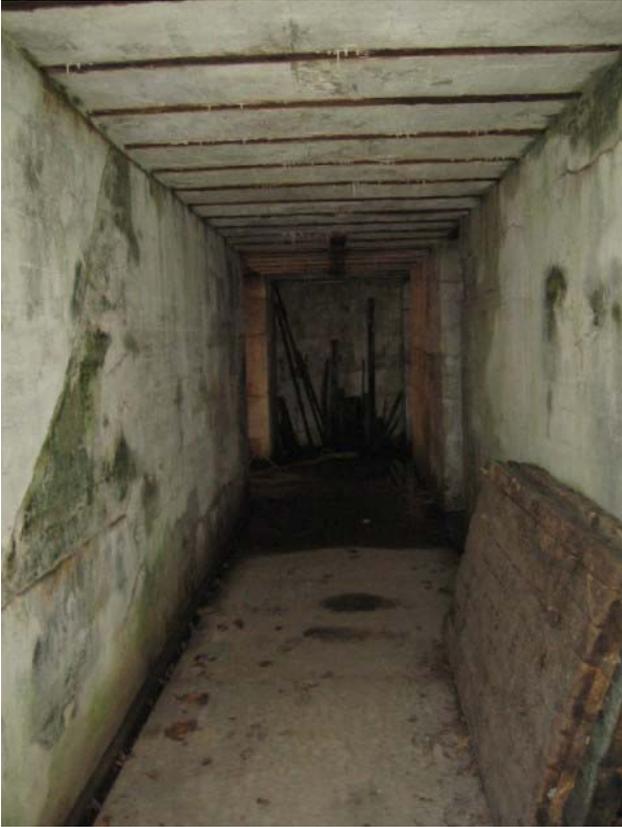
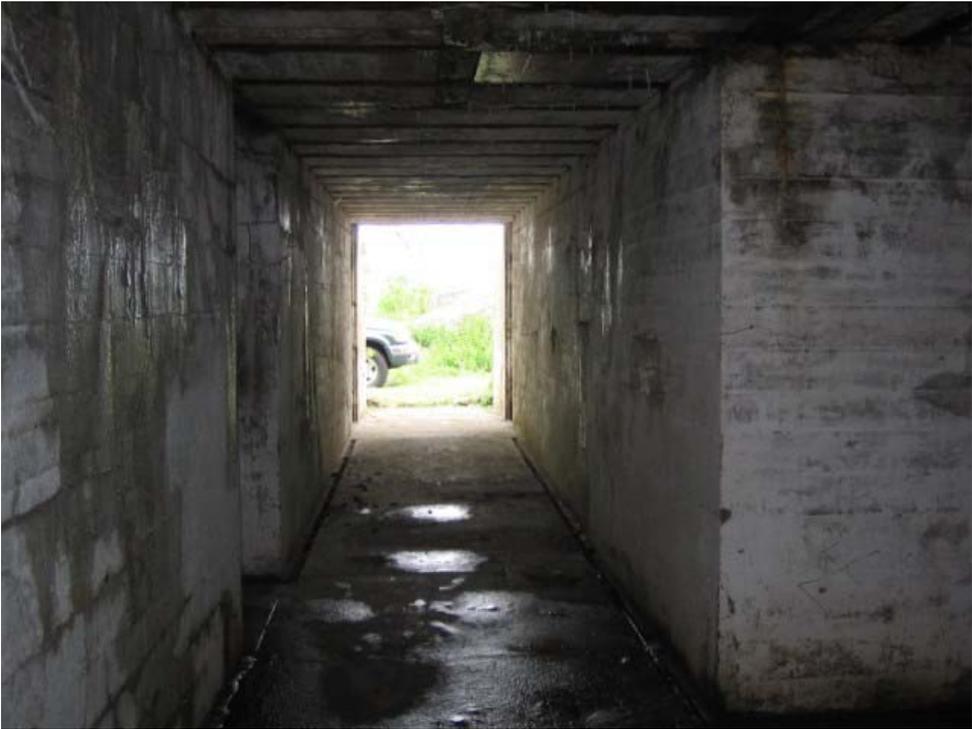
Entry Corridor

Deficiencies: oxide jacking
 surface dampness
 mineral deposits

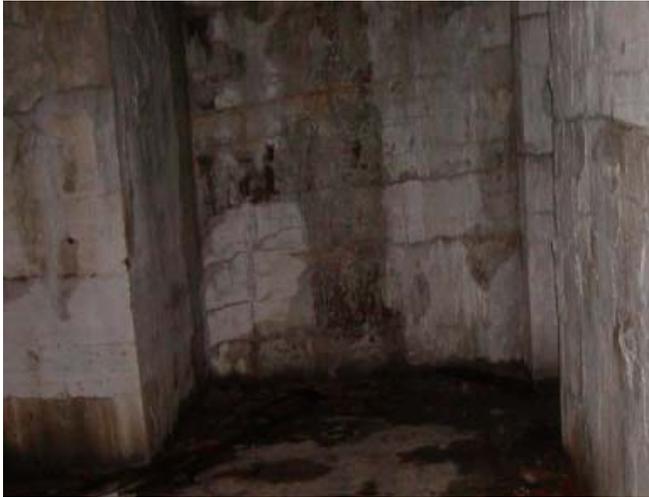
Southeast (End) Wall of Corridor

End wall of corridor, facing east

Description: HC
MD: isolated but thick
SC
*MG: heavy, algal
SD

Deficiencies: horizontal cracking (typically at cold joints)
mineral deposits
spiderweb cracking
microbiological growth

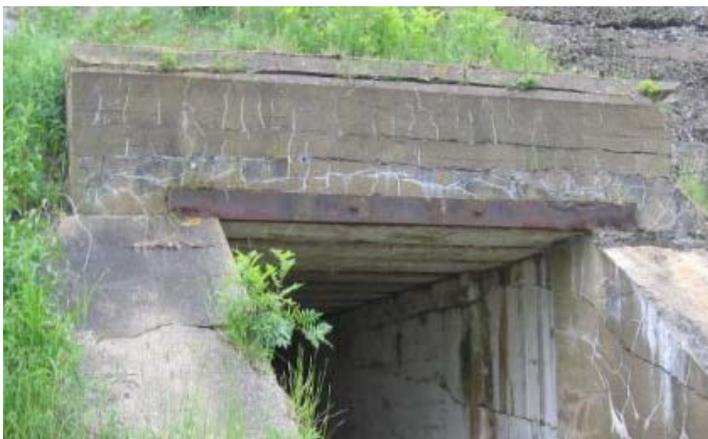
Fascia Above Entrance

Fascia above entrance to Entry Corridor, facing south

Deficiencies: cracking at dissimilar material interfaces
horizontal cracking (typically at cold joints)

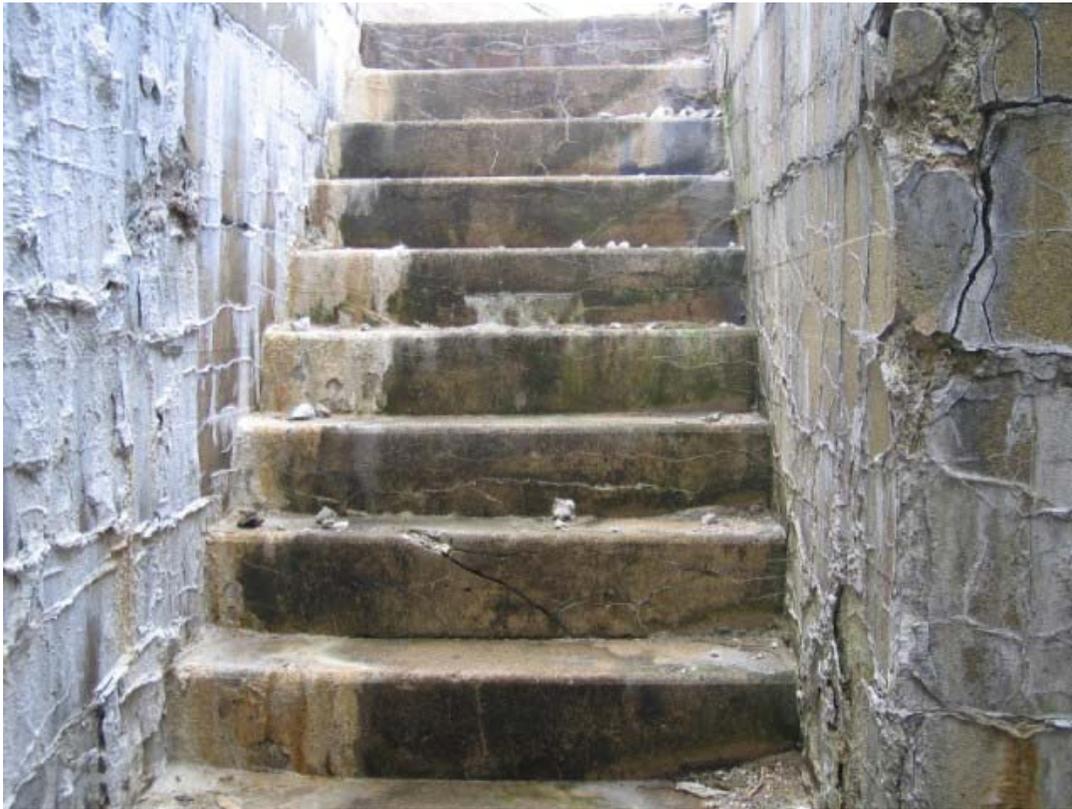
Loading Platform Stair

Loading Platform stair, facing southwest

Deficiencies: horizontal cracking (typically at cold joints)
 spalling
 spiderweb cracking
 mineral deposits

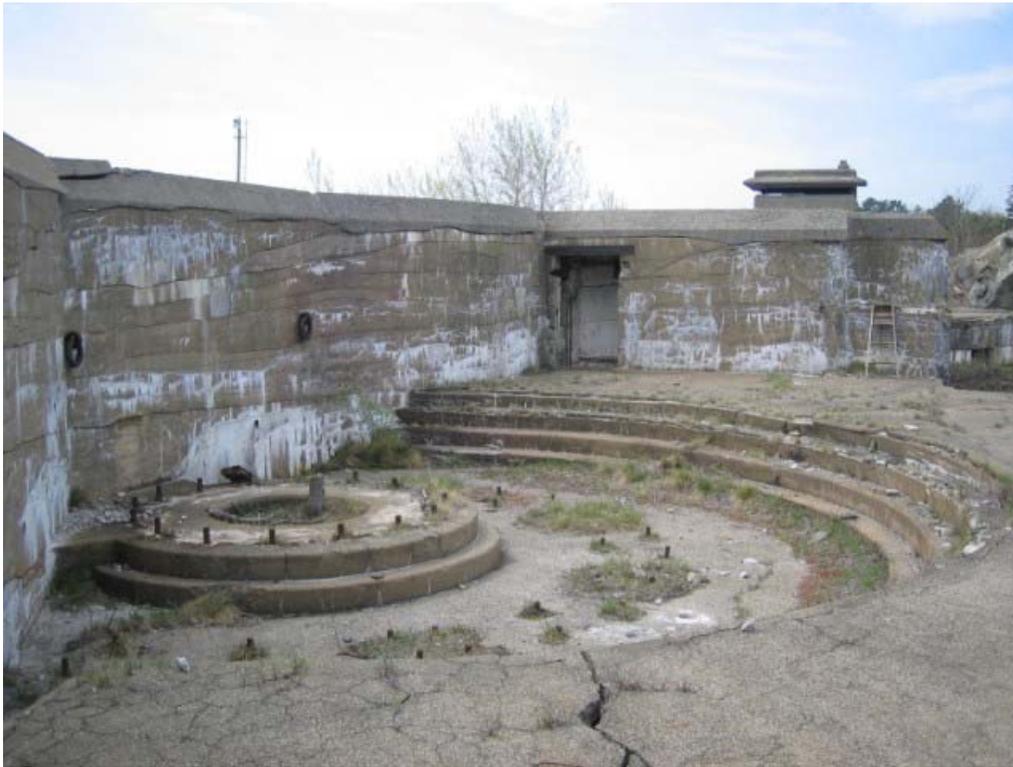
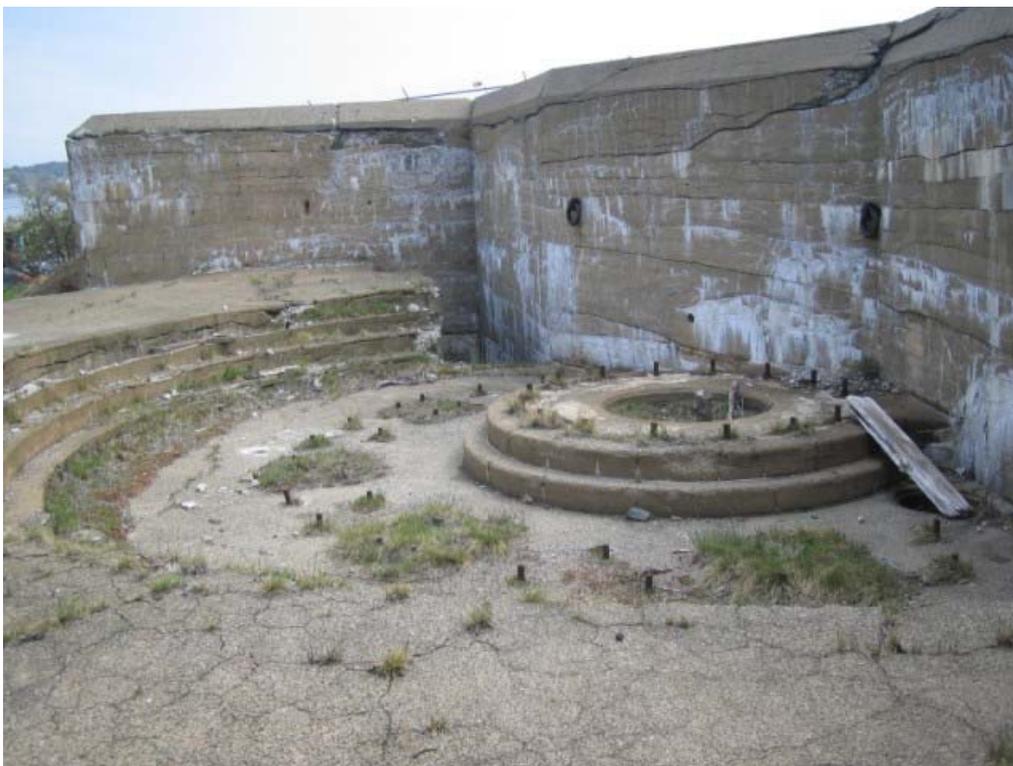
The most dramatic structural movement is evident at the Loading Platform of Gun Emplacement No.1, and in the outward tipping of the Guard Room wall below. (The same is happening to a lesser degree in a similar location and pattern on Gun Emplacement No. 2.) Based on the finding that the present expansive movement of the concrete will continue, especially where aggravated by exposure to the marine atmosphere, it is inevitable that a catastrophic structural failure of the Guard Room wall of Gun Emplacement No. 1 will occur at some point without major structural intervention.⁷

Loading Platform, facing south

Rear wall of Loading Platform, facing northeast

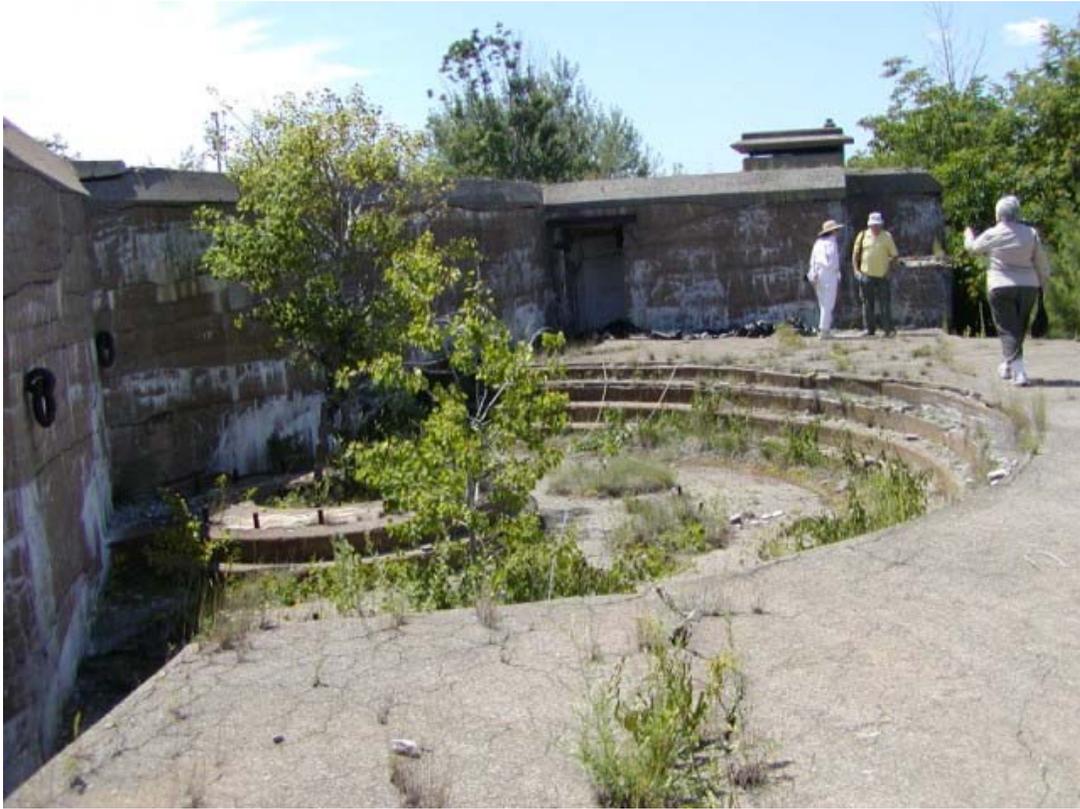
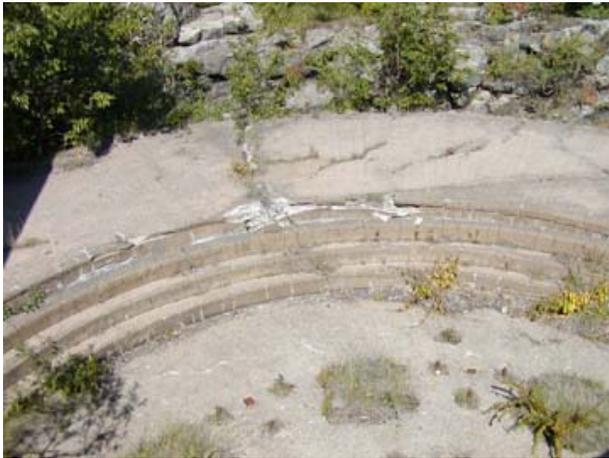
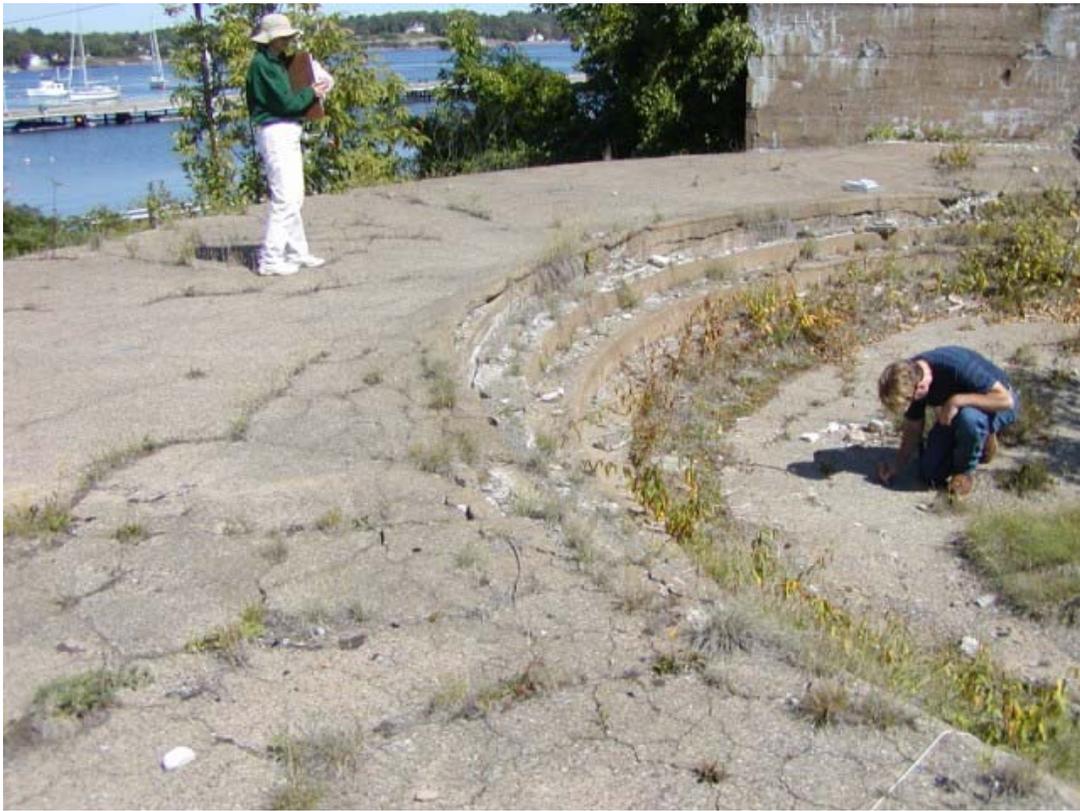
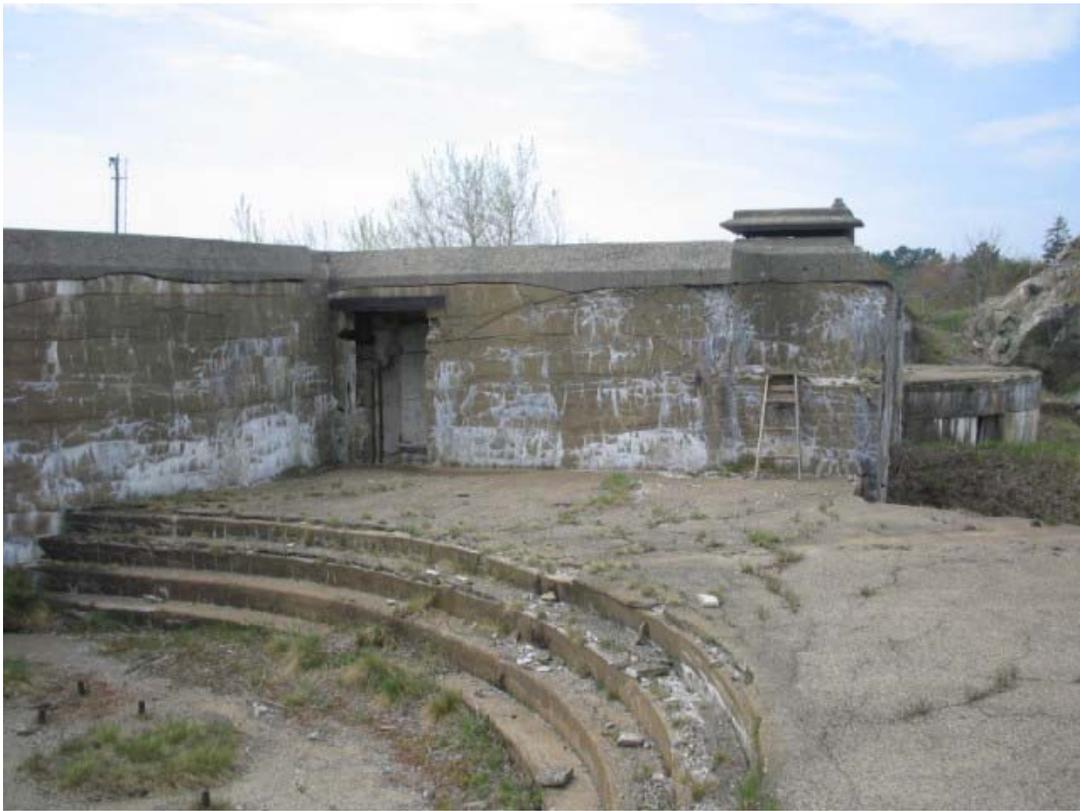
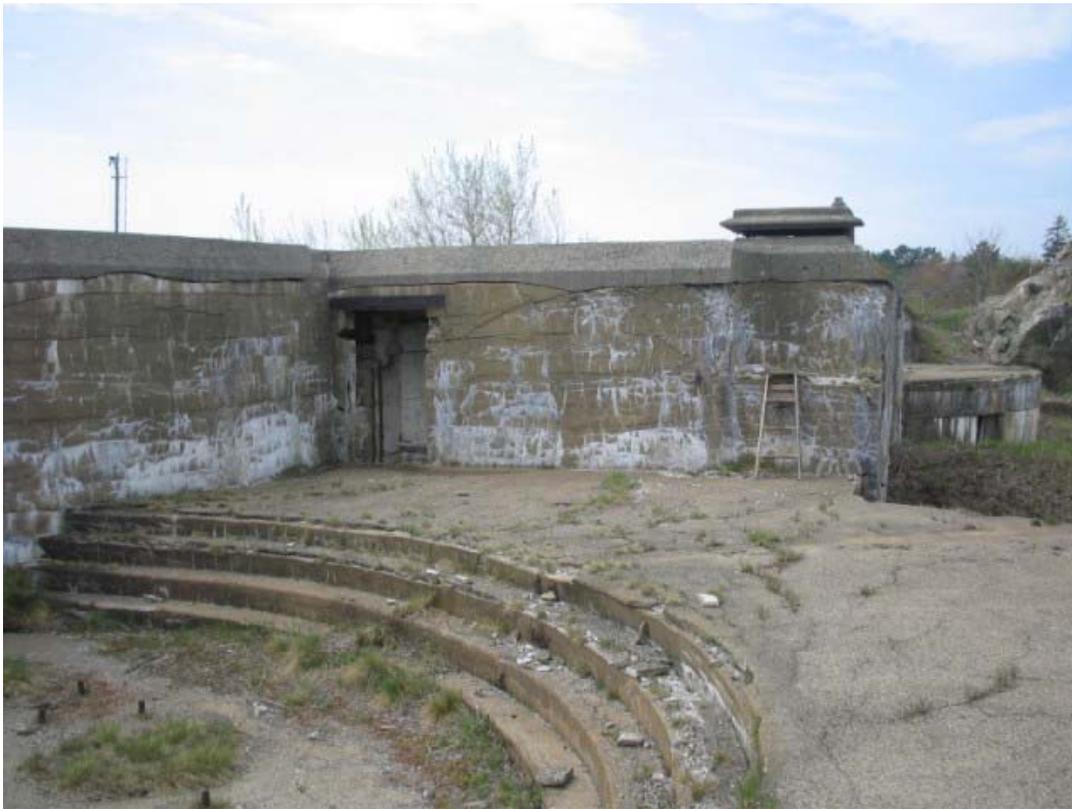
Description: *LC: along curved line of top step; two radial cracks extending from step outward
*SM: radially outward. Loading Platform detached from part of structure with steps and counterweight well

Deficiencies: large- scale structural cracking (more than 1" wide)
structural movement/deformation
spiderweb cracking
vegetation growth
