WALBACH TOWER, BATTERY FARNSWORTH, ASSOCIATED STRUCTURES, AND ENVIRONS

Fort Point
New Castle, New Hampshire

HISTORIC STRUCTURES REPORT

PART II

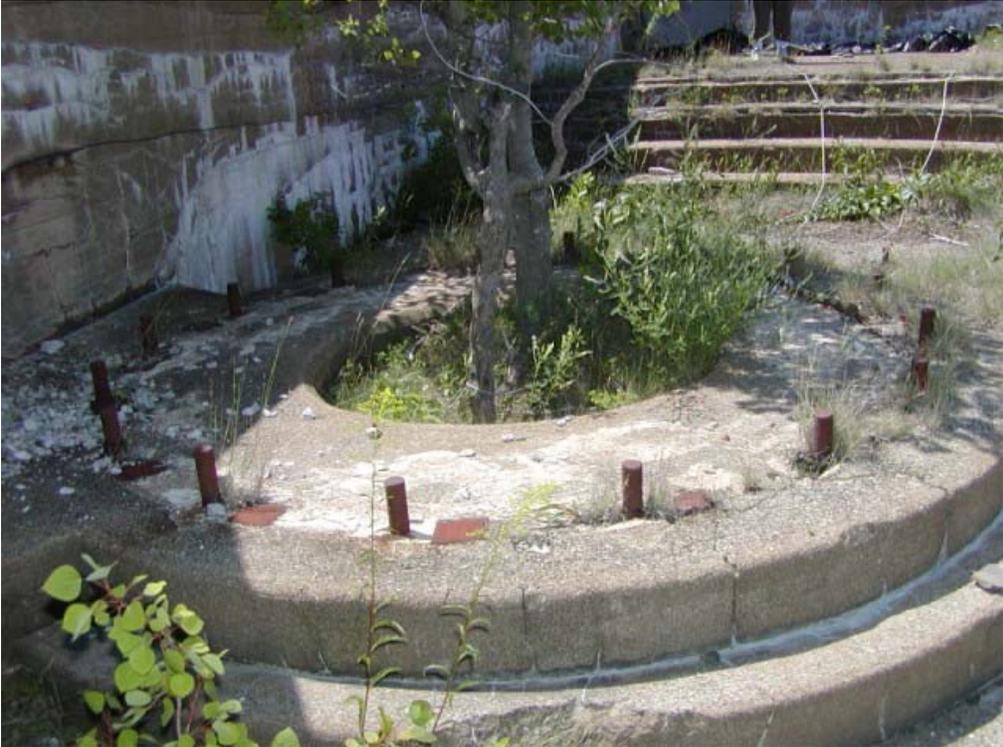
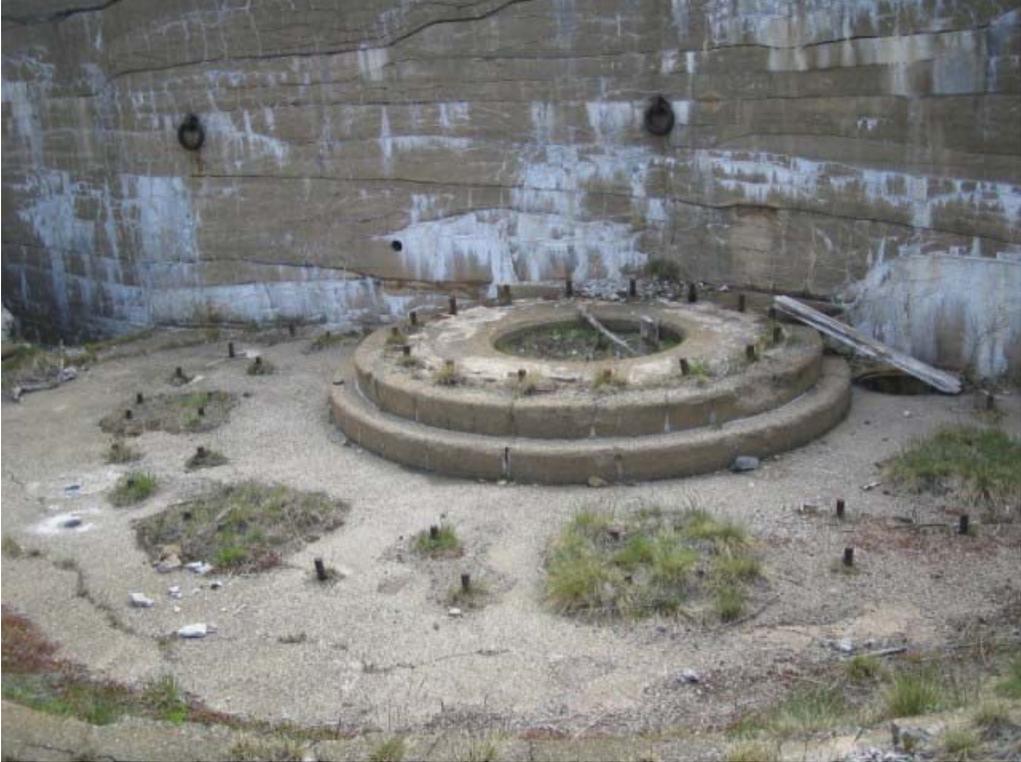
Gun Mount and Counterweight Well

Deficiencies: vegetation growth
 soil or sediment deposits

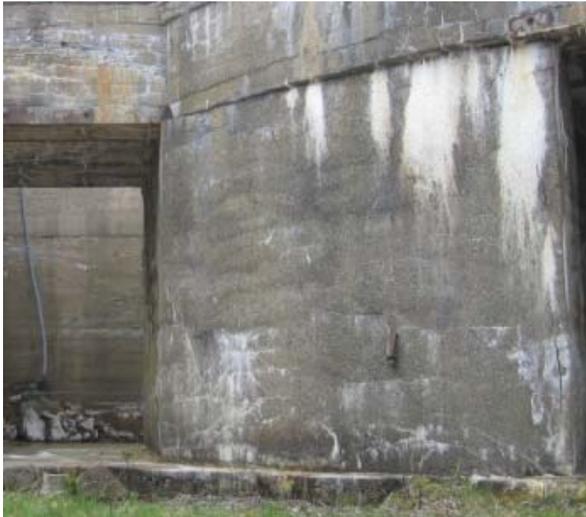
North Section of Curved Wall Below Roof Slab (Exterior of Battery Room)

Deficiencies: vertical cracking
spiderweb cracking
mineral deposits

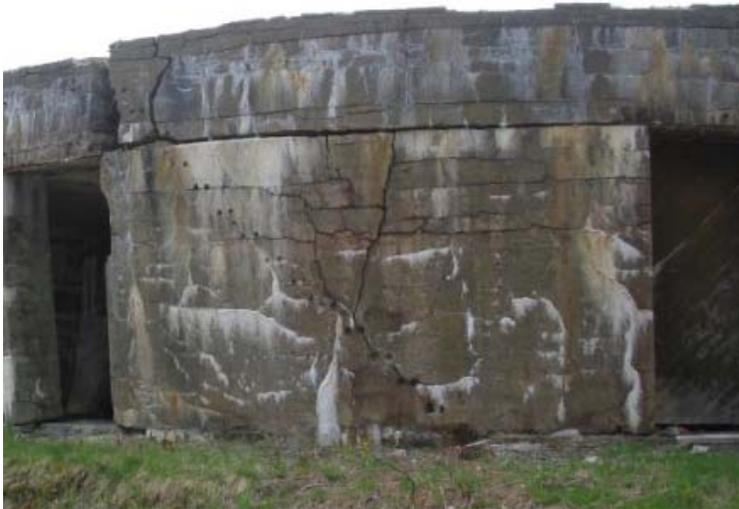
**West Section of Curved Wall Below Roof Slab
(Exterior of Guard and Shot Rooms)**

Deficiencies: horizontal cracking (typically at cold joints)
 vertical cracking
 spiderweb cracking
 structural movement/deformation

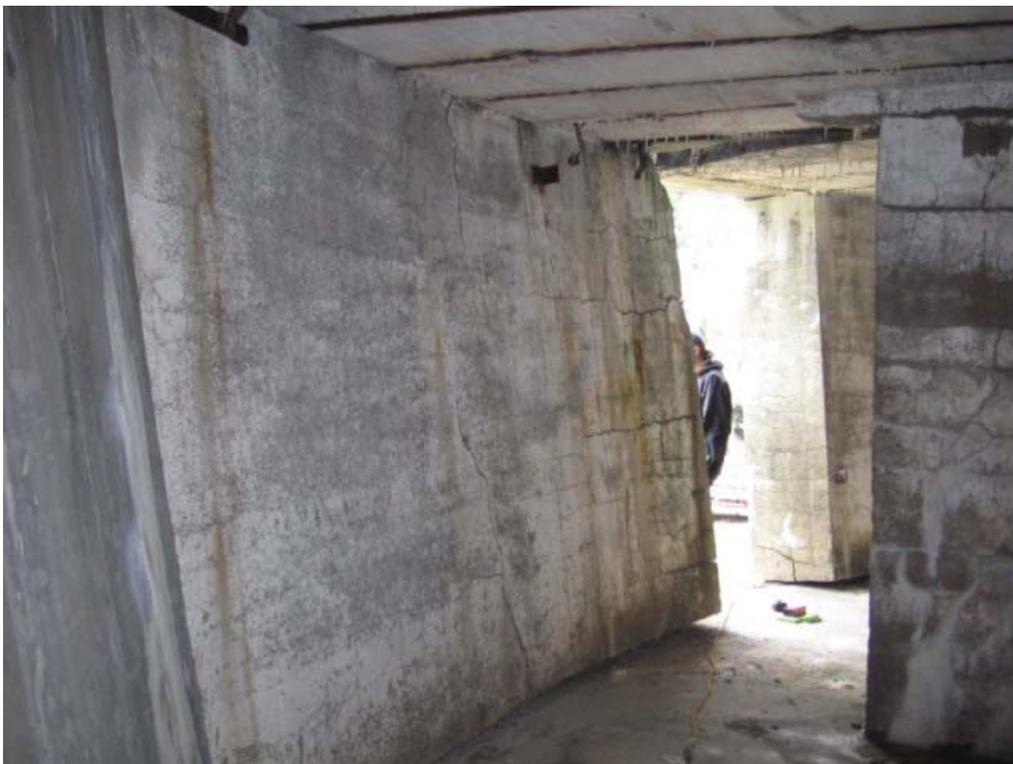
Shot Room, facing north: front curved wall (shared with Guard Room)

Deficiencies: horizontal cracking (typically at cold joints)
 diagonal cracking
 surface dampness
 microbiological growth

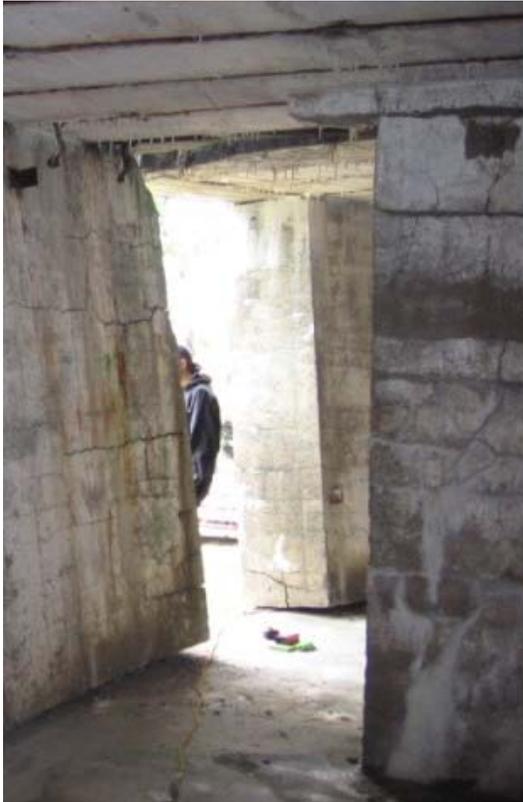
Shot Room, facing north: stub wall shared with Guard Room (at right of photo)

Deficiencies: horizontal cracking (typically at cold joints)
 diagonal cracking
 spiderweb cracking
 mineral deposits

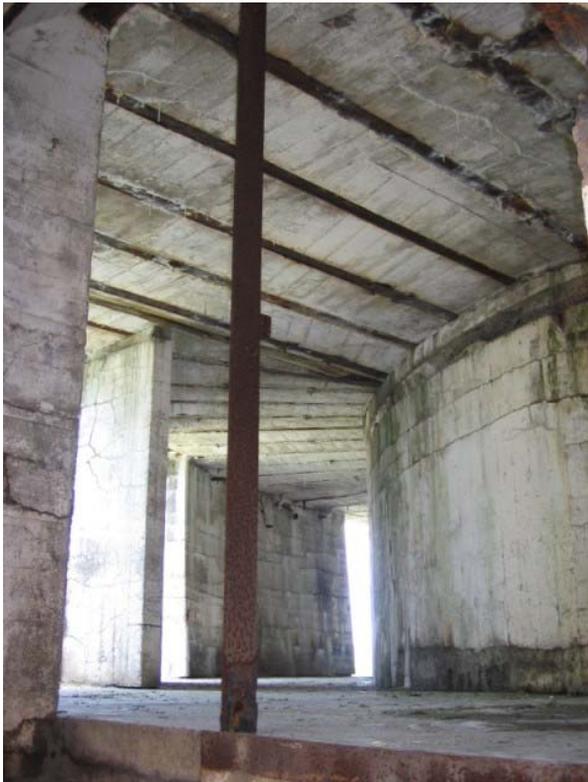
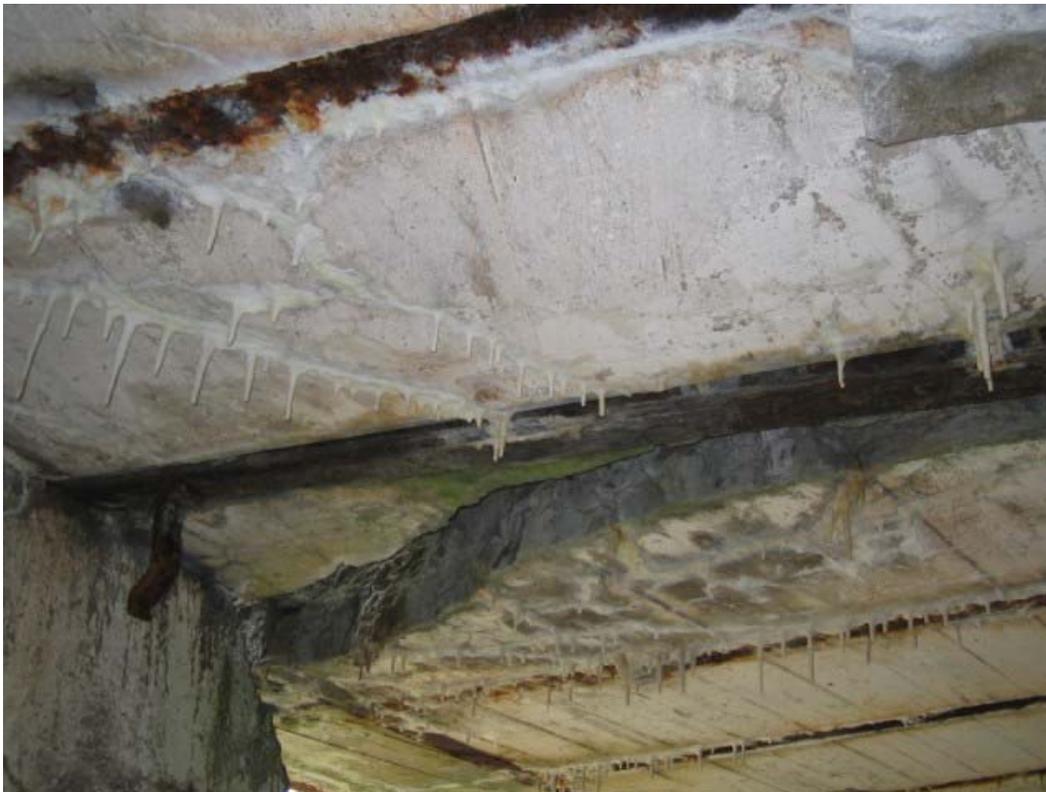
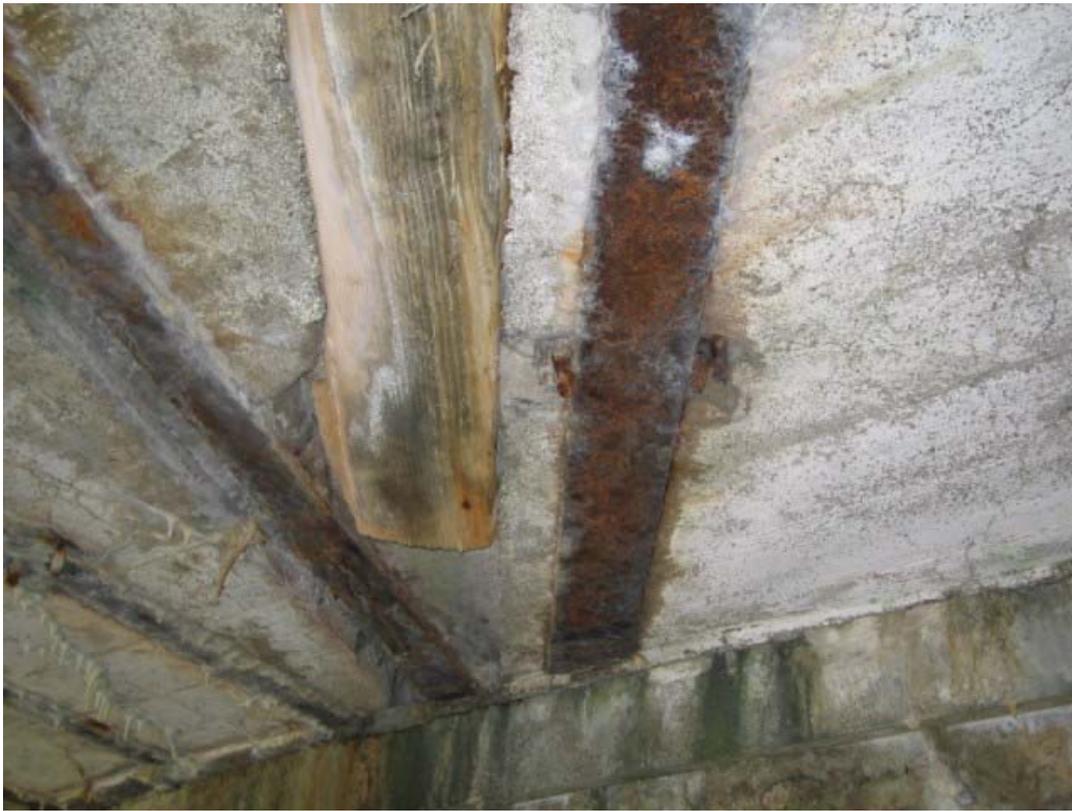
Curved Corridor Ceiling

Left: Curved ceiling of Shot Room and Guard Room. Photo taken from Hoistway, facing north.

Below: Detail of ceiling of Shot Room, facing north

Radial I- beams and wood nailers in ceiling

There is evidence of severe moisture infiltration on all ceiling surfaces. The steel I- beams are all corroded to varying degrees. Where there are wood "beams" (nailers) cast into the ceiling, they are saturated with water. Many areas have clusters or rows of small stalactites.

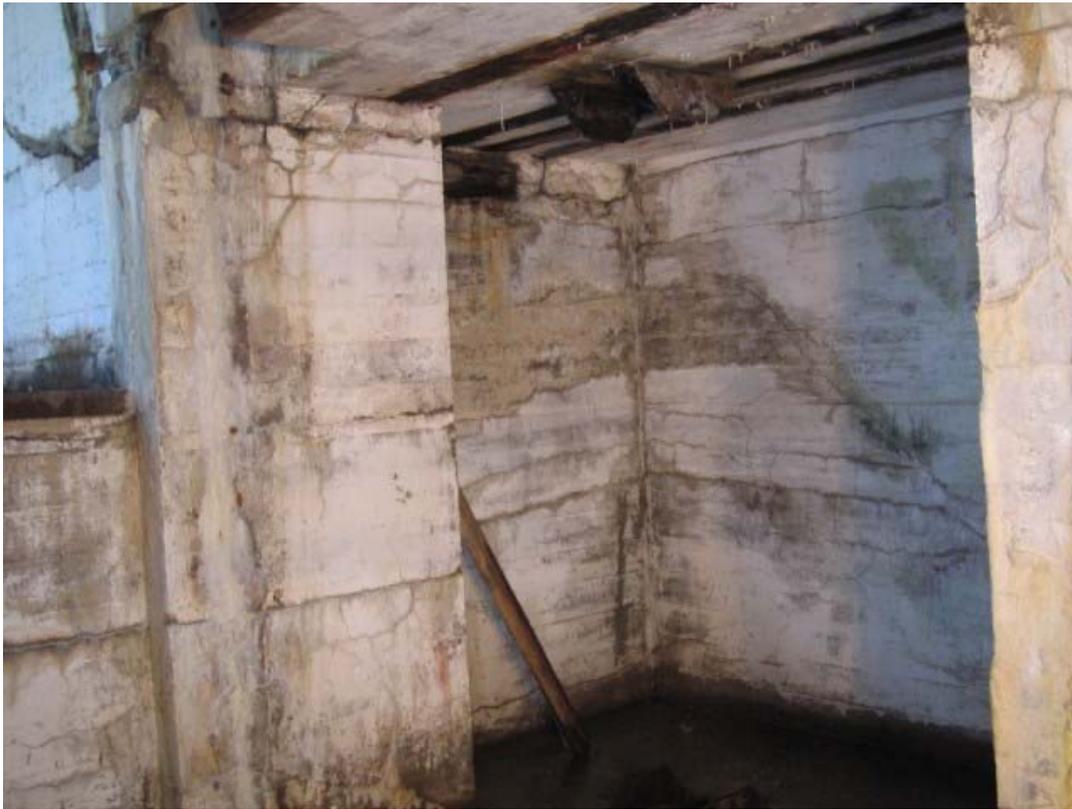
Manual Winch Alcove, looking east

Description: MG: southeast wall; algal
 HC
 DC: northeast wall
 SC
 MD: 70%; heavy
 SD, SW: floor
 MD: heavy on ceiling (in front of Hoistway)

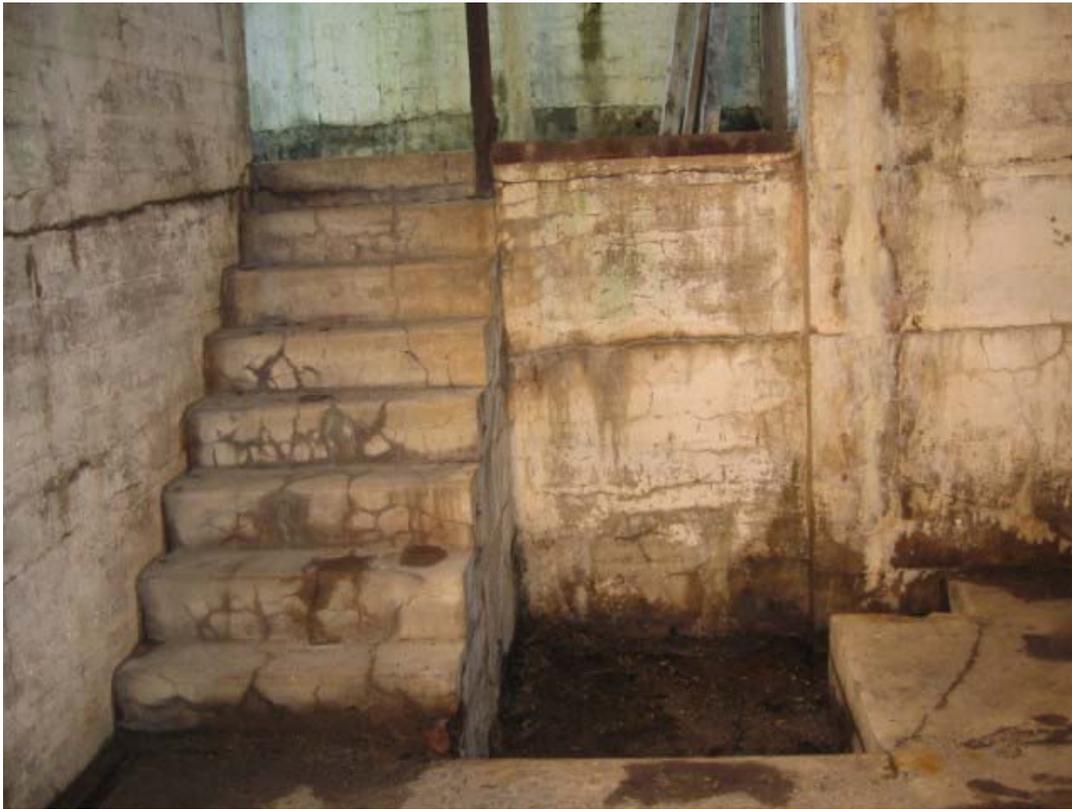
Hoistway and stair, looking northeast. The bottom of the Hoistway is to the right of the stair

There is some horizontal cracking, but relative to many of the other features the Hoistway appears to be in good condition.

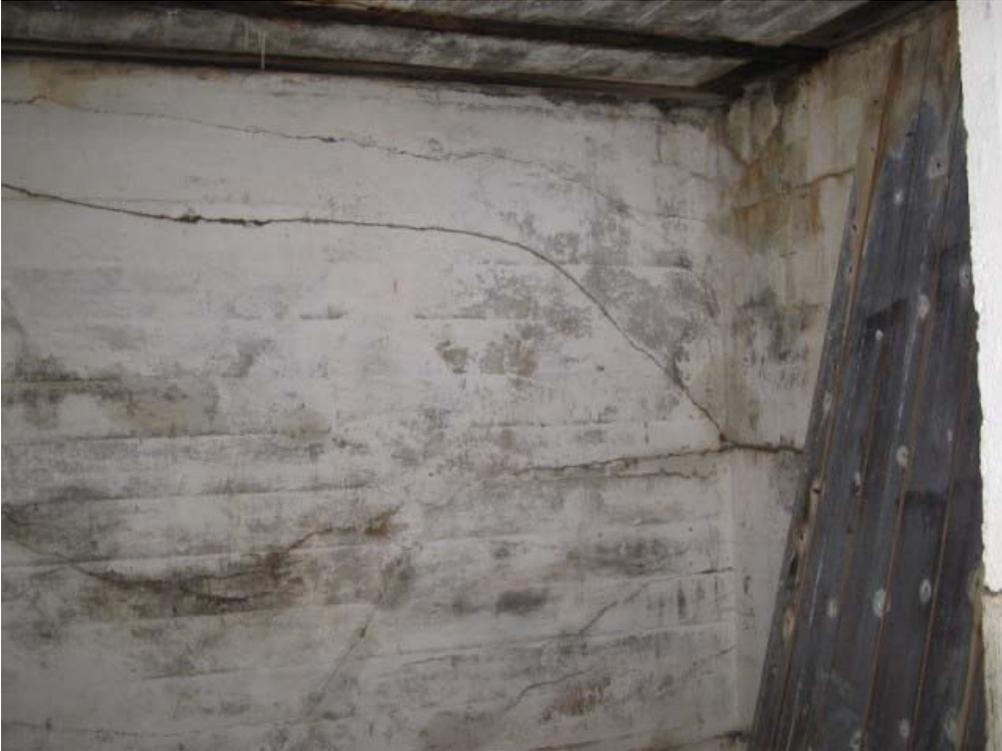
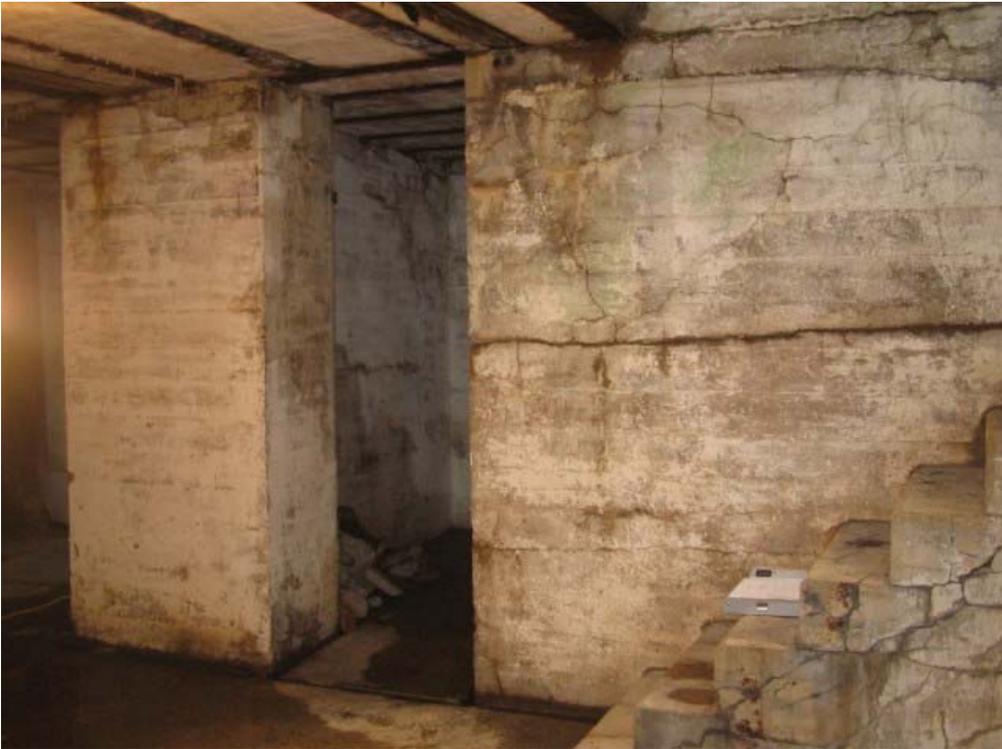
Relocating Room

Description: HC: northeast and southeast walls
 *DC: southeast, northeast, esp. northwest
 SC: minor on southeast
 MD: 10%; thin
 SW: floor

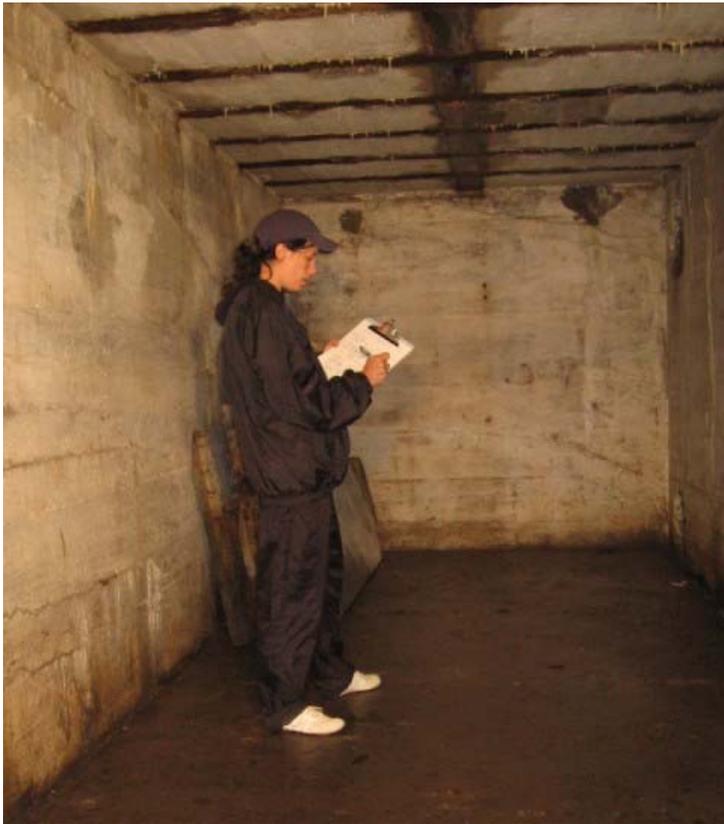
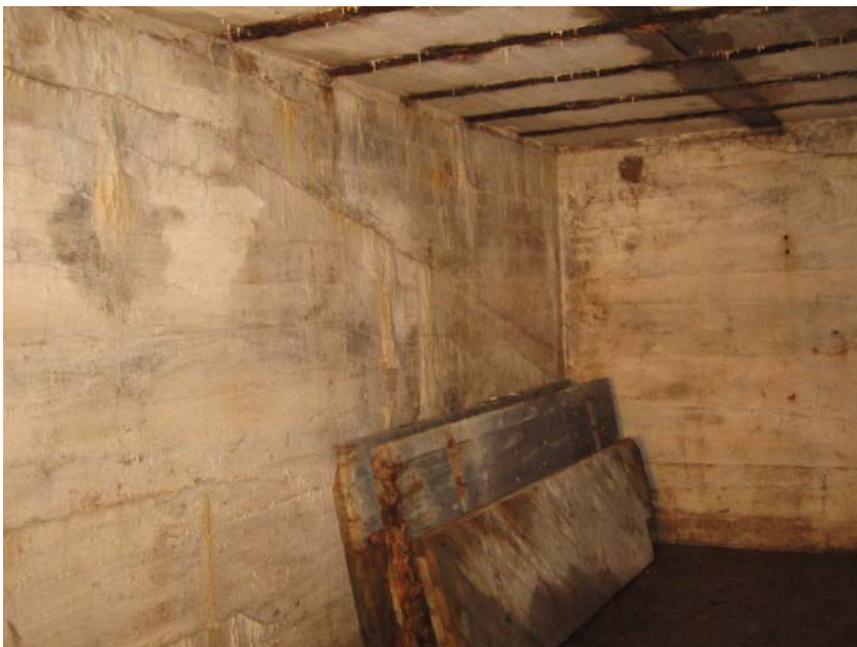
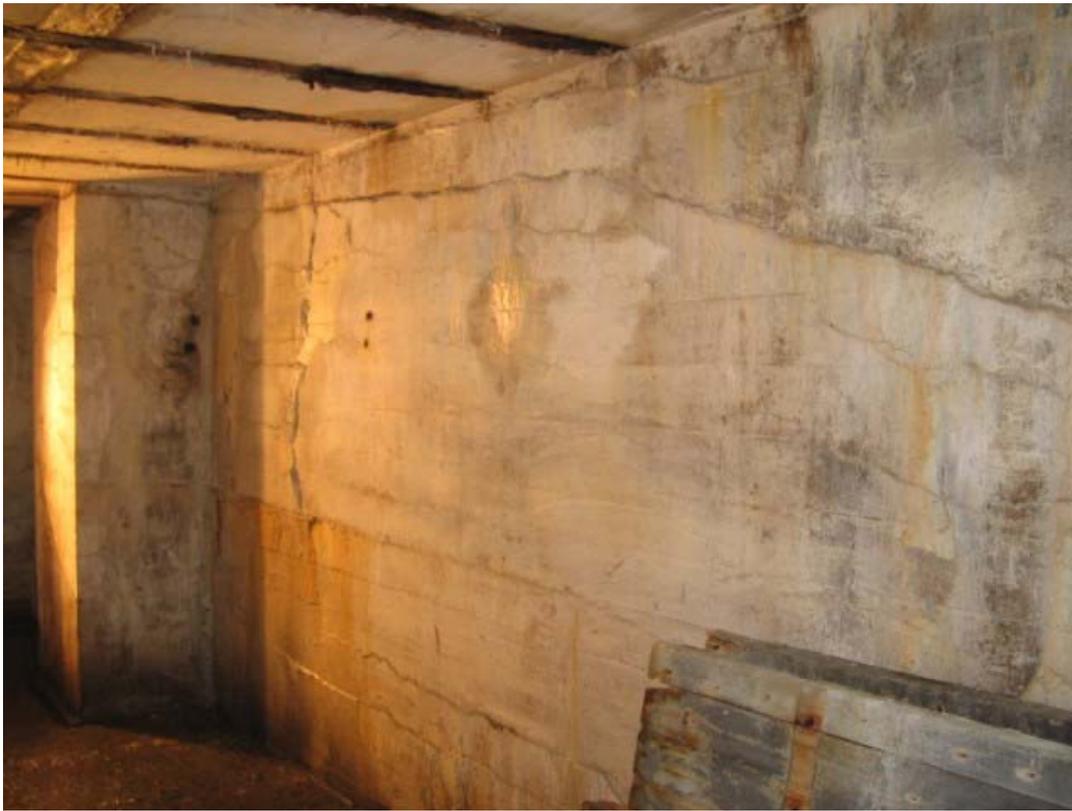
Shell Room

Deficiencies: There is evidence of severe moisture infiltration on all ceiling surfaces. The steel I- beams are all corroded to varying degrees. Where there are wood “beams” (nailers) cast into the ceiling, they are saturated with water. Many areas have clusters or rows of small stalactites.

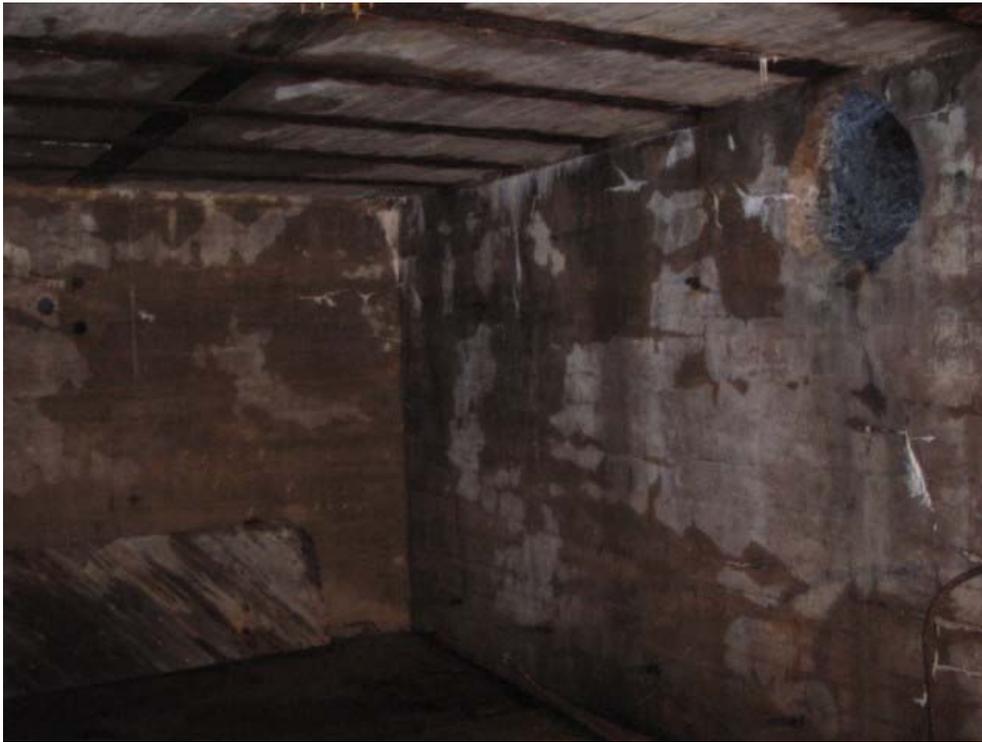
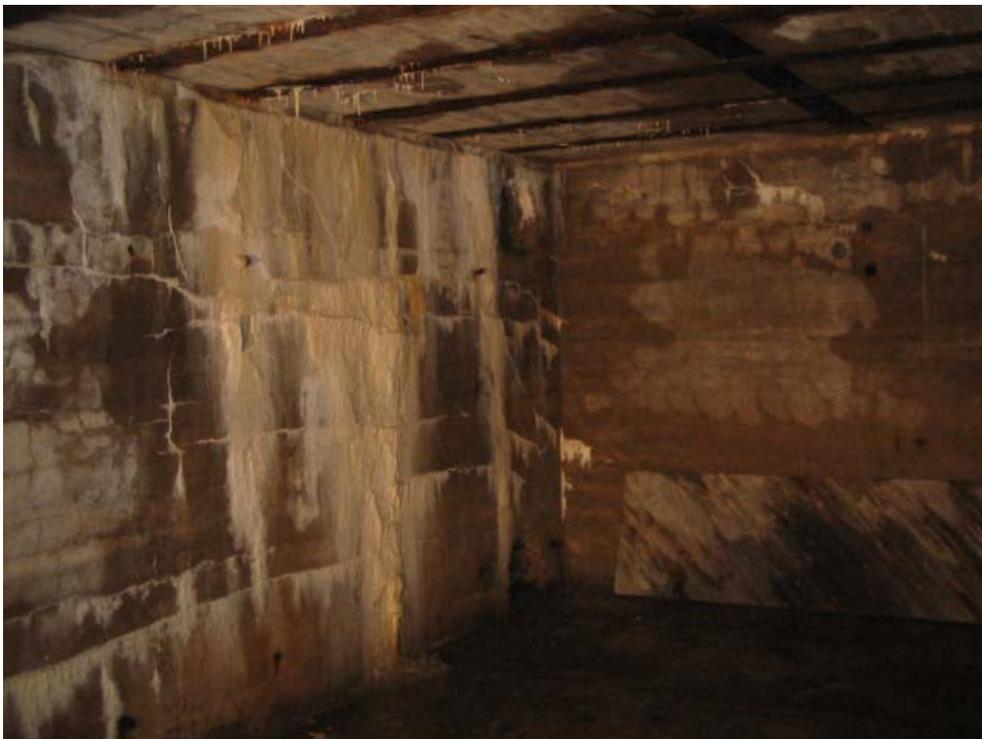
Powder Magazine

Deficiencies: There is evidence of severe moisture infiltration on all ceiling surfaces. The steel I- beams are all corroded to varying degrees. Where there are wood "beams" (nailers) cast into the ceiling, they are saturated with water. Many areas have clusters or rows of small stalactites.

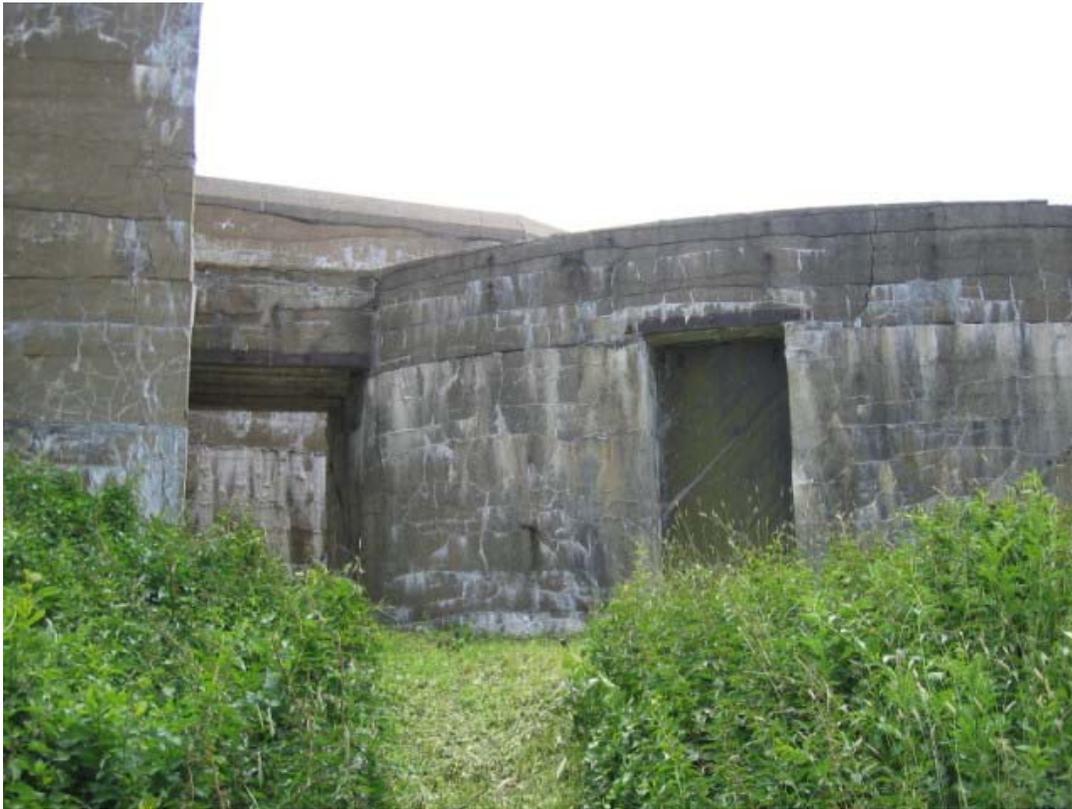
Loading Platform Stair

Deficiencies: horizontal cracking (typically at cold joints)
 large- scale structural cracking (more than 1" wide)
 vertical cracking
 spiderweb cracking

Description: **SP: in association with cracks, and at coping.
 Large areas in east corner and below bridge

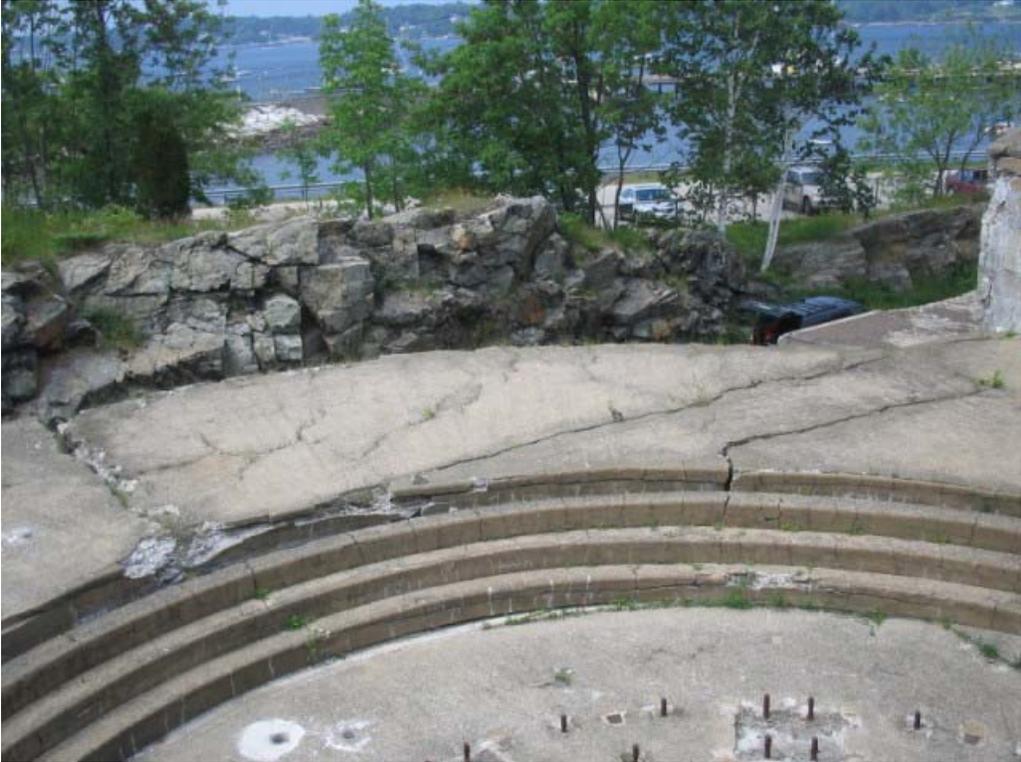
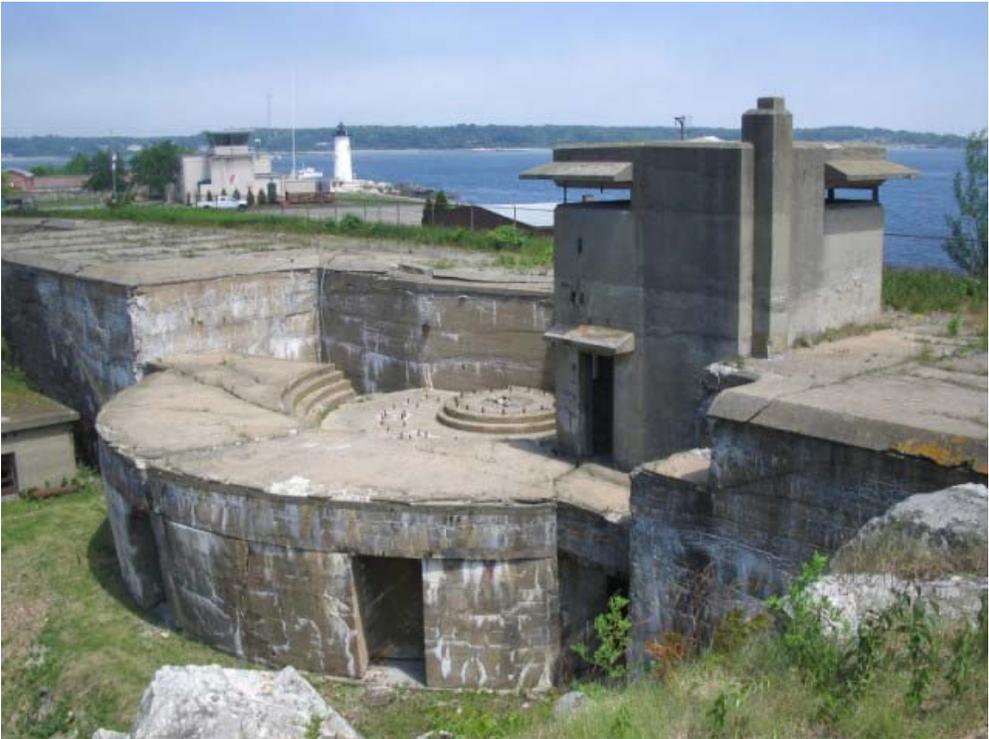
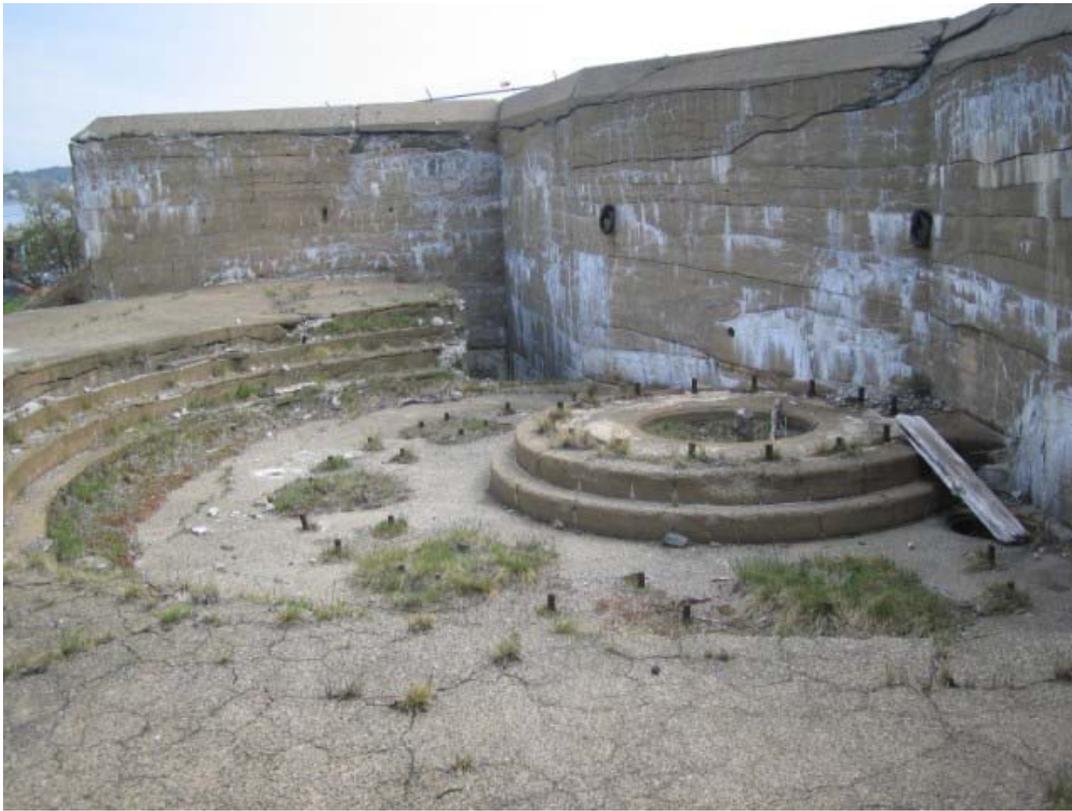
There are two large cracks through the slab thickness where the portion of the slab has detached from the rest of the structure and moved forward. These occur radially from the semicircular steps out to the exterior edge. One, near the northeast end of the slab, is 4 ½ inches wide and traverses the ceiling of the Battery Room. The other, near the southwest end of the slab, crosses the Shot Room ceiling in front of the Observation Station. The movement of the slab, and the resulting structural displacement, is largely within the area circumscribed by these cracks, the semicircular steps, and the exterior edge of this part of the structure.

On the top of the Loading Platform are several large cracks in addition to the ones described previously. One runs along the top semicircular step, one runs radially through the middle, and a third begins close to the middle crack and moves laterally to the northeast corner of the exterior semicircular wall.

Deficiencies: large- scale structural cracking (more than 1" wide)
 structural movement/deformation
 spiderweb cracking
 spalling

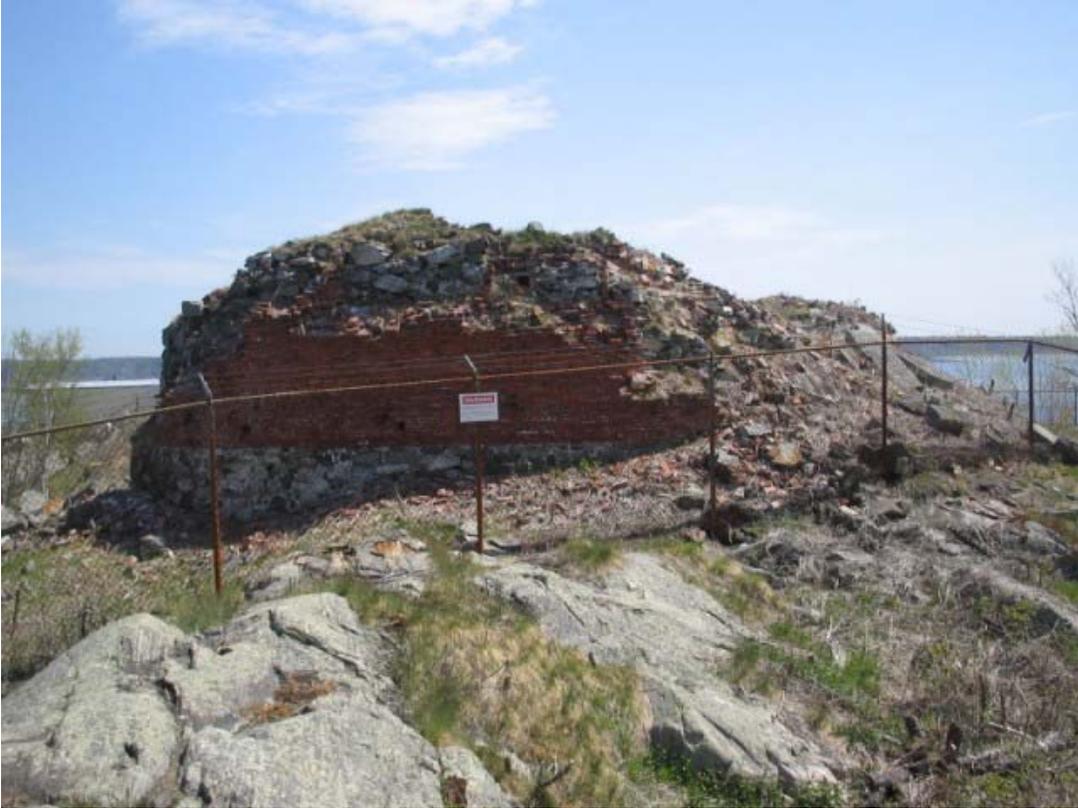
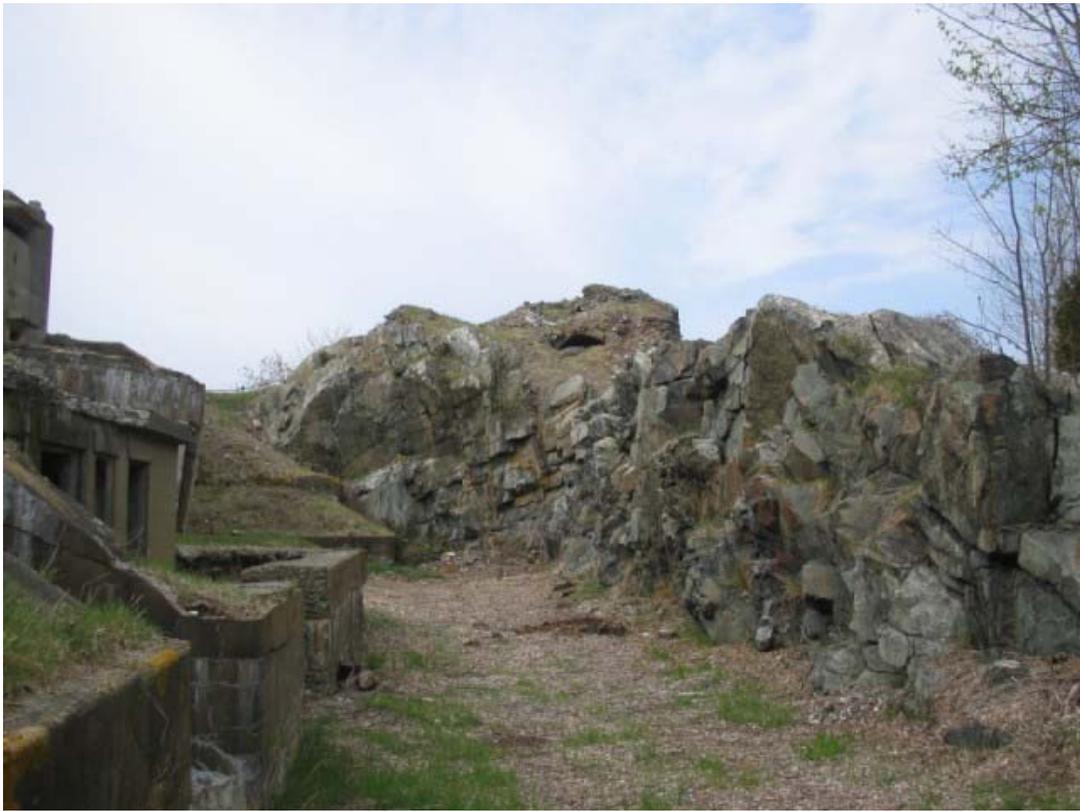
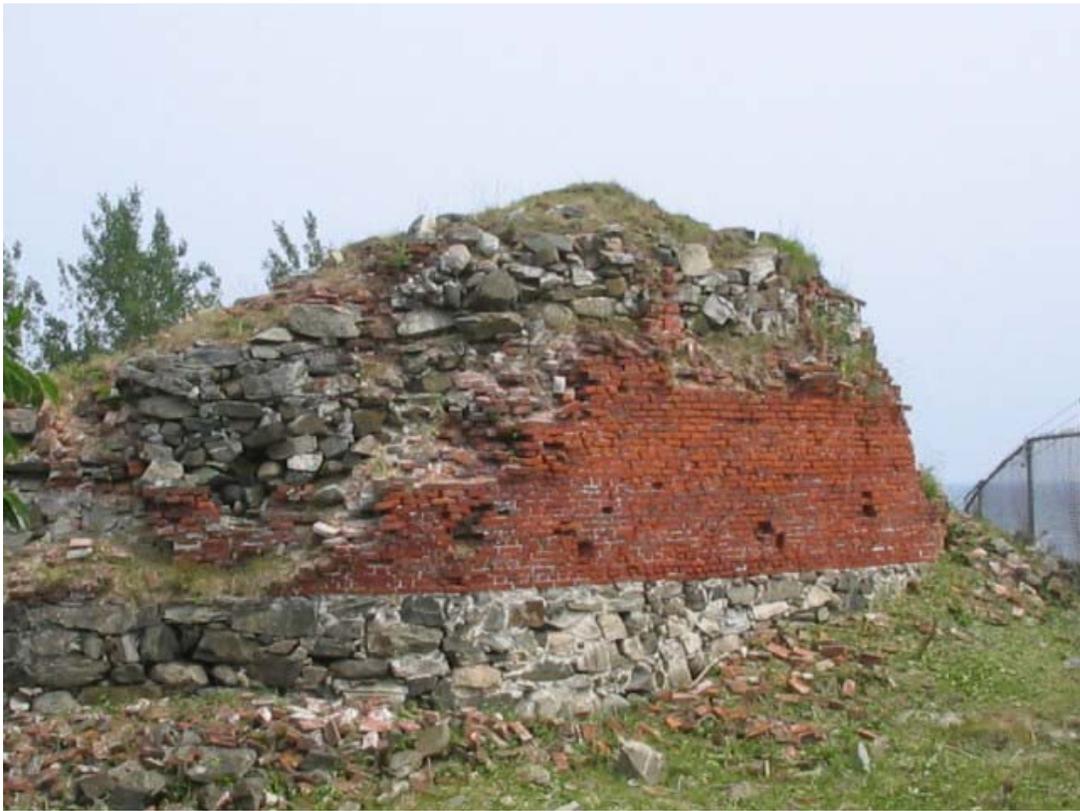
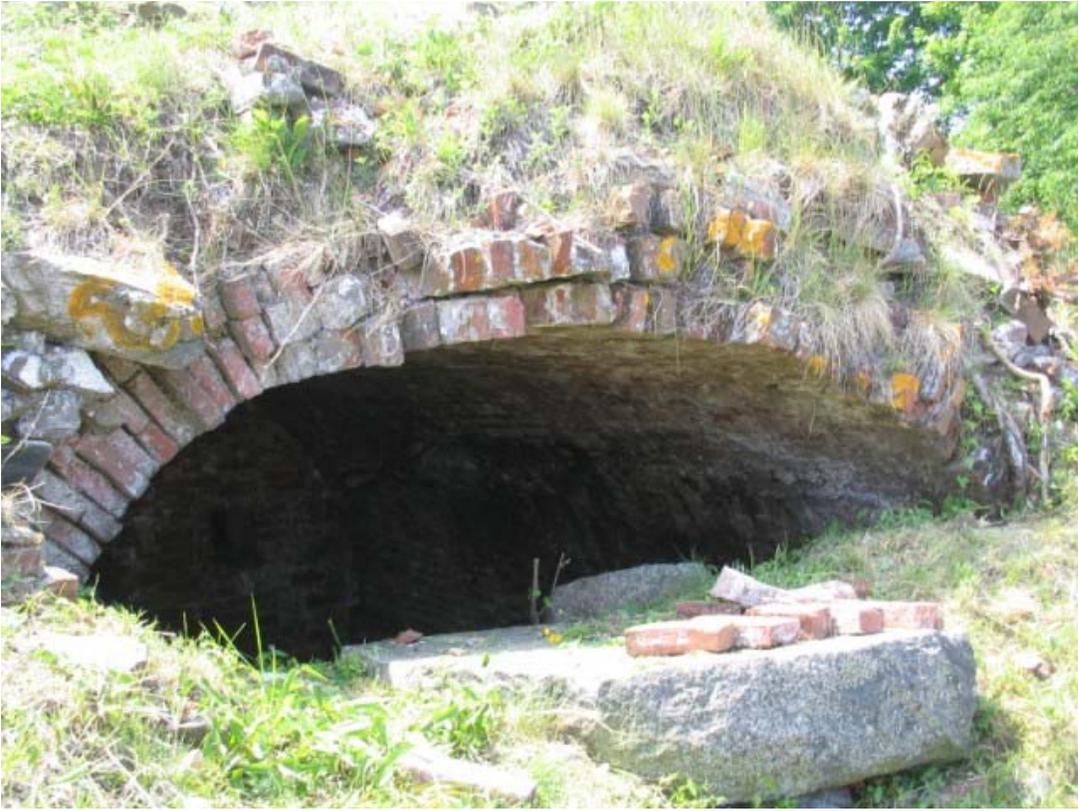
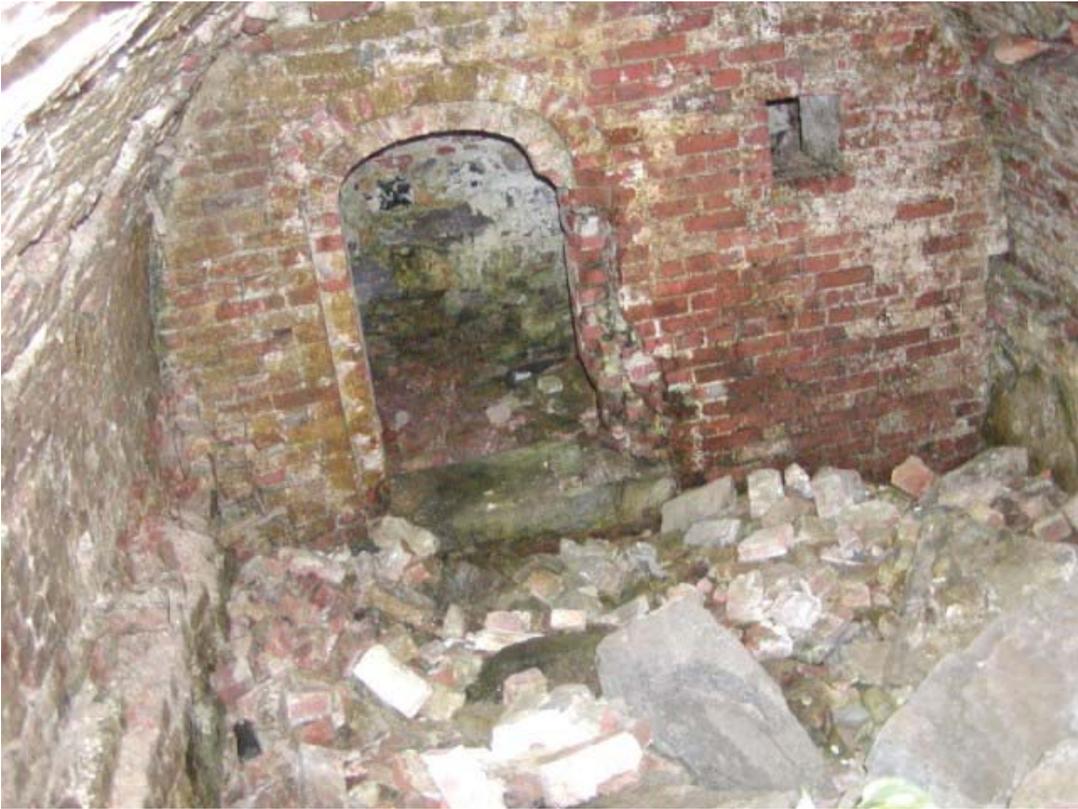
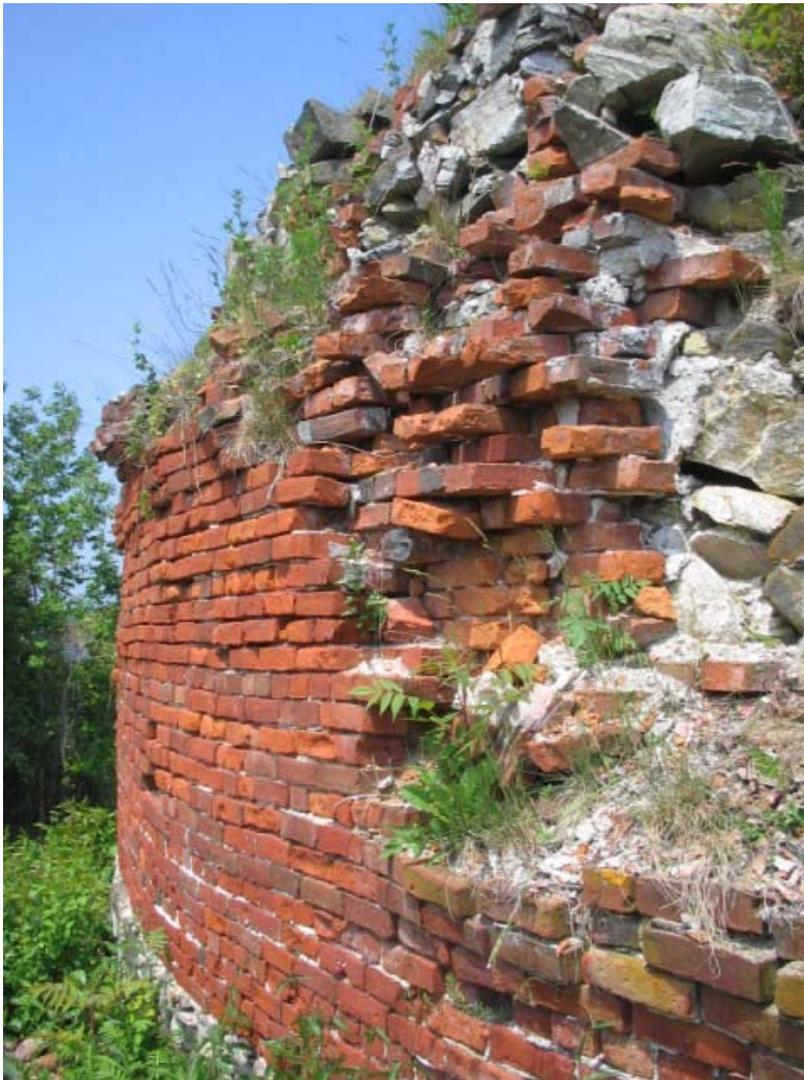
WALBACH TOWER

As described in the "Feature Description" section, Walbach Tower is a ruin, or a fragmentary structure in an advanced state of deterioration. Historical photographs from the early 20th century (date?), however, show that the structure has been a ruin for most of its existence. It is probable that the tower was never even completed as intended. The above- grade masonry remains are in unstable condition. The mortar bonding the brick and stone courses and wythes is failing, causing the fragmentary wall to "unravel" as the masonry units at the edges fall off or become dislodged, exposing the units behind them to the same fate. Water can penetrate at all faces of the walls, including directly into their interior from above. This uncontrolled, omnidirectional moisture infiltration is hastening the deterioration of the mortar and wall structure.

The situation of the tower walls partially within the rock outcropping, as well as the infill of the above grade casemates, results in differential drainage conditions that further encourage moisture movement through the walls, draining from the filled/buried side of wall to the other side: the interior of the powder magazine, and the exterior wall of the upper casemates.) There is ample evidence of moisture infiltration in these areas. The brick of the exterior is porous and worn, with mortar deterioration. The bricks and mortar of the interior vault are also deteriorating, with numerous cracks through both bricks and mortar and open joints. The west side of the vault is damp, and there is thick biological growth.
