WALBACH TOWER, BATTERY FARNSWORTH, ASSOCIATED STRUCTURES, AND ENVIRONS

Fort Point
New Castle, New Hampshire

HISTORIC STRUCTURES REPORT

PART II

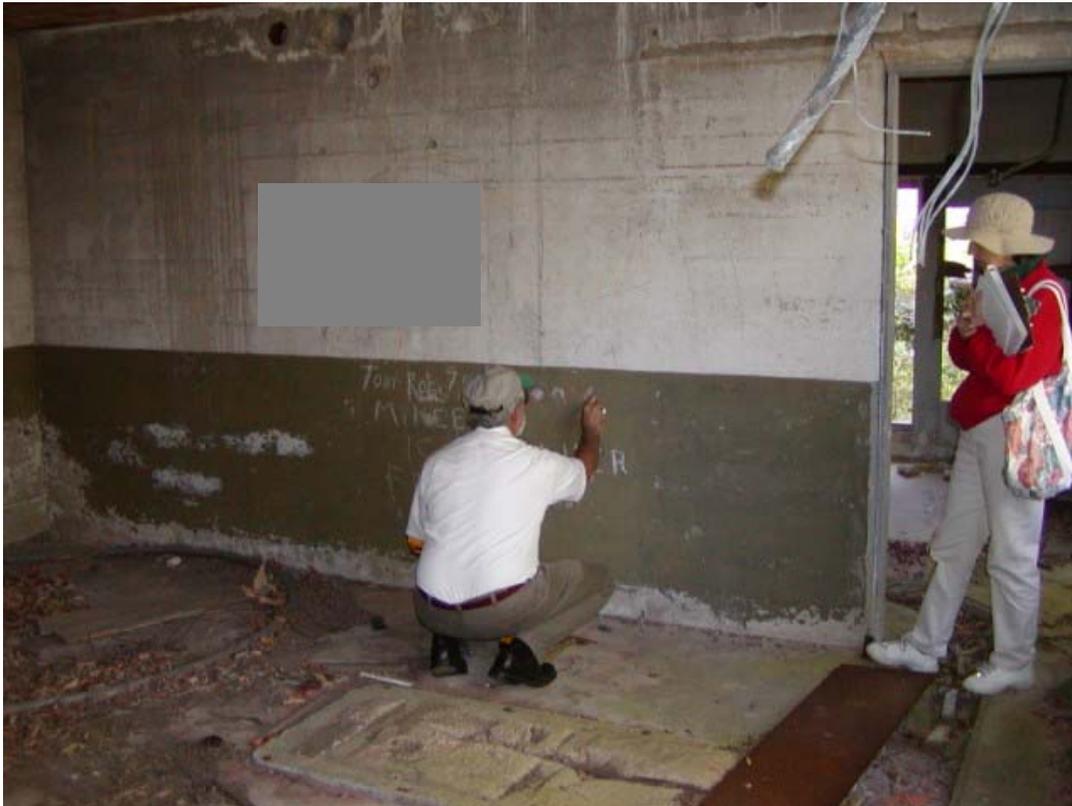
Engine Room

The Power Plant is in good condition relative to most of the other structures. Because the rebar of the walls is not too close to the concrete surface, there is relatively little of the spalling that sometimes plagues reinforced concrete buildings of this vintage. There is a white carbonate "wash" along the upper part of the S wall at the ceiling juncture.

The ceiling has been carelessly repointed with Portland cement. There are patches of white efflorescence along the W (front) side, with associated delamination and spalling of the terra- cotta tiles. This area of water damage corresponds to the spalled cornice on the exterior.

The doors and window sashes are missing. There is a diagonal crack above the E corner of the doorway leading to the Radiator Room.

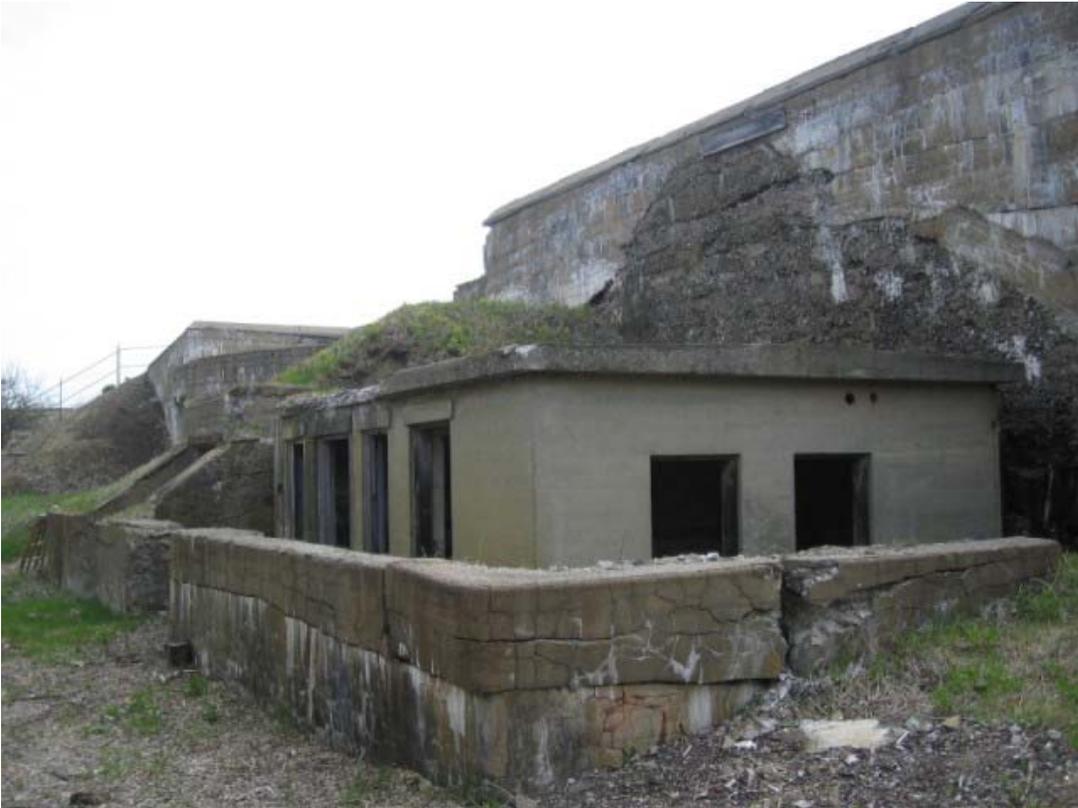
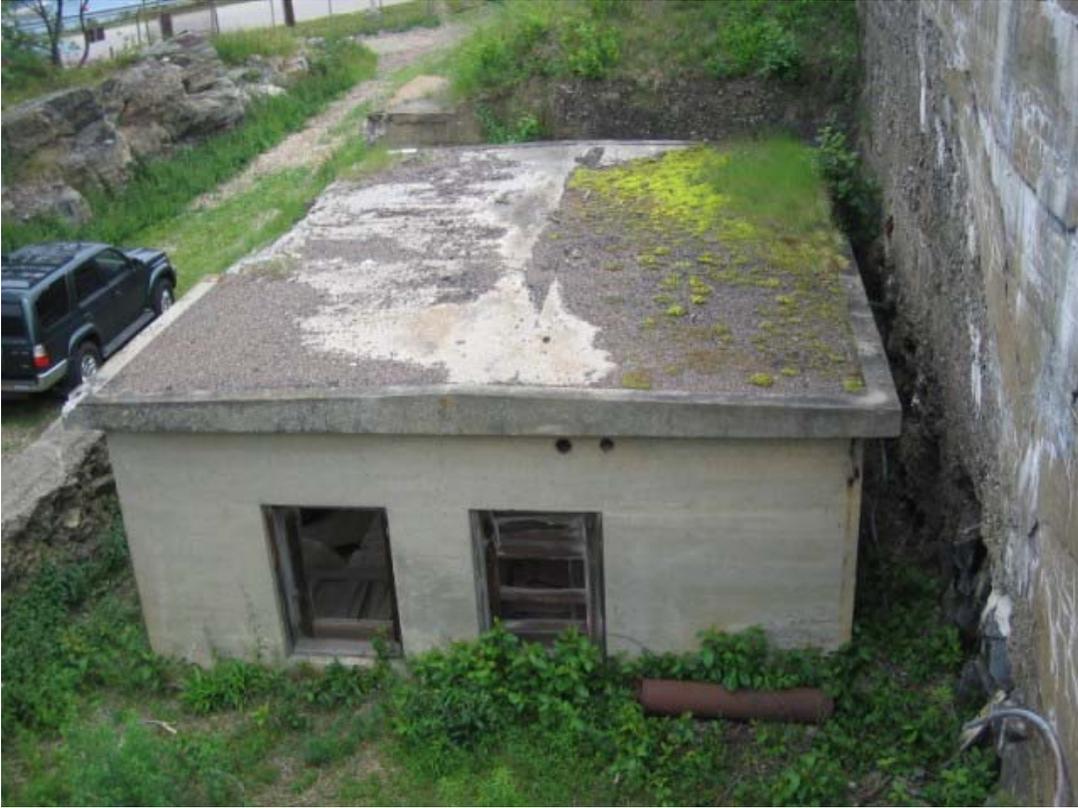
Exterior and Roof

The Power Plant is in good condition relative to the rest of Battery Farnsworth.

The roof overhang is spalled along the northwest (front) elevation both on the northeast half and at the southwest corner. There is exposed rebar in the middle 9- 12" of the slab. On the lintel of the northeast window on the northwest elevation there is a 3" x 12" spall. The cornice is spalled at the northeast end of the southeast (rear) elevation, beneath the tree.

There is green biological growth on the southeast elevation, and red and yellow lichen growth on the northeast elevation where it is shaded by the berm. There is also some lichen growth on the northwest elevation. The northwest elevation has the carbonate "washing" seen on the interior between the roof overhang and the lintels on the Engine Room façade, particularly around the northeast window.

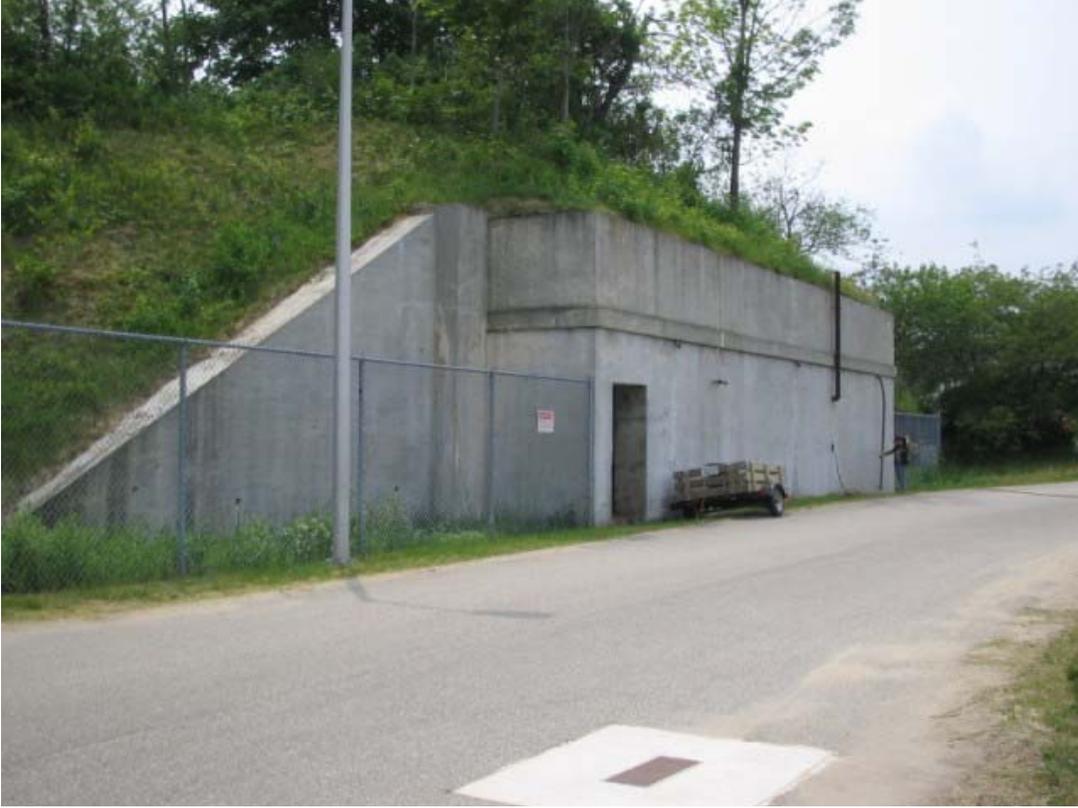
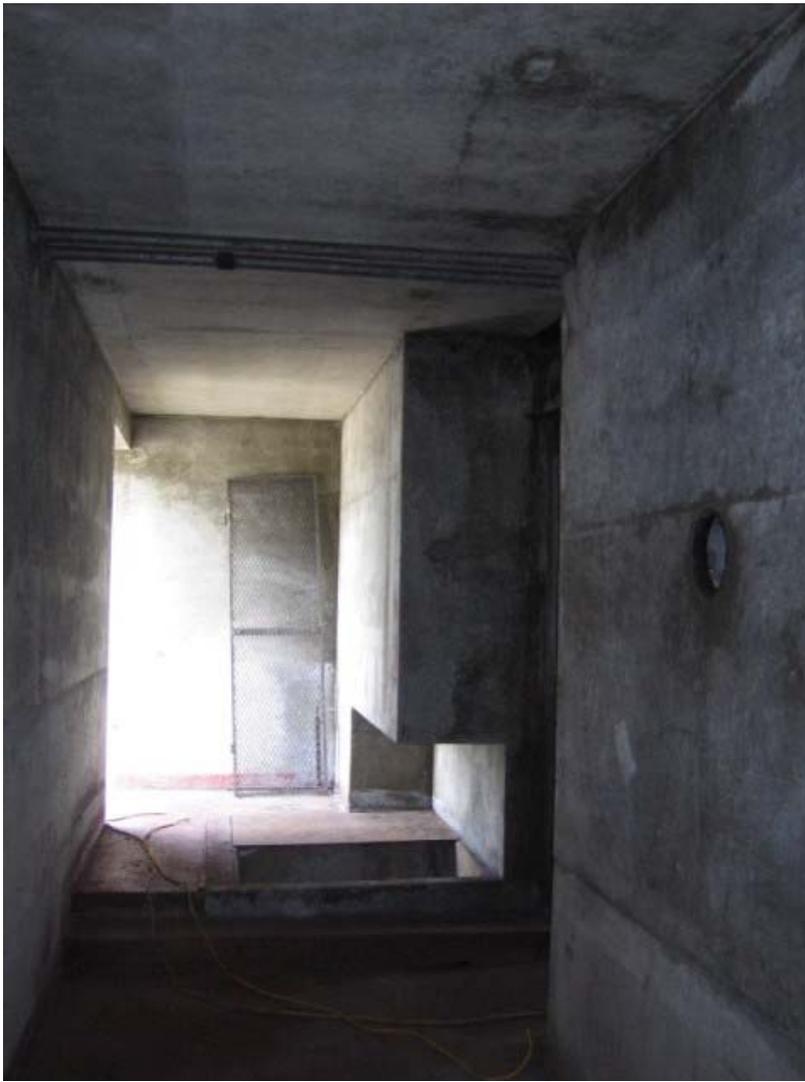
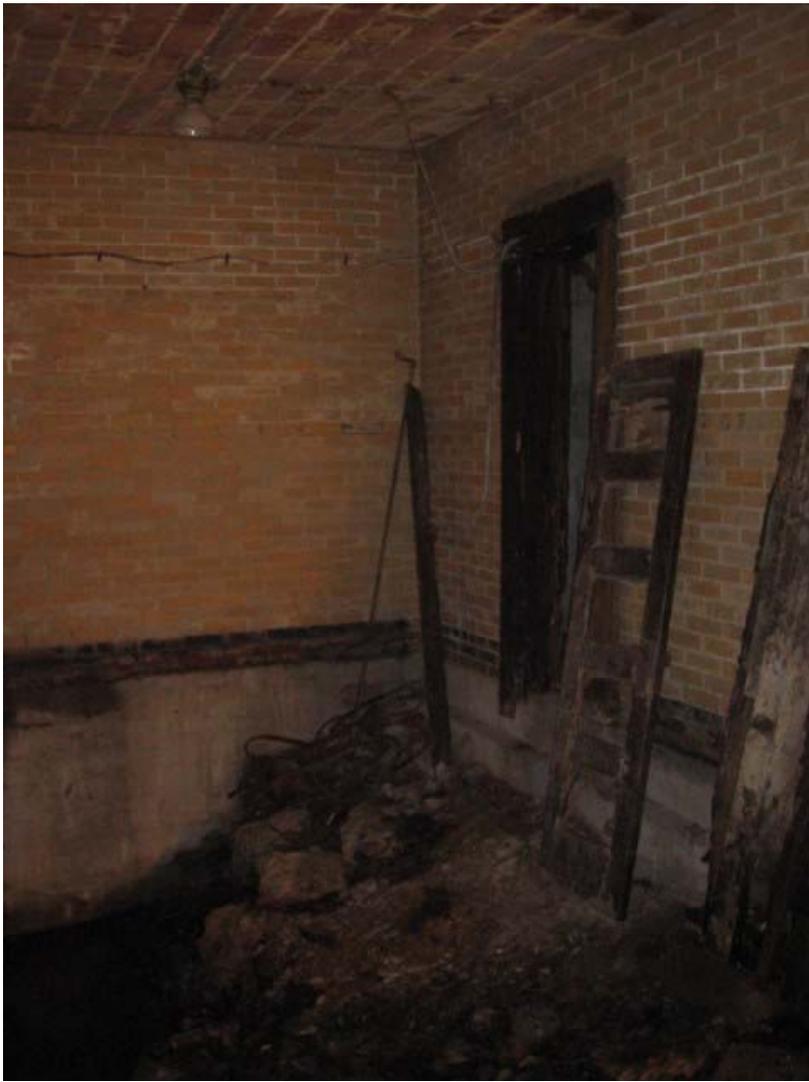
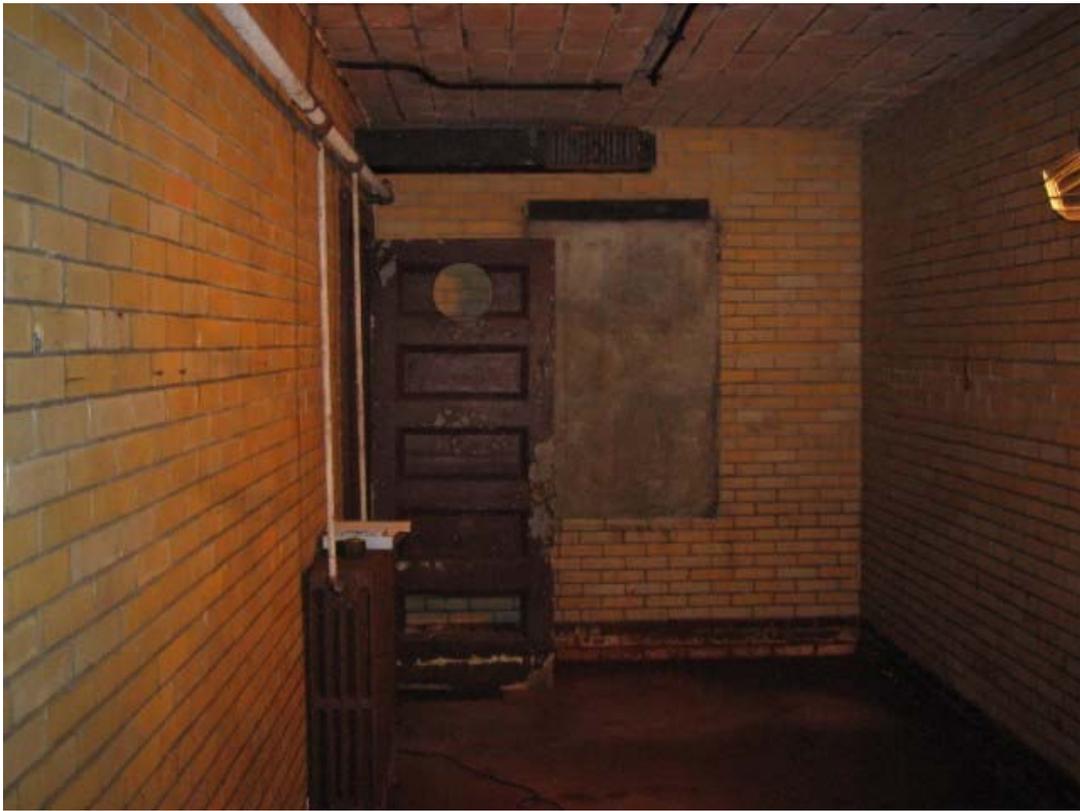
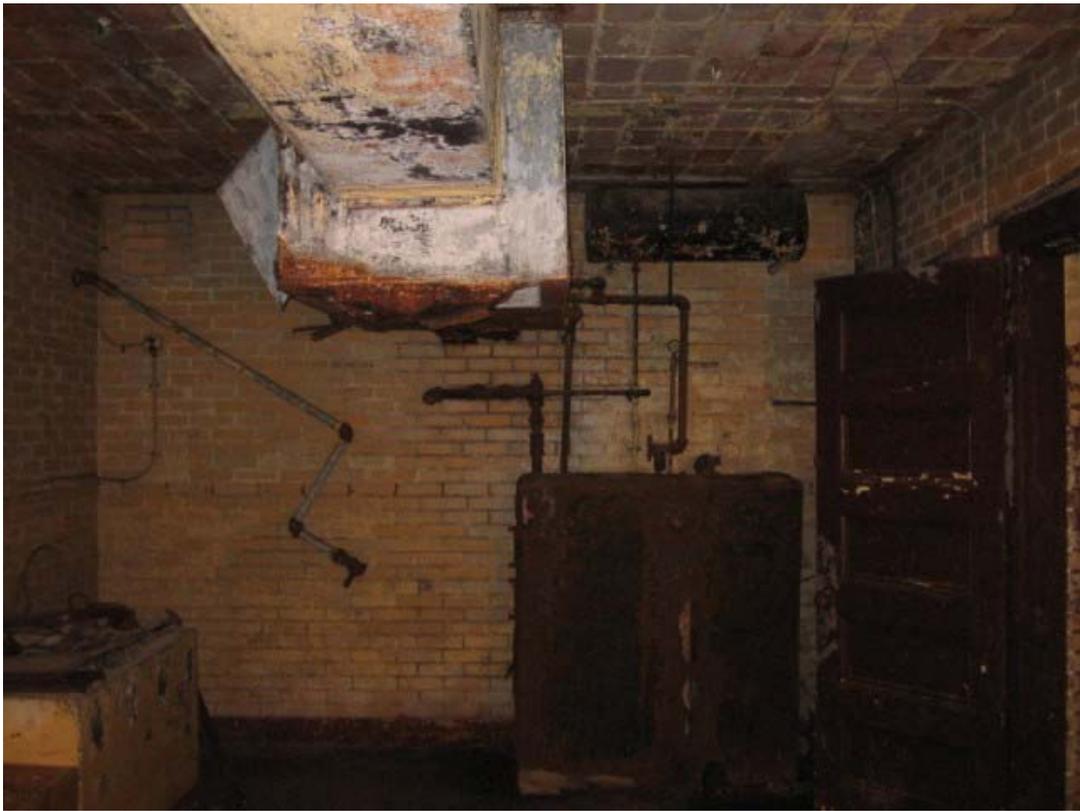
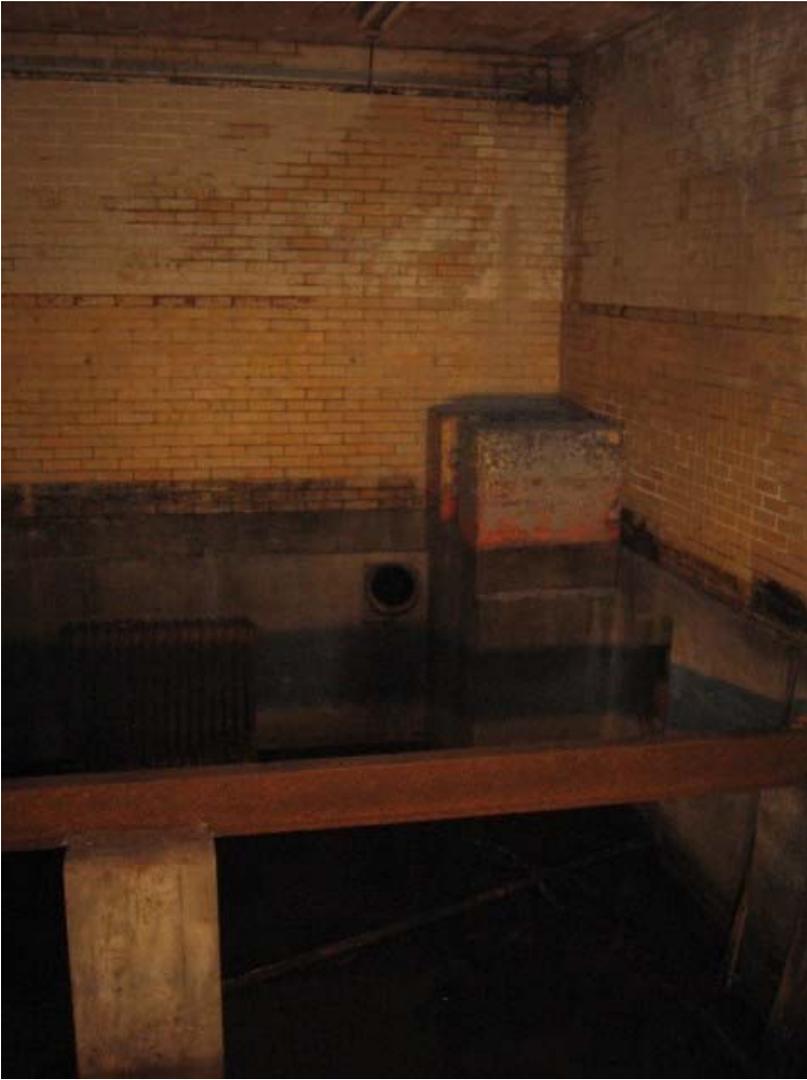
1920 MINING CASEMATE

The Mining Casemate is structurally stable but has drastic moisture problems in every part of the structure. The Operating Room, Dormitory, and toilet room (all with missing wood floors) flood with up to 2' of water after heavy rains. Other surfaces are damp, and all remaining metal elements in the structure are corroded. There are stalactites hanging from the concrete ceiling in the interstitial space, and mortar efflorescence in the tile ceiling and brick walls of the inner structure.

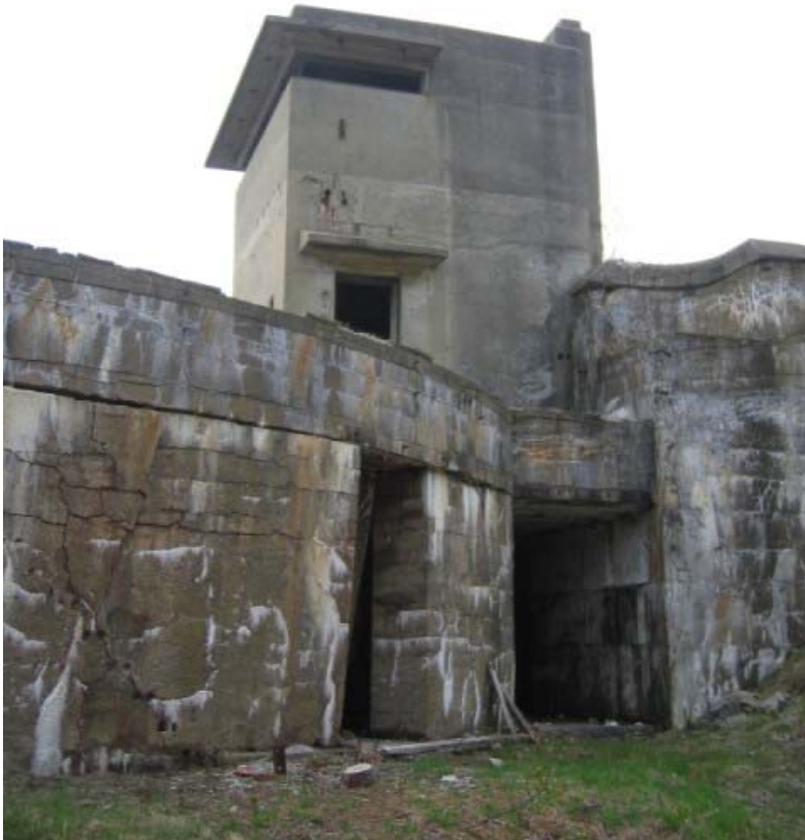
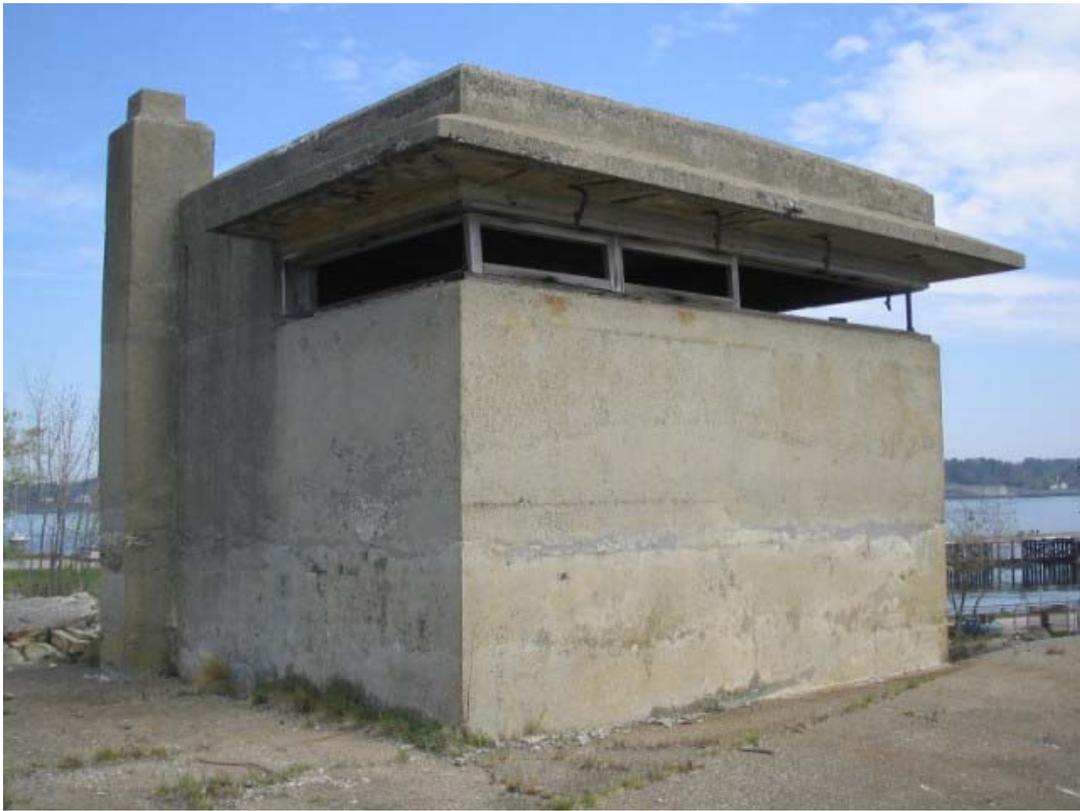
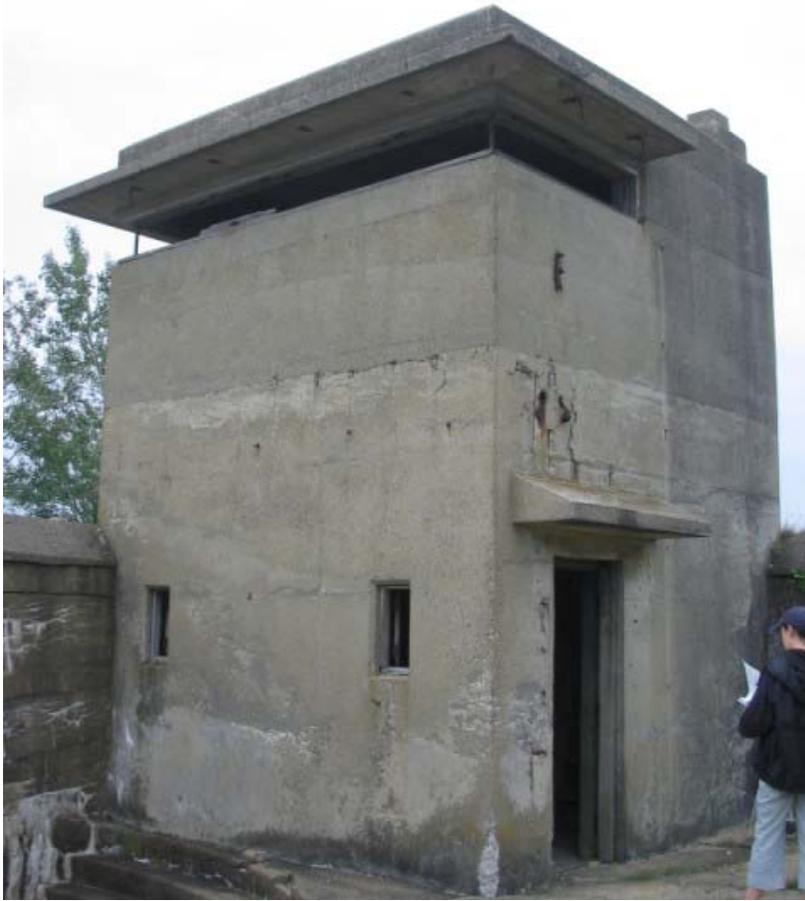
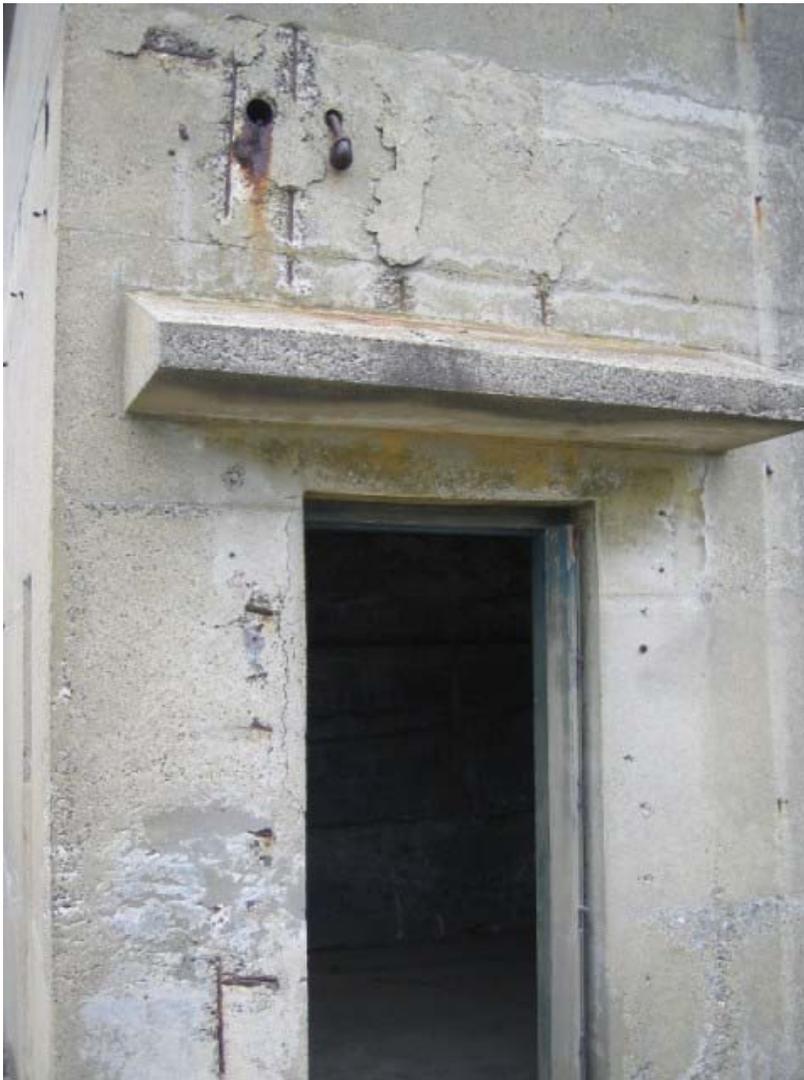
1943 OBSERVATION STATION (EXTERIOR)

The weight of the Observation Station, superimposed on the Loading Platform floor and scarp walls has resulted in differential loading and movement in the Loading Platform slab. This movement is evidenced by a 3" wide crack of undetermined depth separating the outer platform slab from the portion supporting the Observation Station. In addition, the level of the slab supporting the Observation Station is 2" lower than the remainder of the Loading Platform slab.

There is about 4 sf of exposed rebar along the lower left side of the northwest wall, northeast of the doorway opening. There is another substantial area of exposed rebar on the northwest wall above the doorway hood, totaling 15 sf. There are incipient spalls adjacent to the already exposed rebar. On the north wall there is an area of exposed rebar along a pour line, 11'- 0" above the Loading Platform floor. This area is approximately 7'- 0" long x 6"- 8" wide.

The roof overhang fascia is failing in several areas totaling approximately 8 lf, due to the thin section of the overhang, poorly consolidated aggregates in the concrete mix, and placement of rebar too close to the surface of the concrete. The roof soffit shows a number of areas of spalling concrete and exposed rebar, totaling 10 sf. The beveled edge of the top of the roof slab has approximately 4 sf of spalled or poorly consolidated concrete. The west corner of the chimney base shows cracking and spalling possibly related to differential settlement. This damage appears to be of fairly recent origin.
